Civil Engineering and Development Department

**Agreement no. CE 47/2014 (GE)
-Landslip Prevention and Mitigation
Programme near Bride's Pool Road,
Tai Po – 3SE-D/SA2**

**Monthly Environmental Monitoring and
Audit Report for
September 2024**

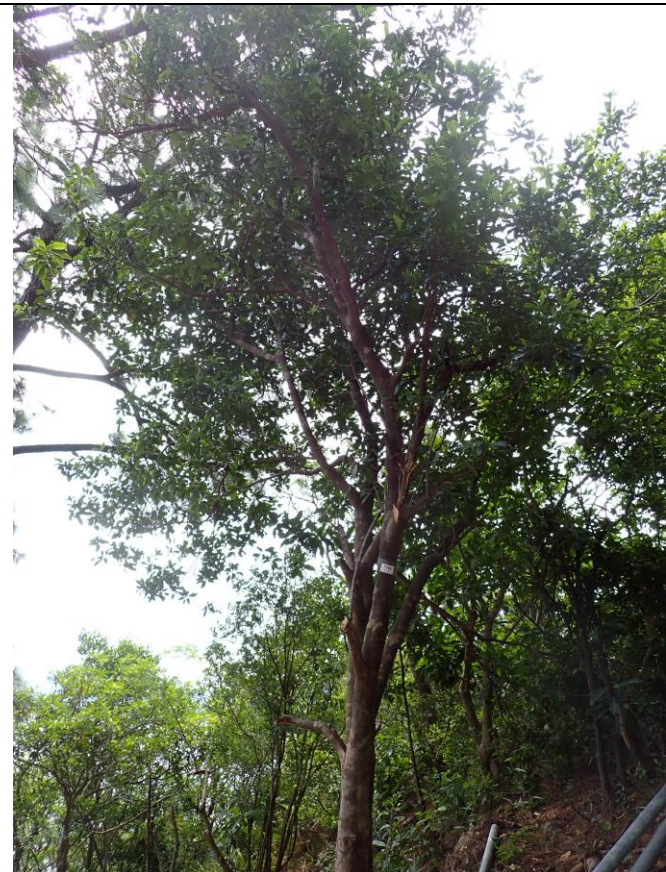
Tree No.	Chinese name	Scientific name	Jurisdiction (AFCD & Highways)	Amenity value	Form	Health	Structural condition	Conservation status	Remarks	Remarks (September)
				(High(H)/ Medium(M)/ Low(L))						
T169	山油柑	<i>Acronychia pedunculata</i>	AFCD	M	A	A	A	/	/	Grow on slope, broken branches
T170	山油柑	<i>Acronychia pedunculata</i>	AFCD	H	G	G	A	/	/	Grow on slope, broken branches, exposed root
T171	鴨腳木	<i>Schefflera heptaphylla</i>	AFCD	H	G	G	A	/	/	Grow on slope, broken branches, dead branches
T172	木荷	<i>Schima superba</i>	AFCD	H	G	G	A	/	/	Grow on slope, broken branches, water sprouts
T173	黃瑞木	<i>Adinandra millettii</i>	AFCD	M	A	A	A	/	/	Grow on slope, broken branches, water sprouts
T174	鴨腳木	<i>Schefflera heptaphylla</i>	AFCD	M	A	A	A	/	wound at intersection of codominant trunk	Grow on slope, incline, covered by climbers, water sprouts
T175	銀柴	<i>Aporosa dioica</i>	AFCD	M	G	A	A	/	/	Grow on slope, broken trunk, broken branches

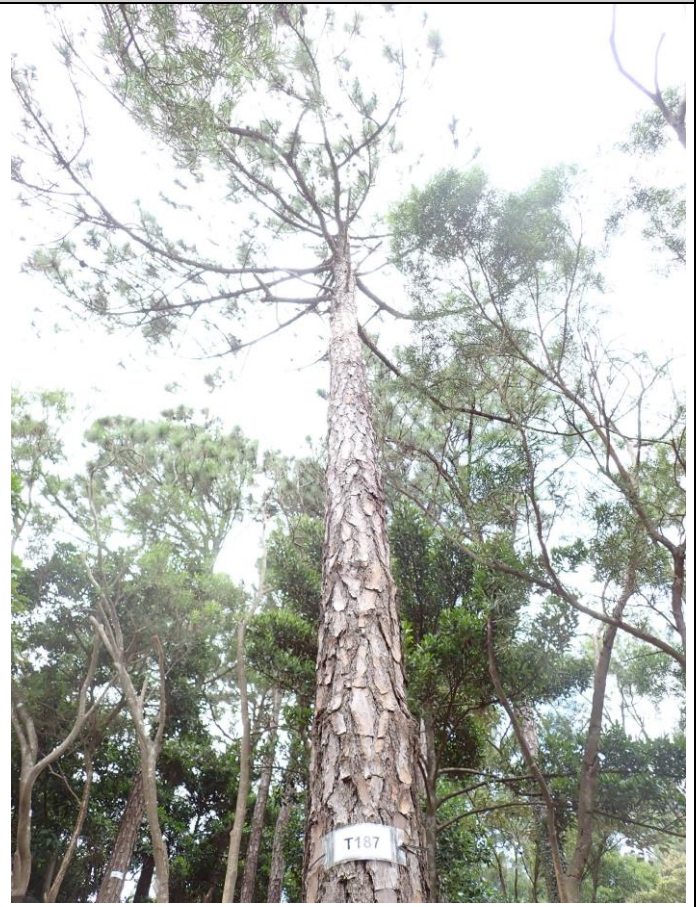
Tree No.	Chinese name	Scientific name	Jurisdiction (AFCD & Highways)	Amenity value	Form	Health	Structural condition	Conservation status	Remarks	Remarks (September)
				(High(H)/ Medium(M)/ Low(L))	(Good(G)/ Average(A)/ Poor(P))					
T178	鴨腳木	<i>Schefflera heptaphylla</i>	AFCD	M	A	A	A	/	/	Grow on slope, incline, covered by climbers, dead branch, water sprouts
T182	台灣相思	<i>Acacia confusa</i>	AFCD	M	A	A	A	/	/	Grow on slope, incline, broken branches, water sprouts, dead branch
T183	濕地松	<i>Pinus elliotii</i>	AFCD	M	A	A	A	/	/	Grow on slope, branches
T184	白楸	<i>Mallotus paniculatus</i>	AFCD	M	A	A	A	/	/	Grow on slope, incline, broken branches
T185	白楸	<i>Mallotus paniculatus</i>	AFCD	M	A	A	A	/	/	Grow on slope, incline, dead branches, broken branches
T186	台灣相思	<i>Acacia confusa</i>	AFCD	M	A	A	A	/	codominant trunk	Grow on slope, incline, water sprouts, dead branches, die back
T187	濕地松	<i>Pinus elliotii</i>	AFCD	H	G	G	A	/	/	Grow on slope broken branches

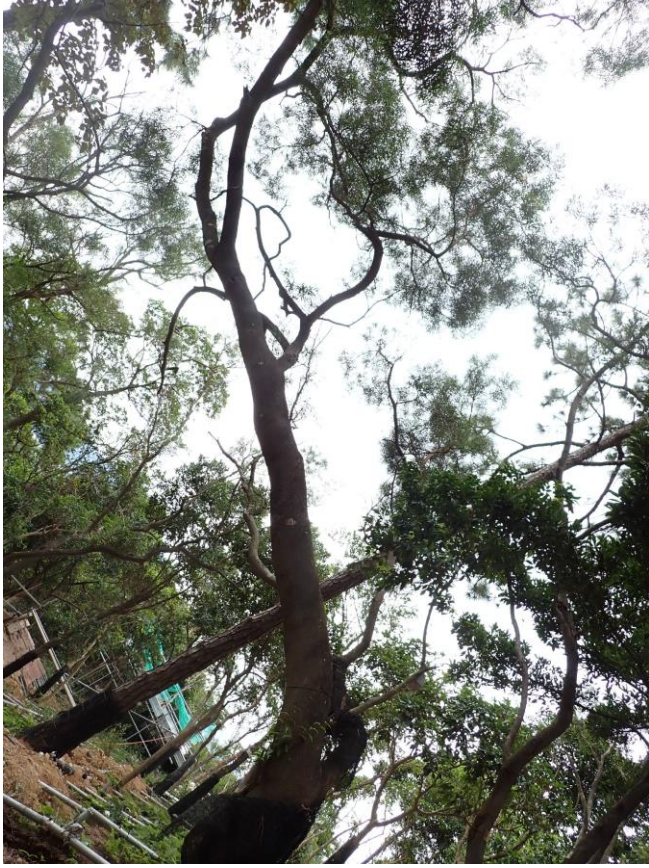
T188	台灣相思	<i>Acacia confusa</i>	AFCD	L	P	A	A	/	/	Grow on slope, co-dominant, incline, dead branches, broken branches
T189	黃牙果	<i>Garcinia oblongifolia</i>	AFCD	H	G	G	A	/	/	Grow on slope, water sprouts. Broken branches

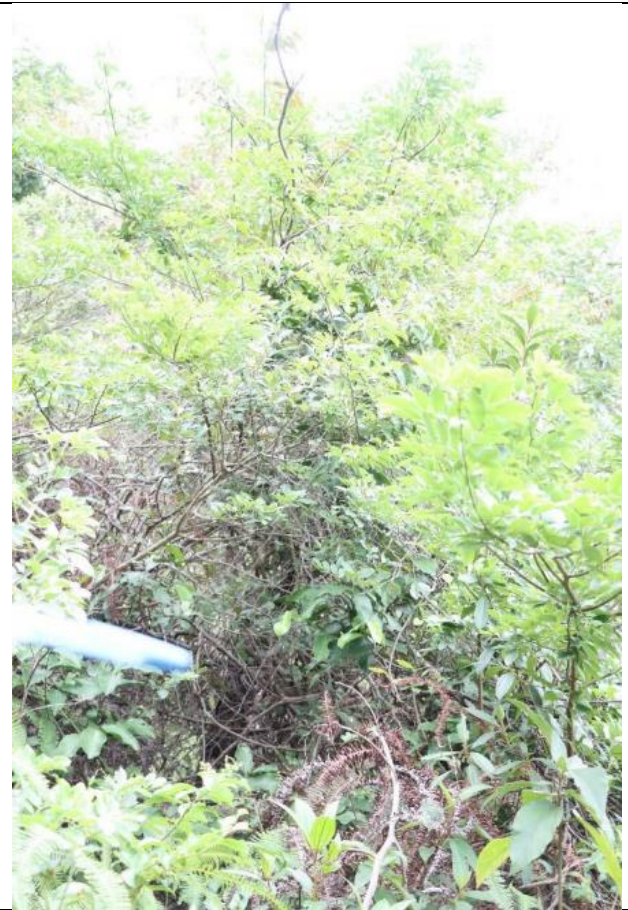
T418 (baseline stage)

T418 (low foliage)

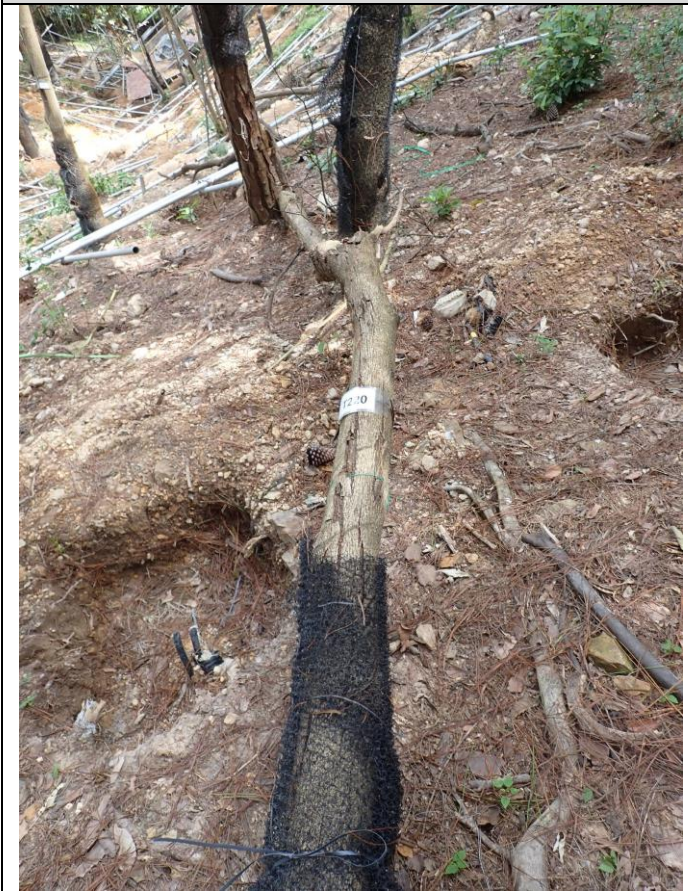
T220 (Dead)

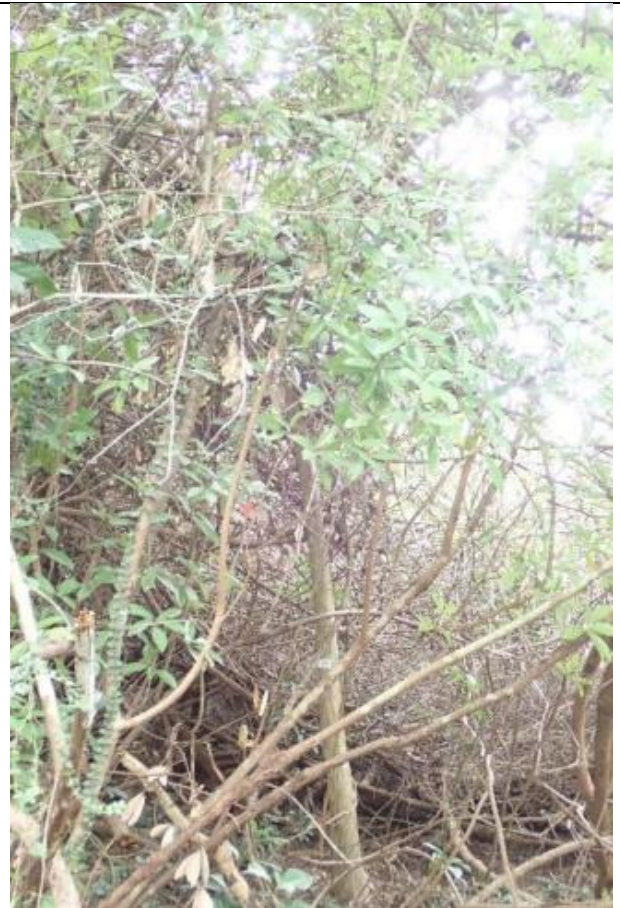
T445 (Dead)

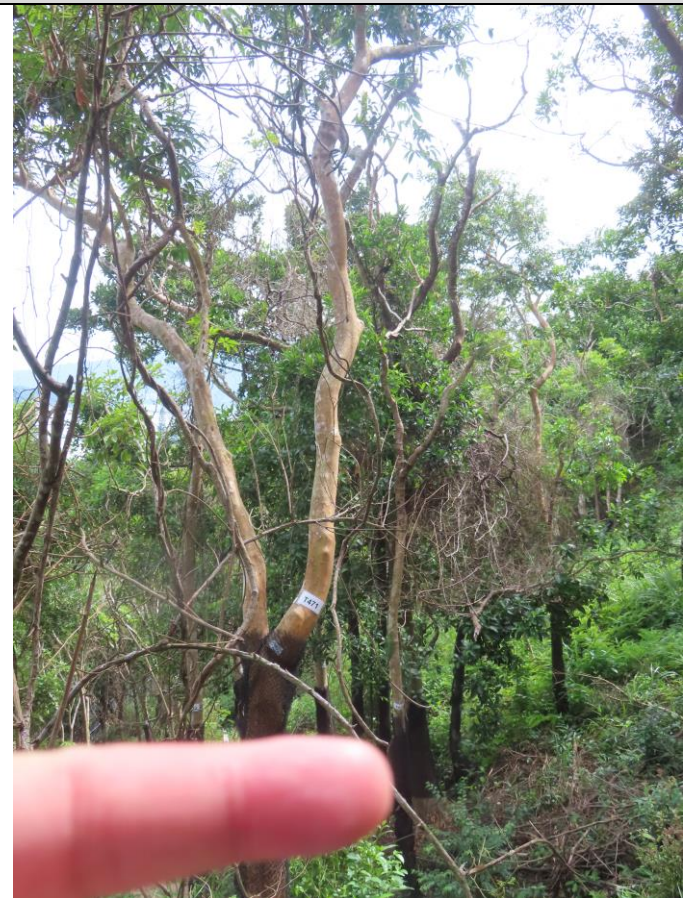
T474 (Dead)

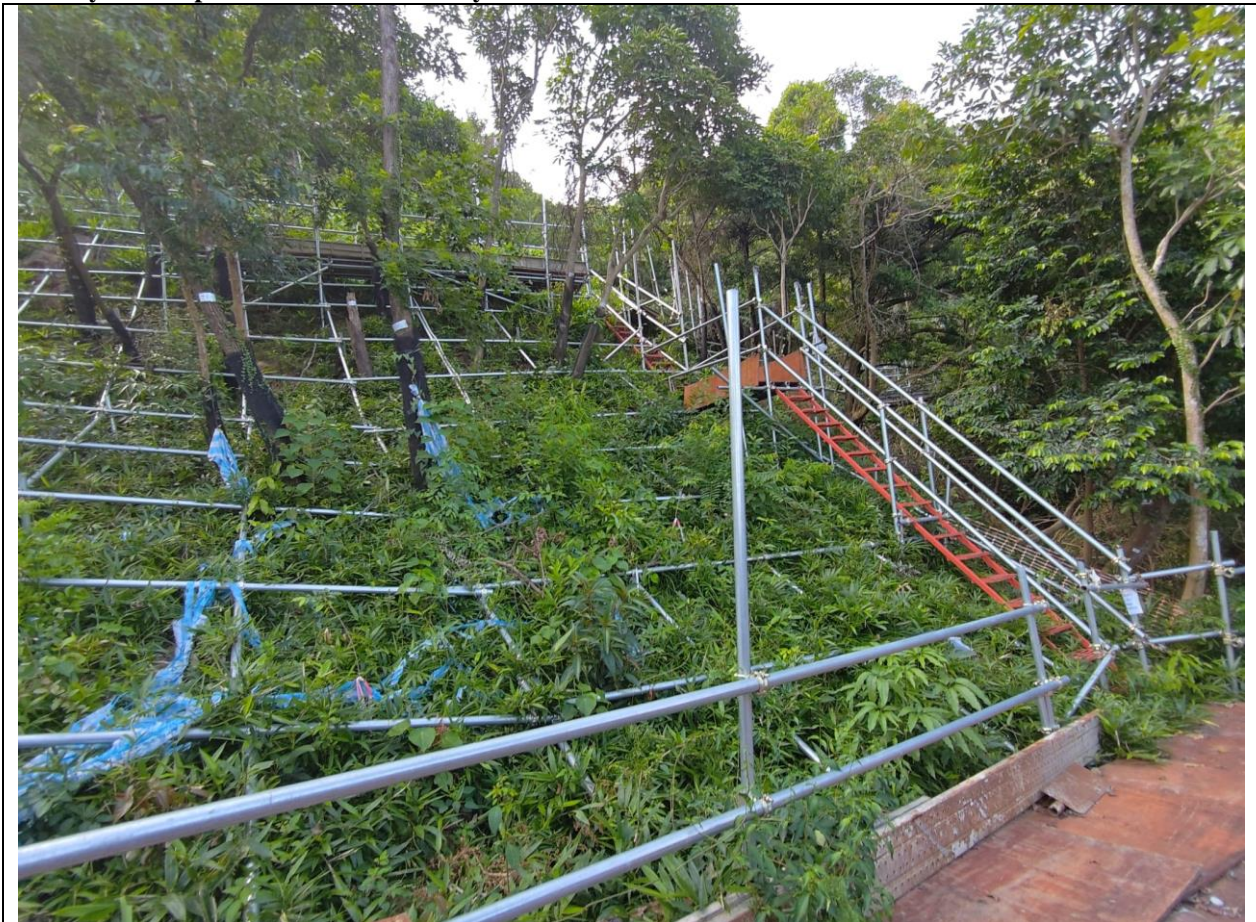
Photo 3: Site photo of Catchment C

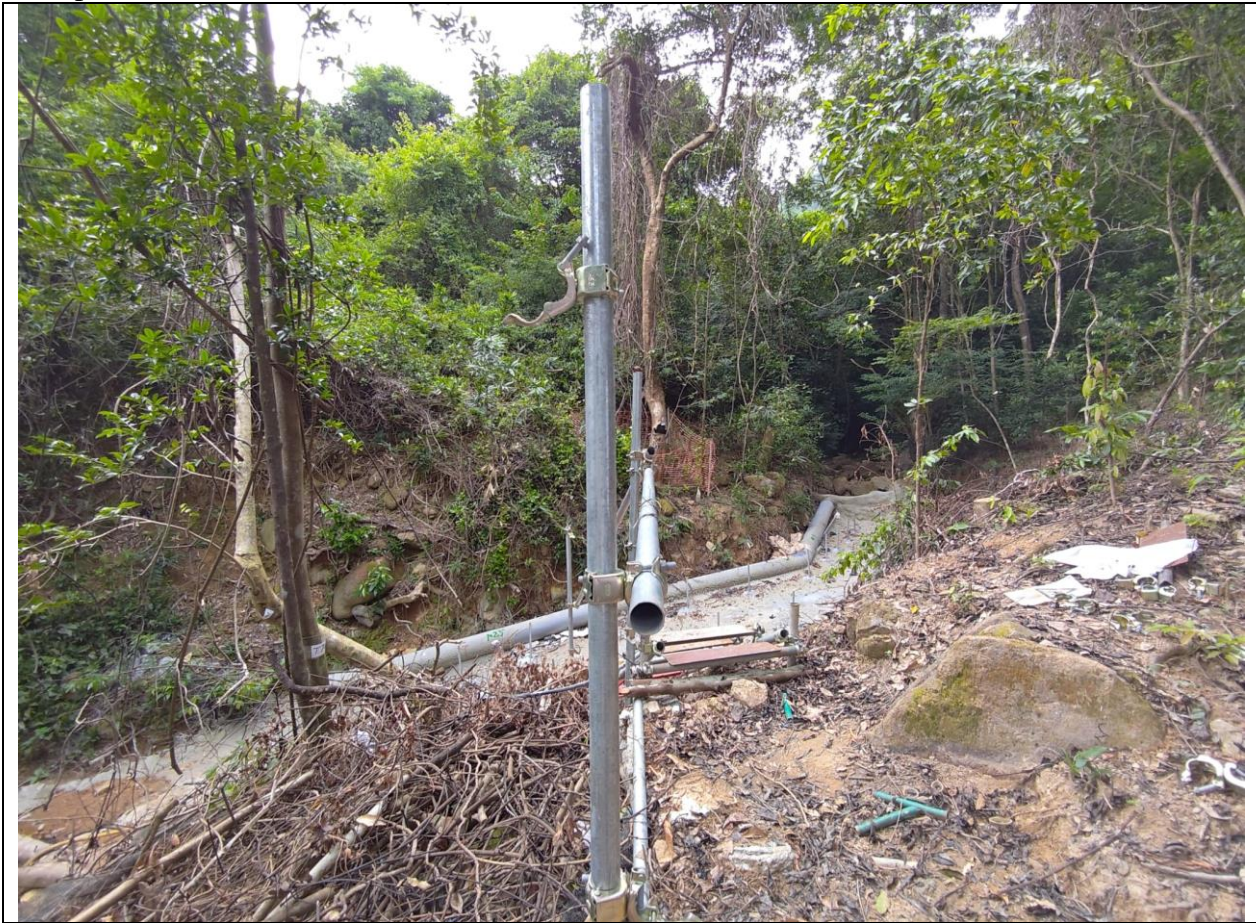
Photo 1: Site photo of Catchment A

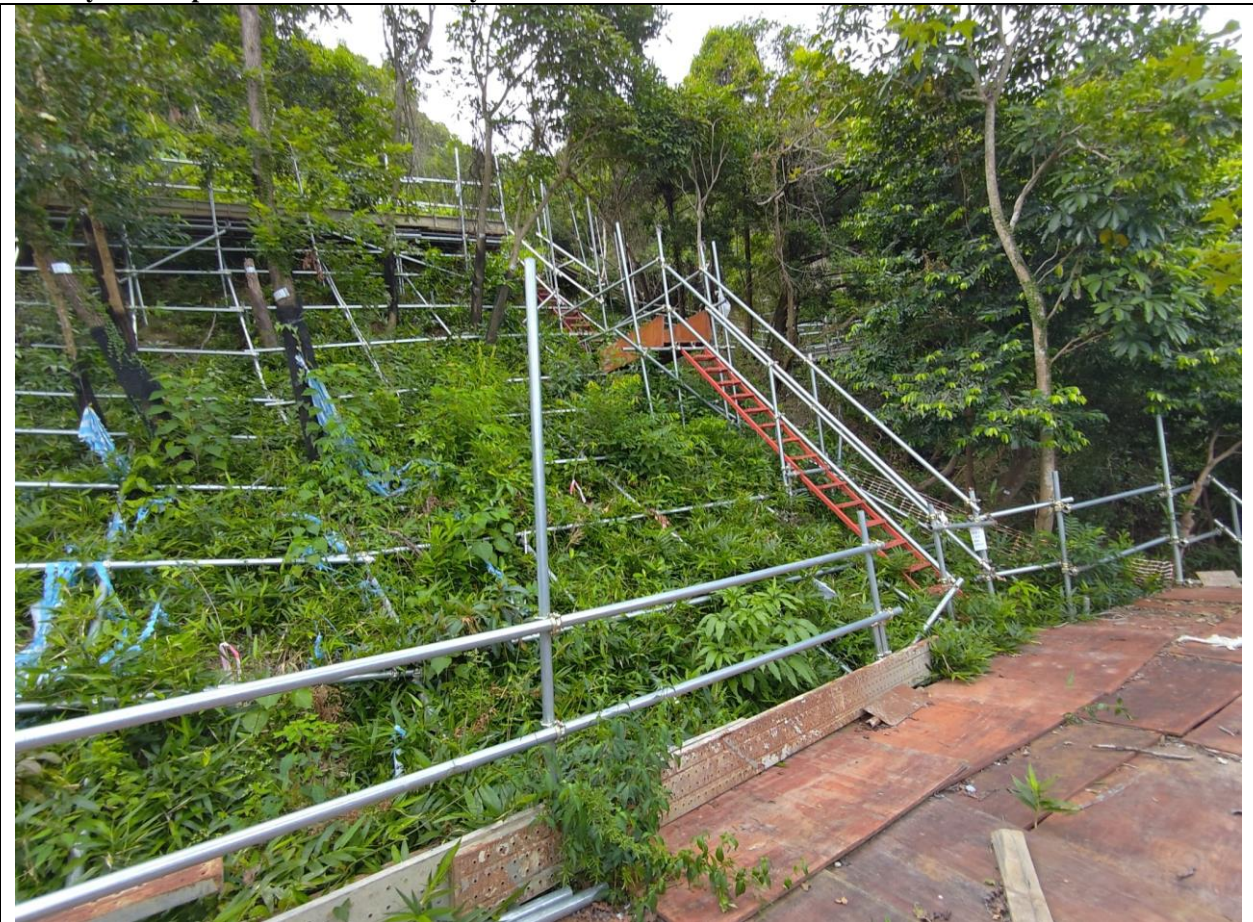
Photo 3: Site photo of Catchment C

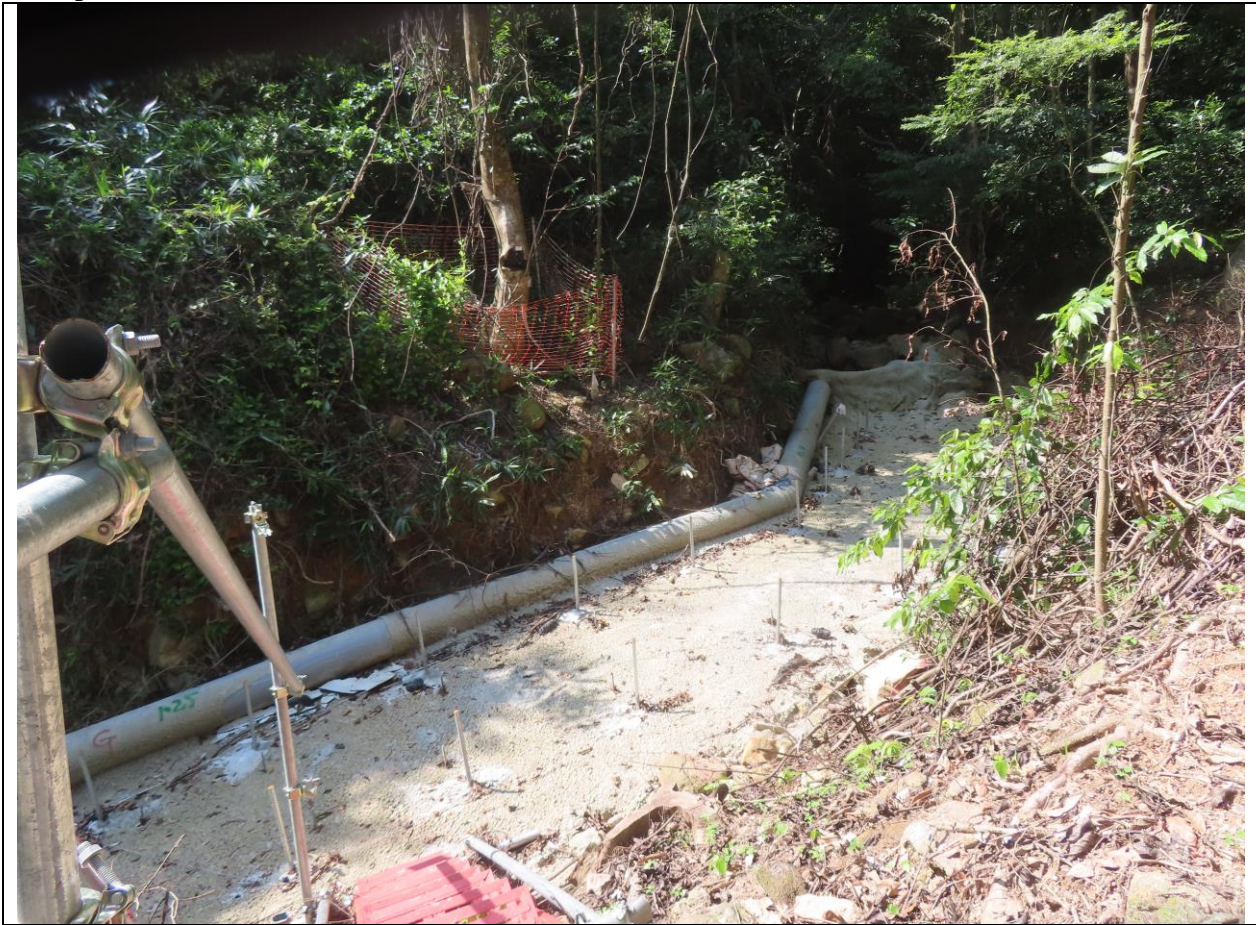
Photo 1: Site photo of Catchment A

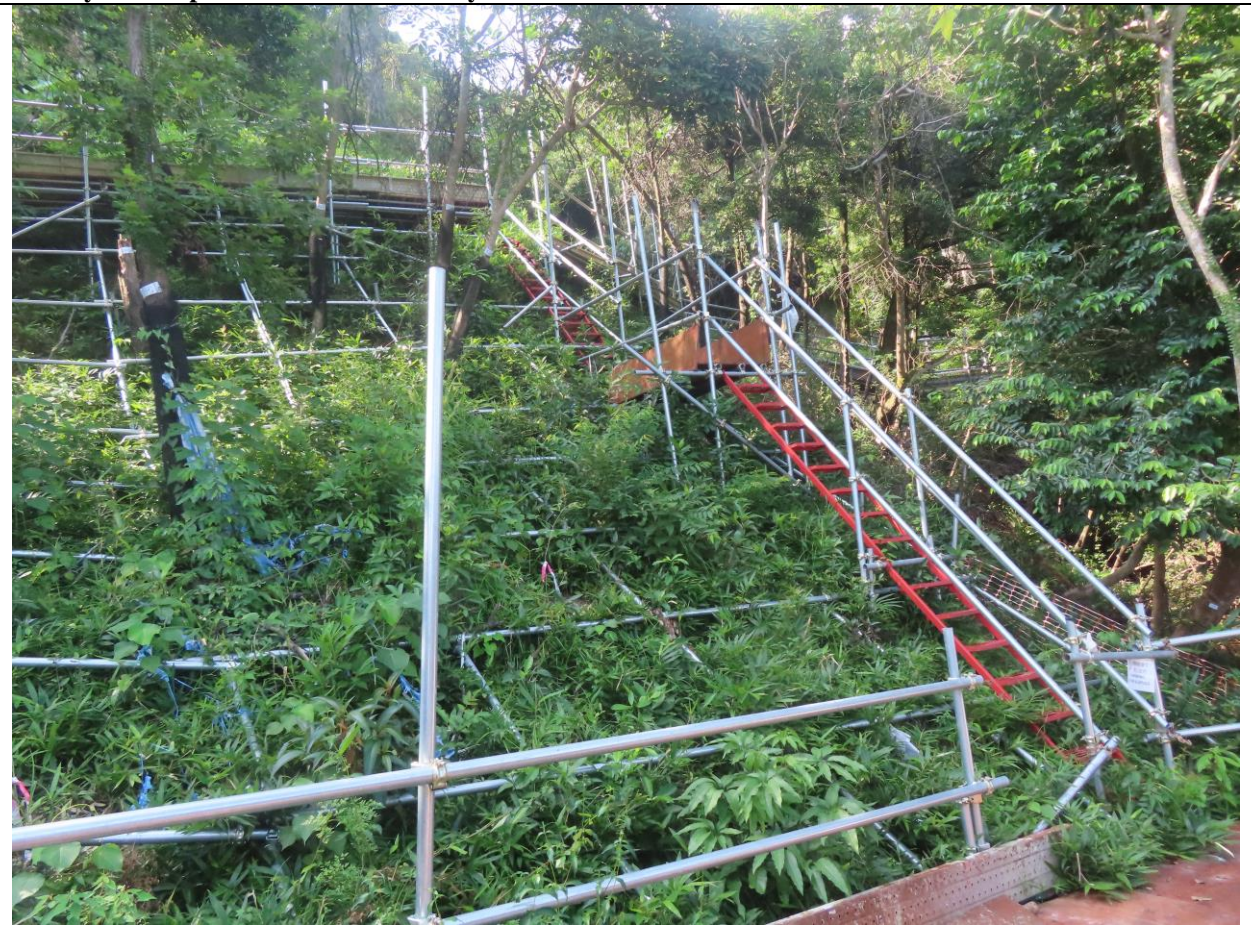
Photo 3: Site photo of Catchment C
