翠谷工程有限公司 Green Valley Landfill, Limited

## South East New Territories (SENT) Landfill Extension

**Restoration and Ecological Enhancement Plan (Rev. 3)**

September 2021

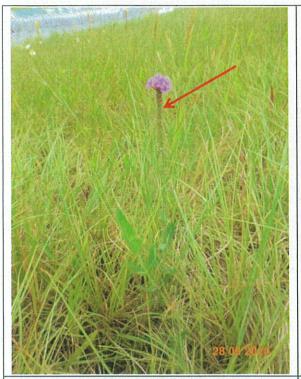
Photo 17 | *Vitex rigida* 顯脈馬鞭草 were planted in place of S9 seedlings.

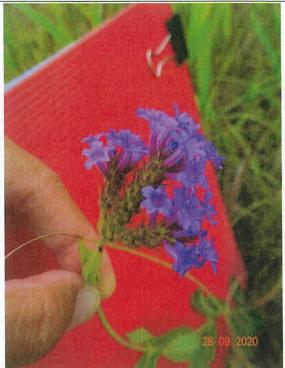
Photo 18 | *Vitex rigida* 顯脈馬鞭草 were planted in place of S9 seedlings.

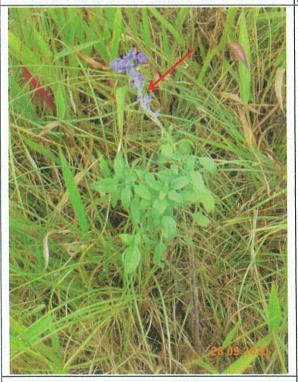
Photo 19 | *Salvia* sp. 鼠尾草屬 were planted in place of S9 seedlings. (rejected)

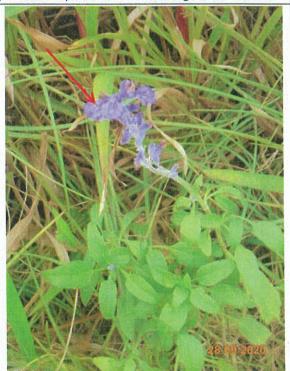
Photo 20 | *Salvia* sp. 鼠尾草屬 were planted in place of S9 seedlings. (rejected)

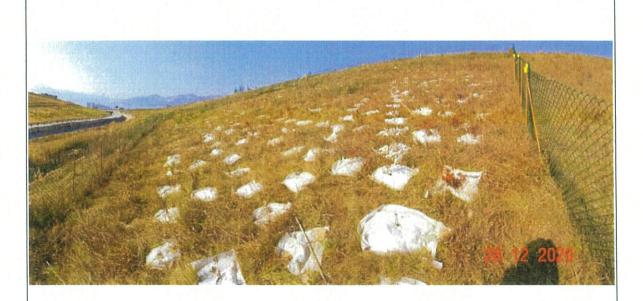
Photo 26 | General view of Trial Nursery (Sub-Area B2)
