**Shatin to Central Link
Contract 1123 – Exhibition Station and Western Approach Tunnel
Submission of Landscape Plan for Further Environmental Permit No. FEP-13/364/2009/H
and FEP-03/376/2009**

**Shatin to Central Link –
Exhibition Station & Western Approach
Tunnel**

Landscape Plan
for
FEP-13/364/2009/H & FEP-03/376/2009

LS/20426 Contract 1123_H2624 - Exhibition Station and Western Approach Runnel
Initial Tree Survey Report

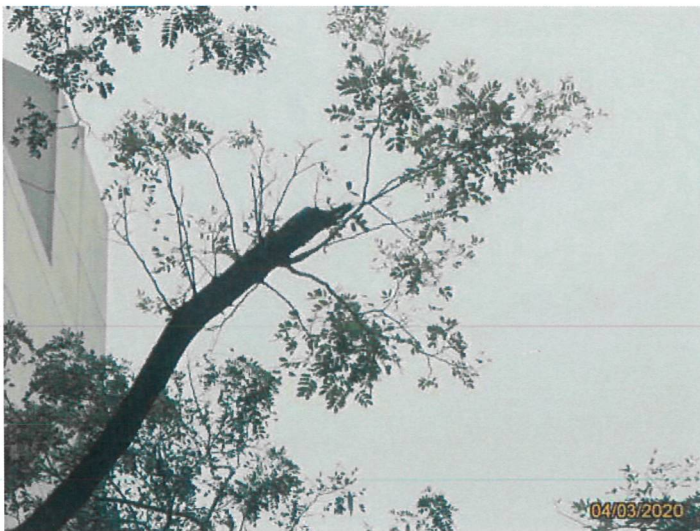
0001 - Broken branch (3)

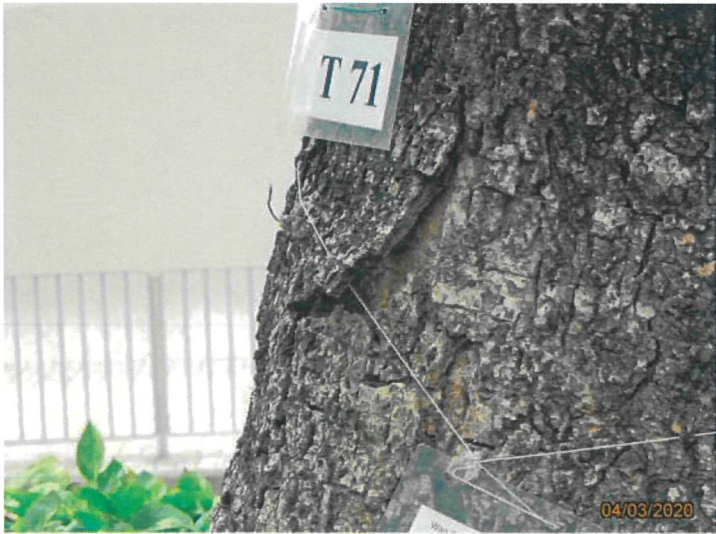
0001 - Wound on trunk

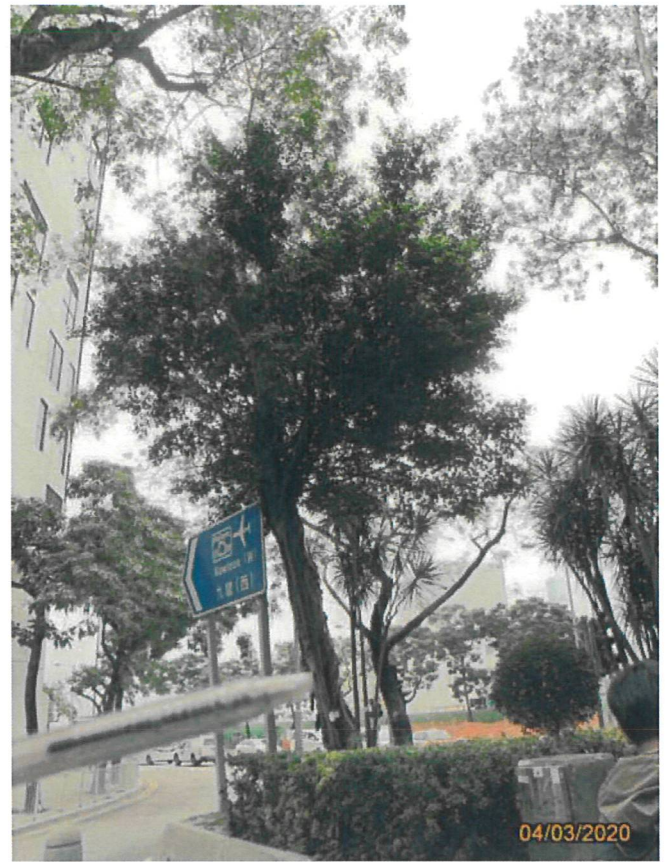
0004 - Overview

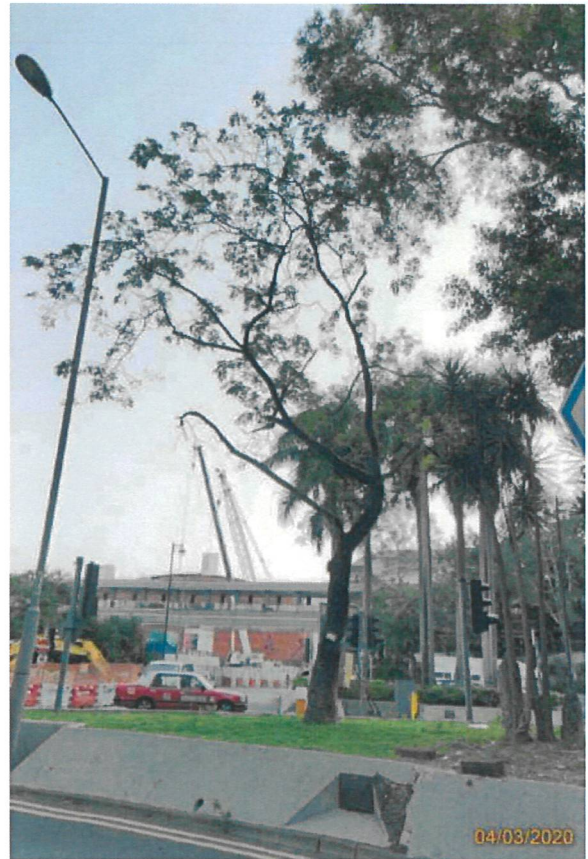
0005 - Overview

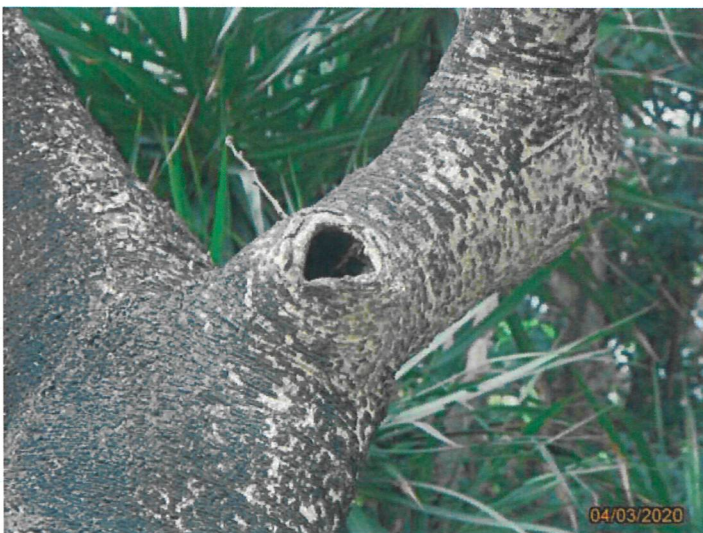
0005 - Cavity

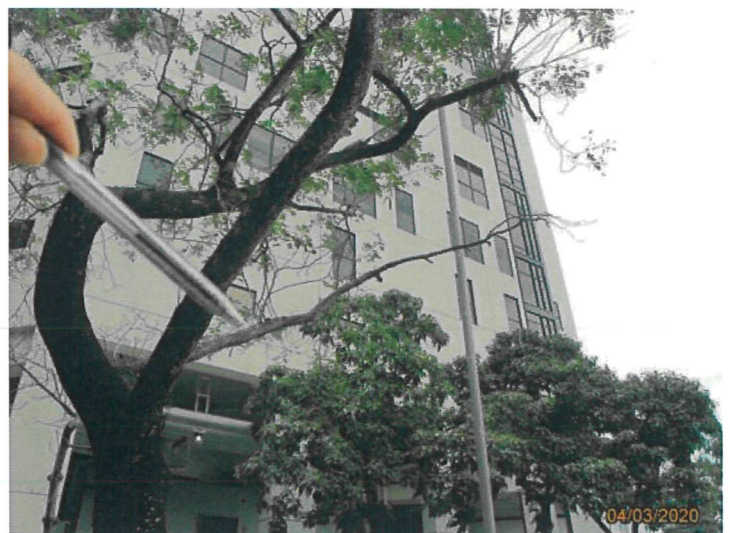
0005 - Dead branch

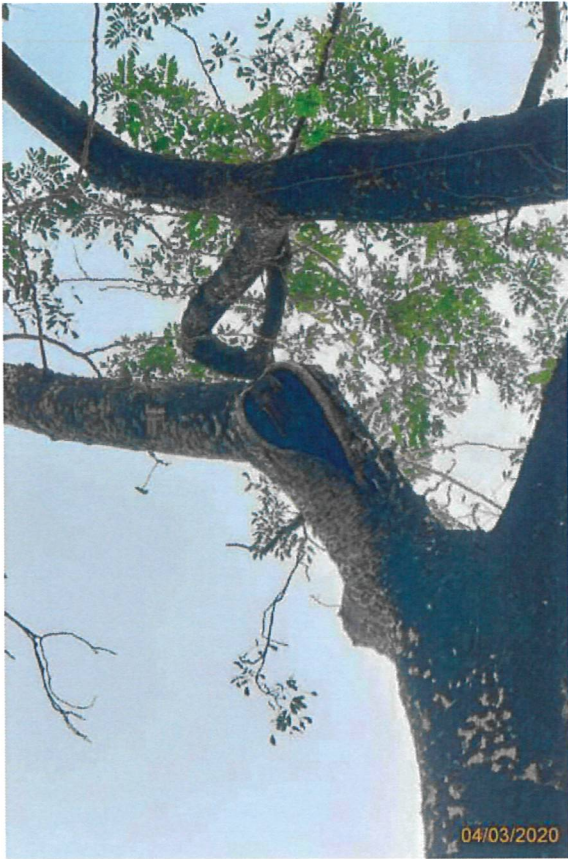
0005 - Wound on branch (2)

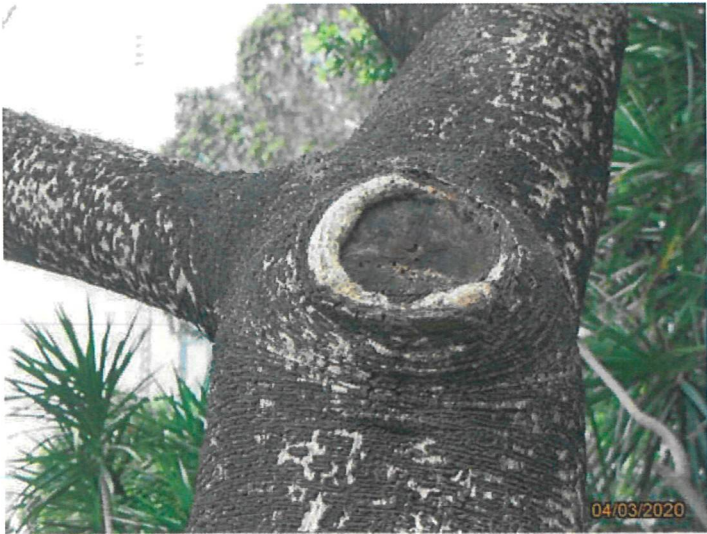
0005 - Wound on trunk

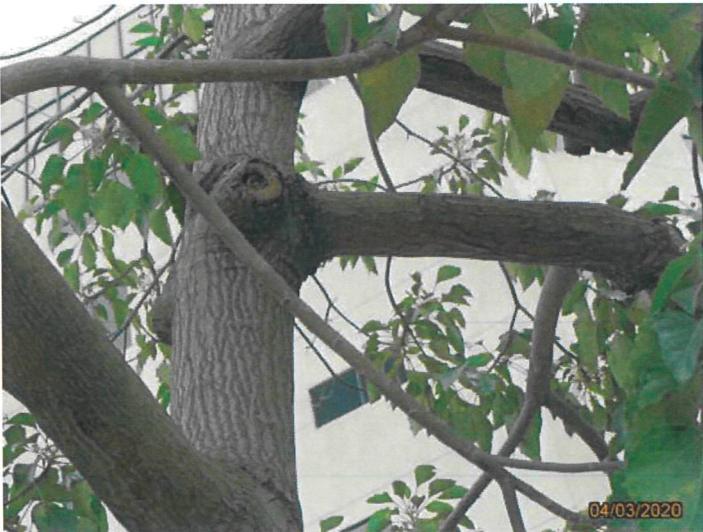
0337 - Wound on branch

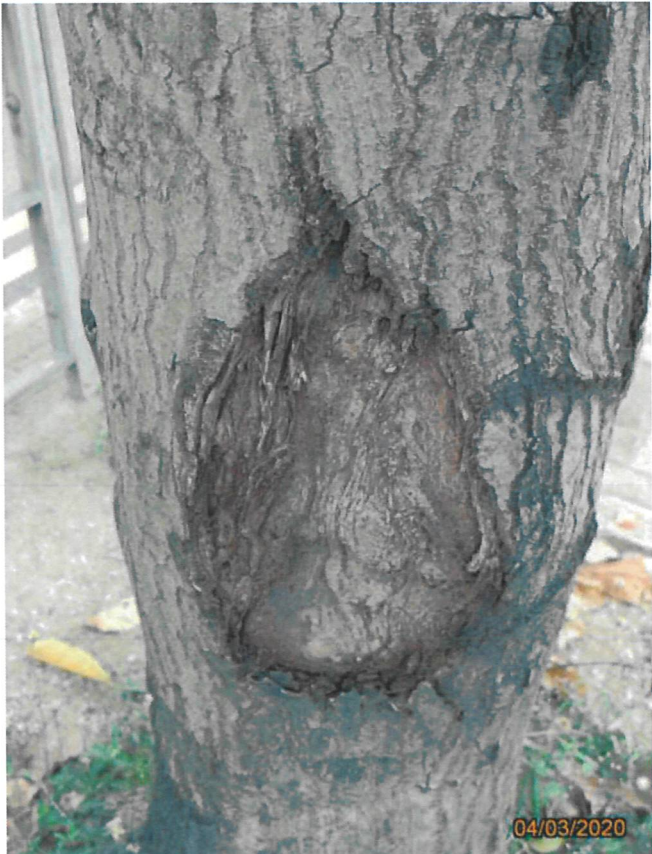
0337 - Wound on trunk

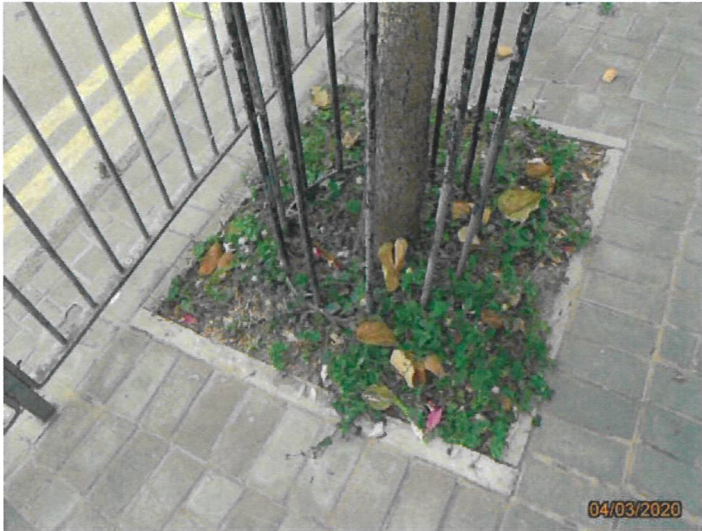
0493 - Restricted rooting area

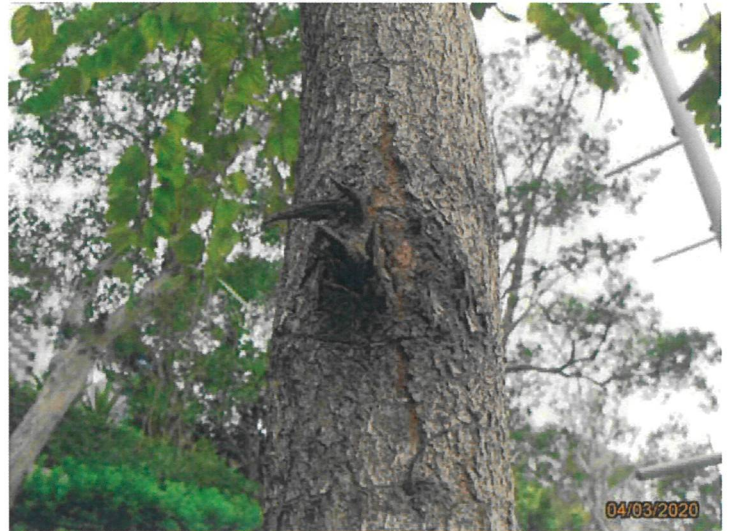
0493 - Wound on trunk

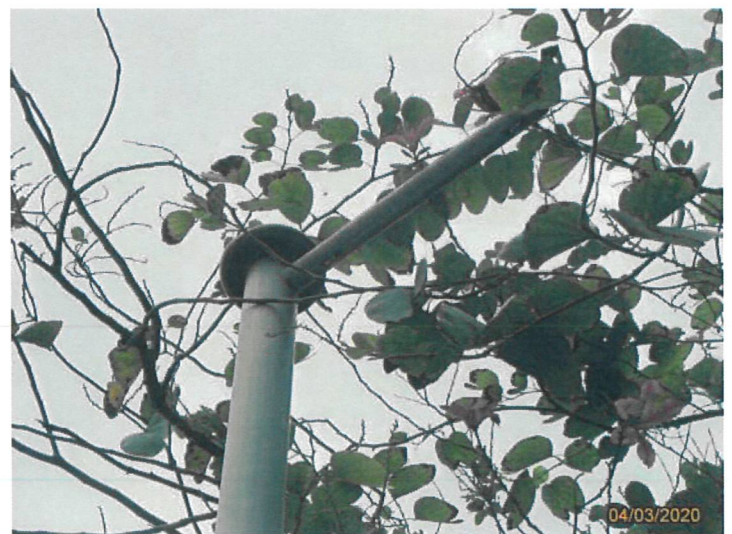
0498 - Conflicted with flagpole

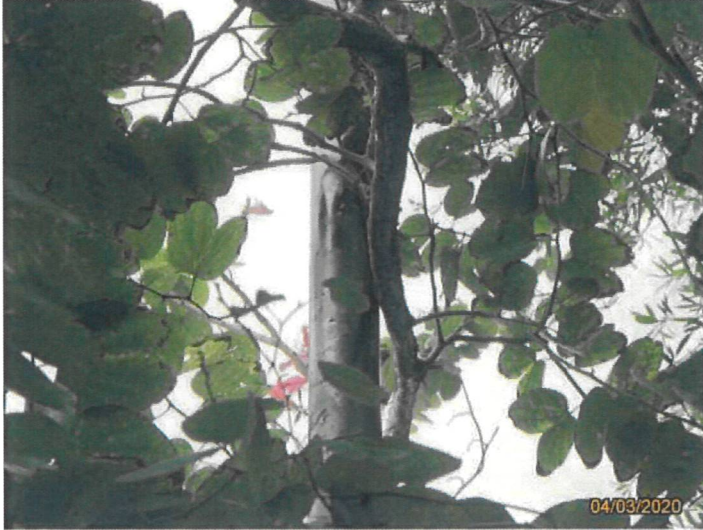
0498 - Conflicted with lamp post

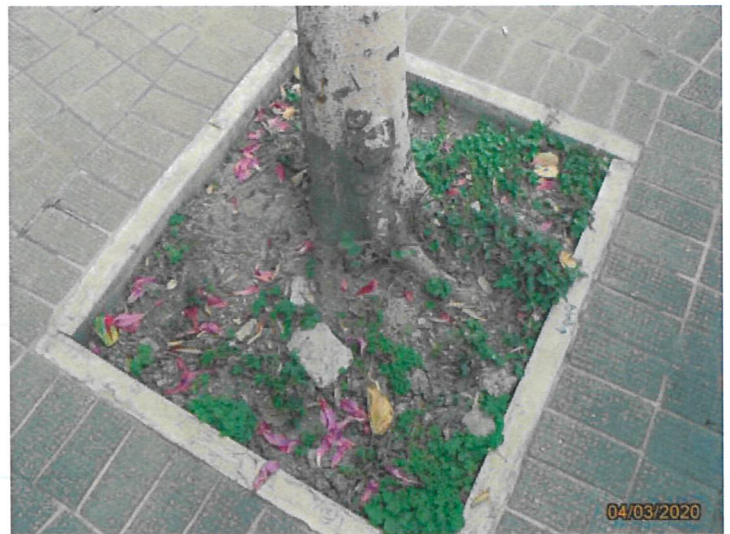
0498 - Restricted rooting area

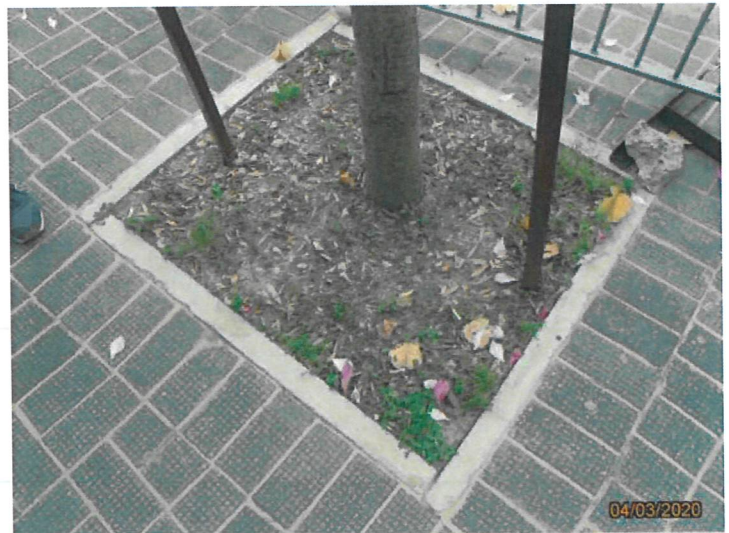
0499 - Restricted rooting area

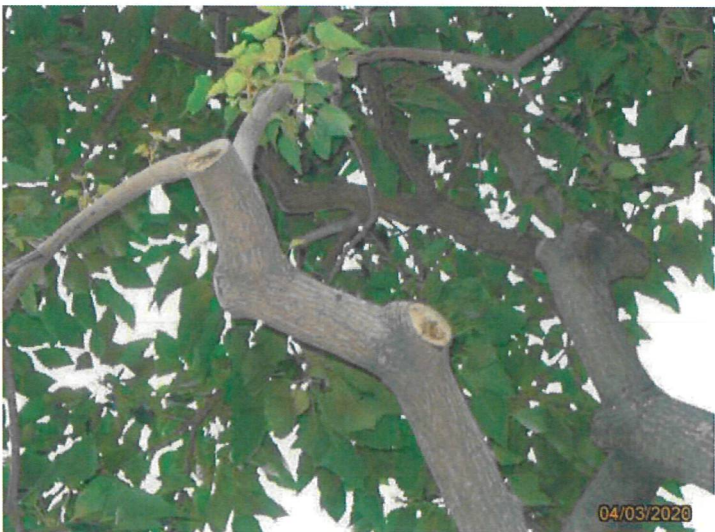
0503 - Pruned wound

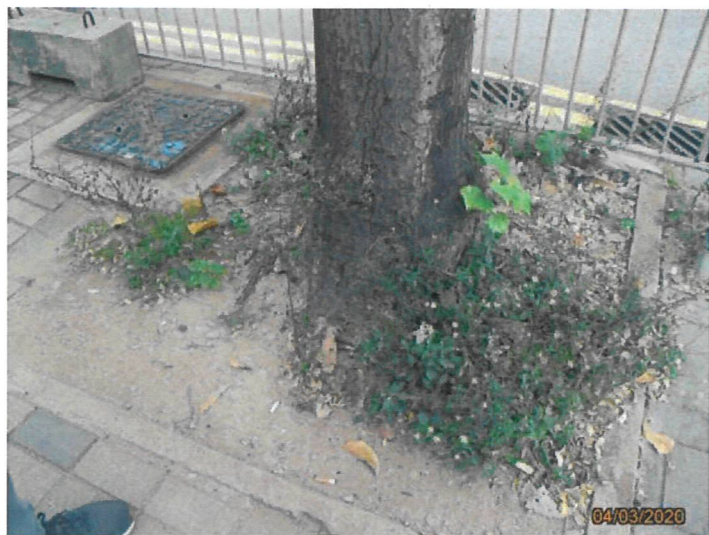
0503 - Restricted rooting area

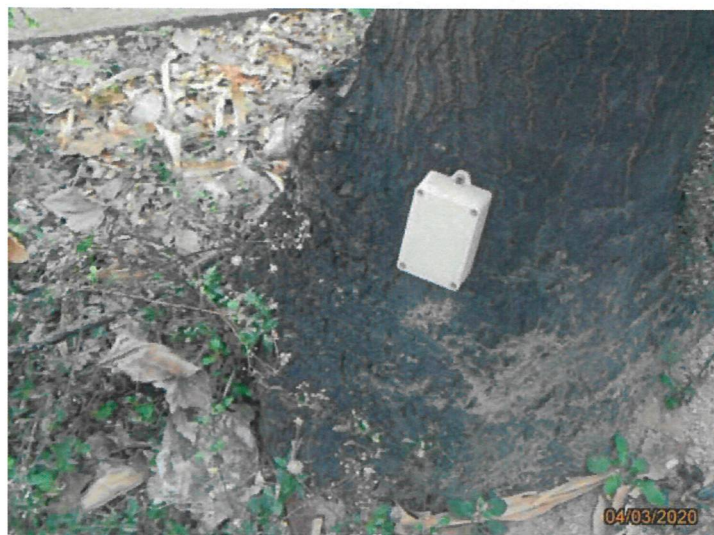
0503 - Tilt sensor attached on root collar

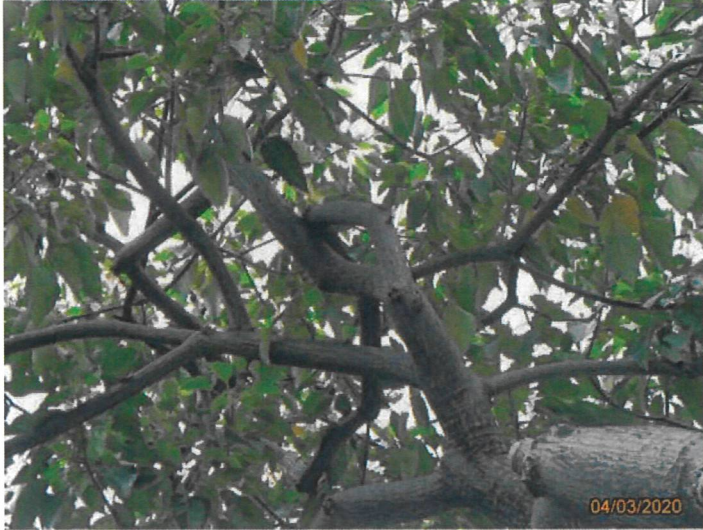
0504 - Crossed branch

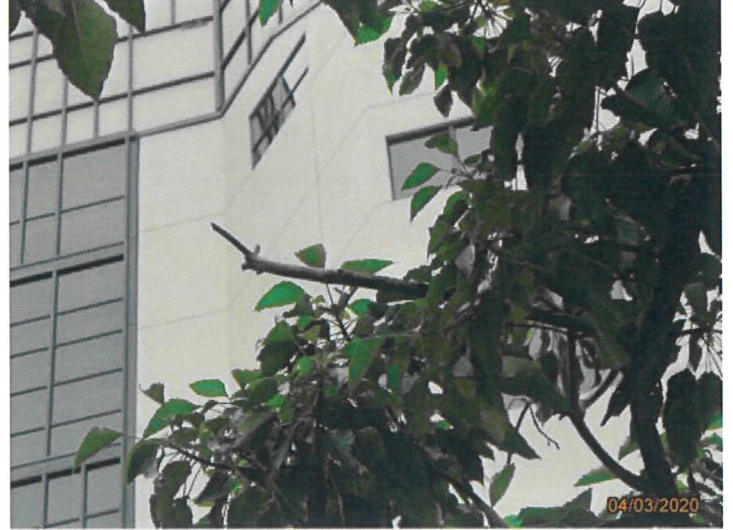
0504 - Dead branch

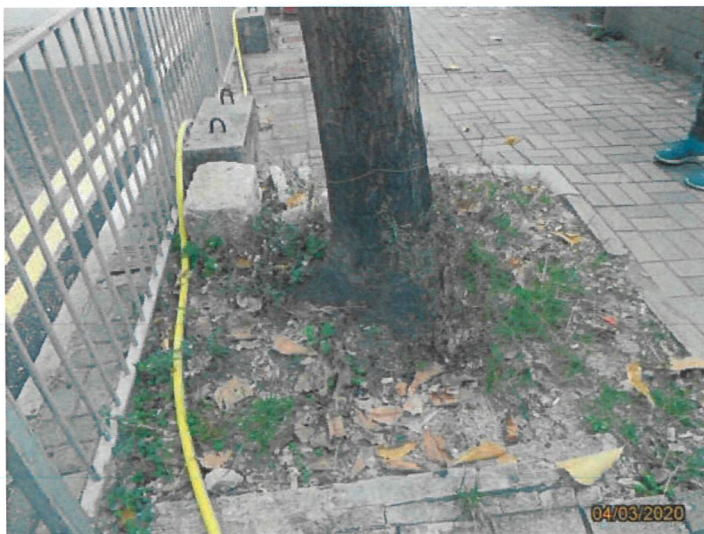
0504 - Restricted rooting area

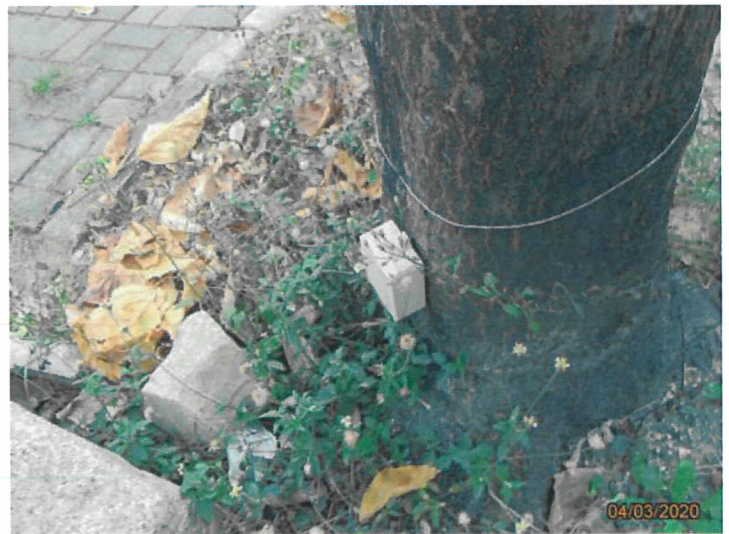
0504 - Tilt sensor attached on root collar

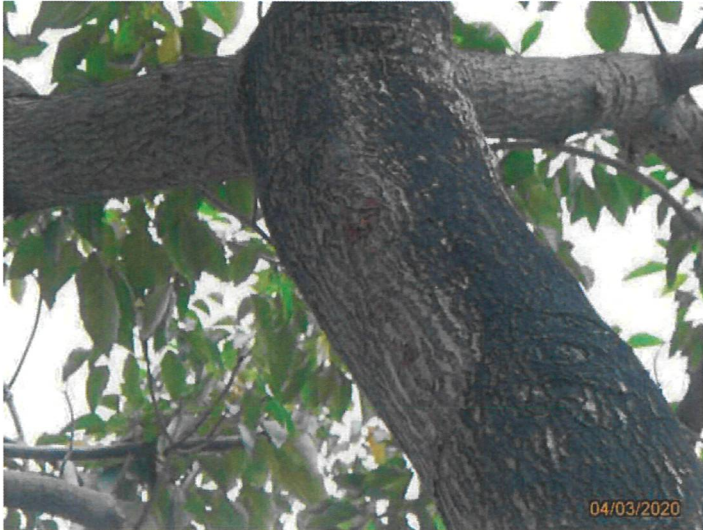
0504 - Wound on branch

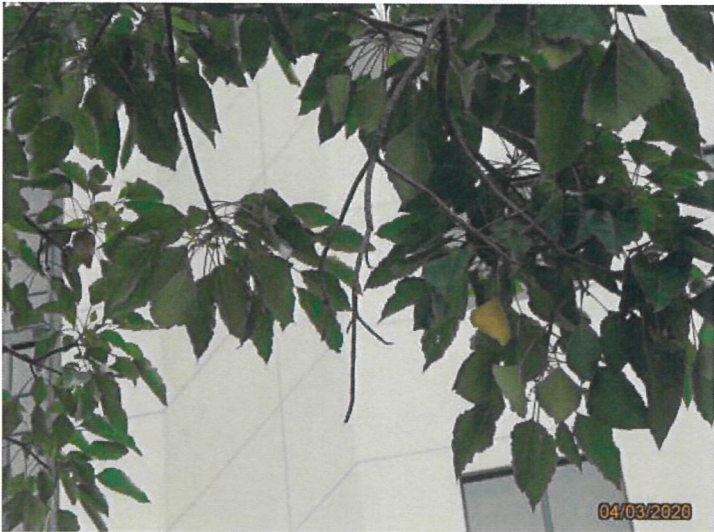
0505 - Dead branch

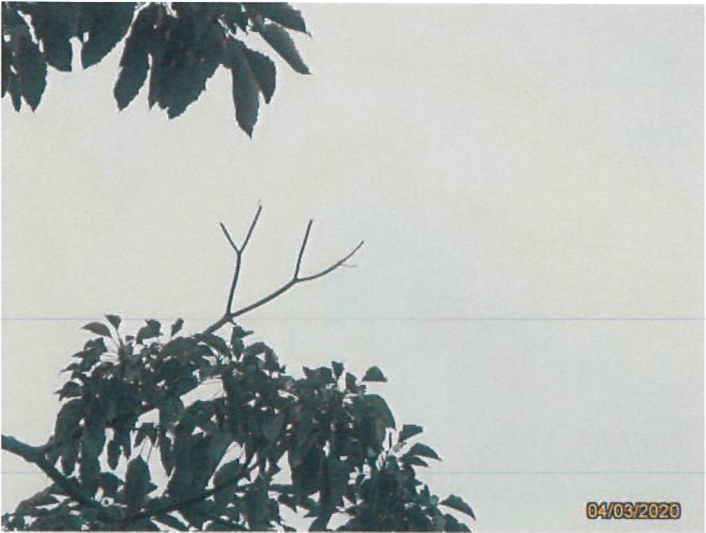
0505 - Dieback

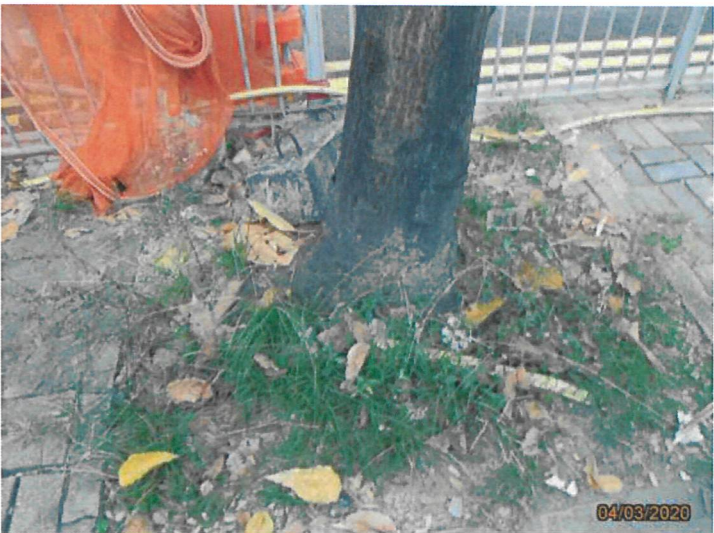
0505 - Restricted rooting area

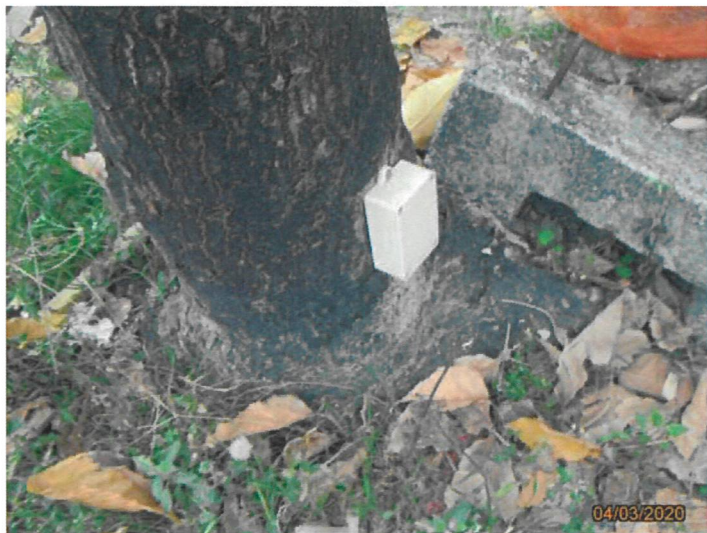
0505 - Tilt sensor attached on root collar

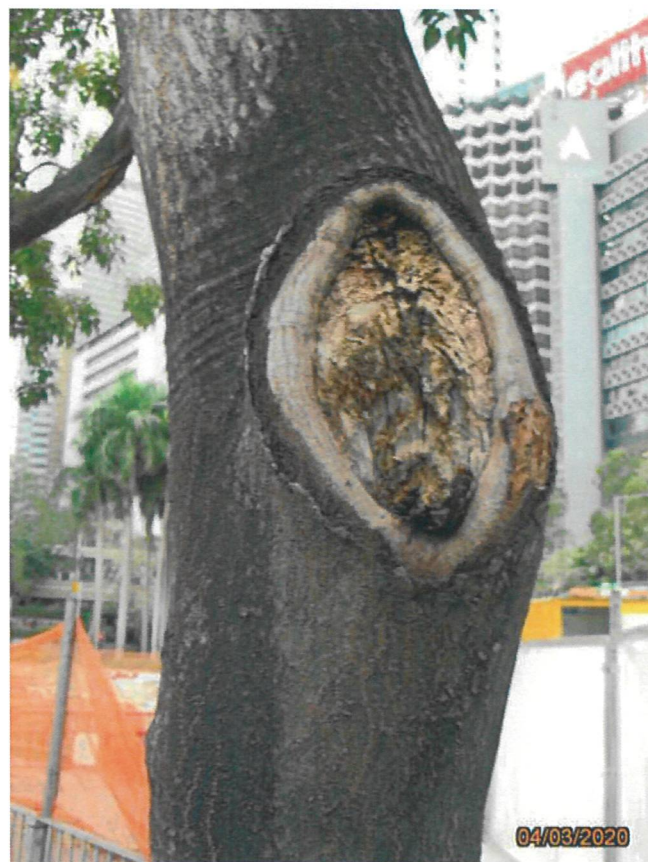
0505 - Wound on trunk

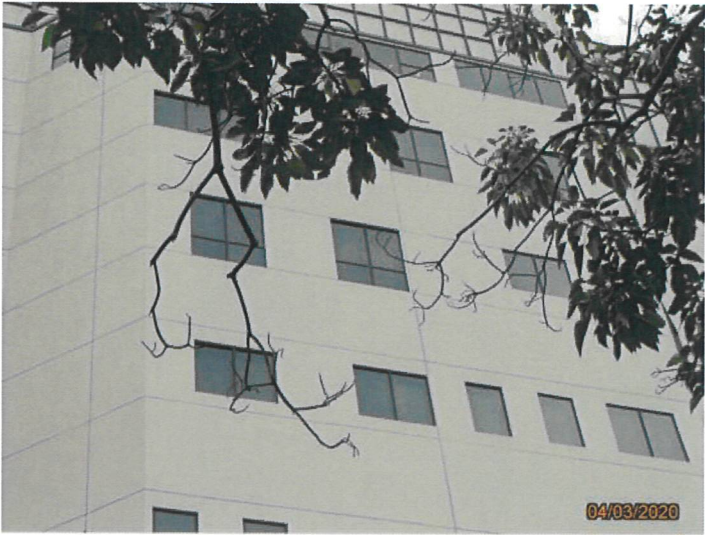
0506 - Dieback

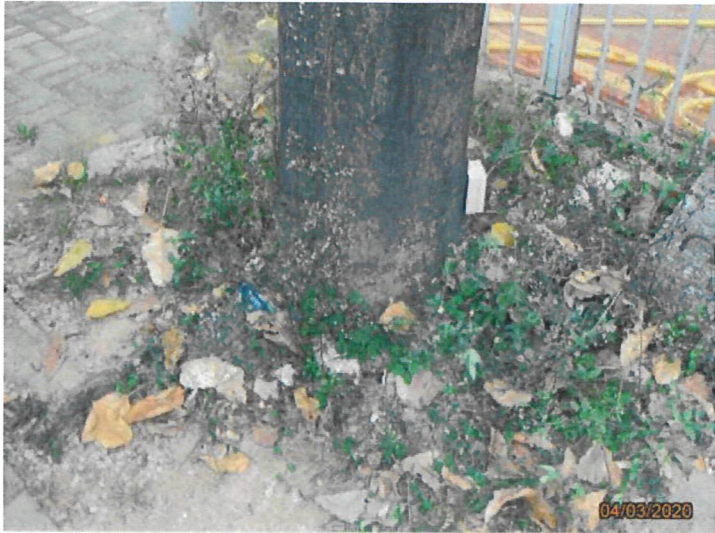
0506 - Restricted rooting area

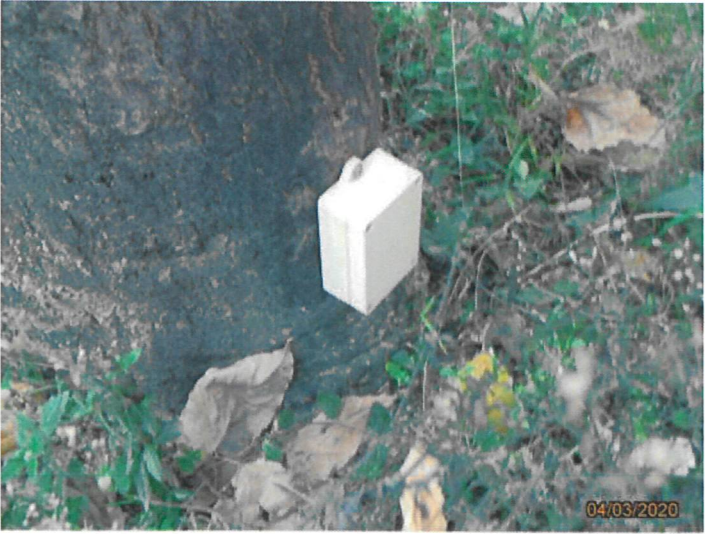
0506 - Tilt sensor attached on root collar

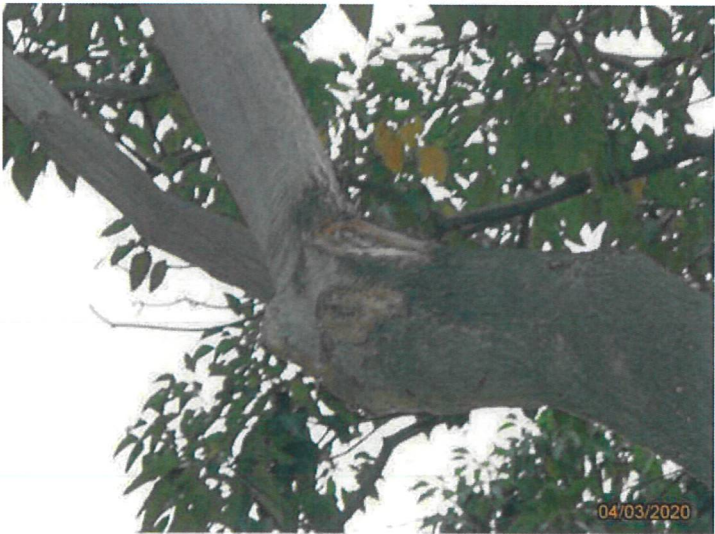
0506 - Wound on branch (2)

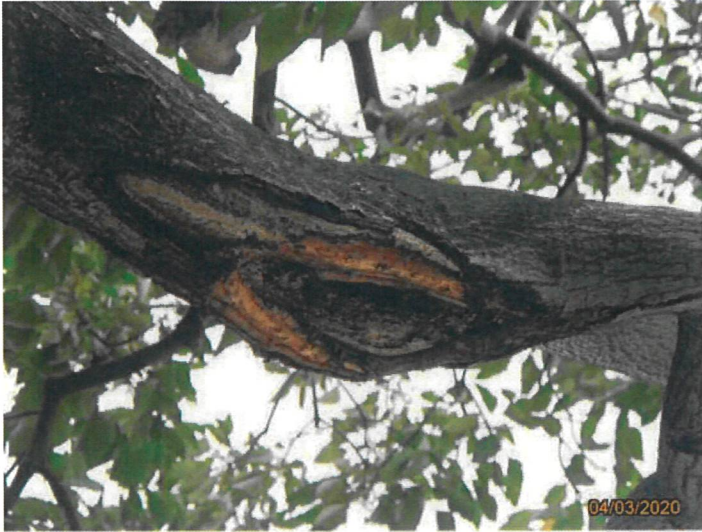
0506 - Wound on branch

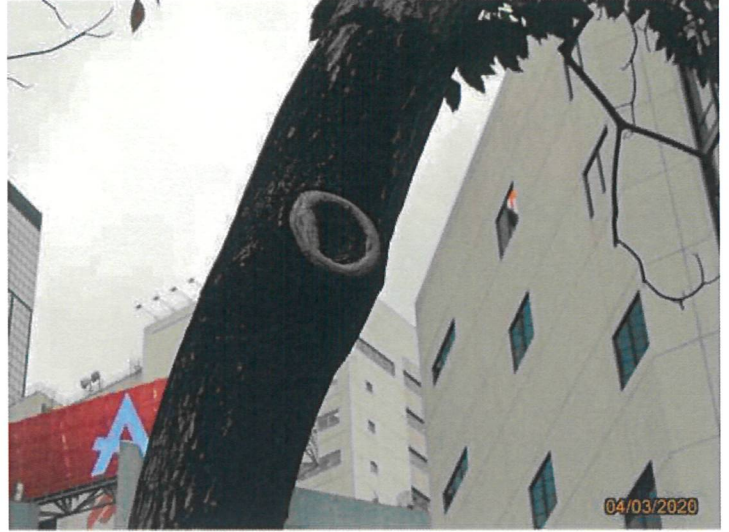
0506 - Wound on trunk

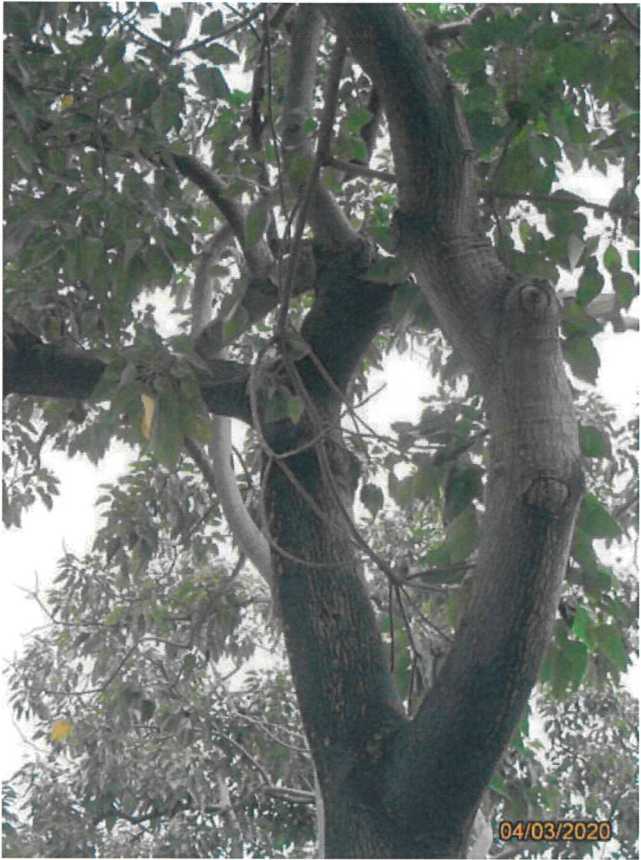
0507 - Crossed branches

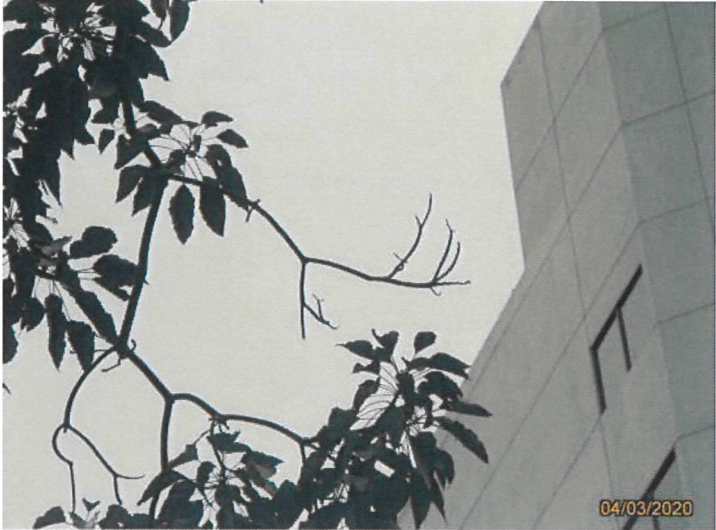
0507 - Dieback

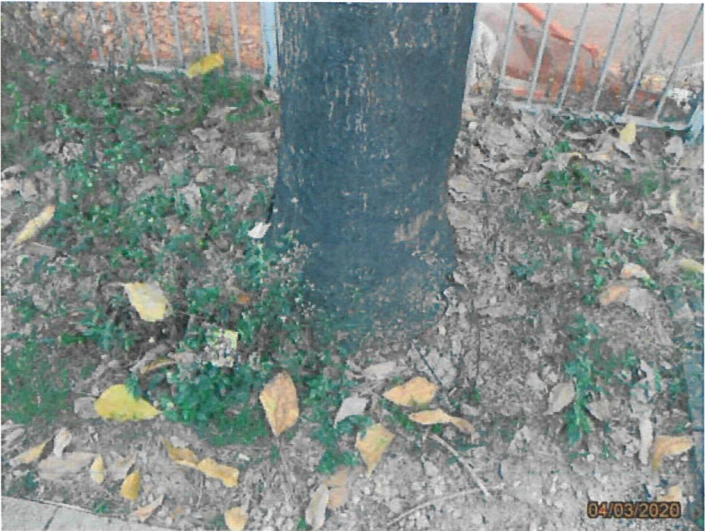
0507 - Restricted rooting area

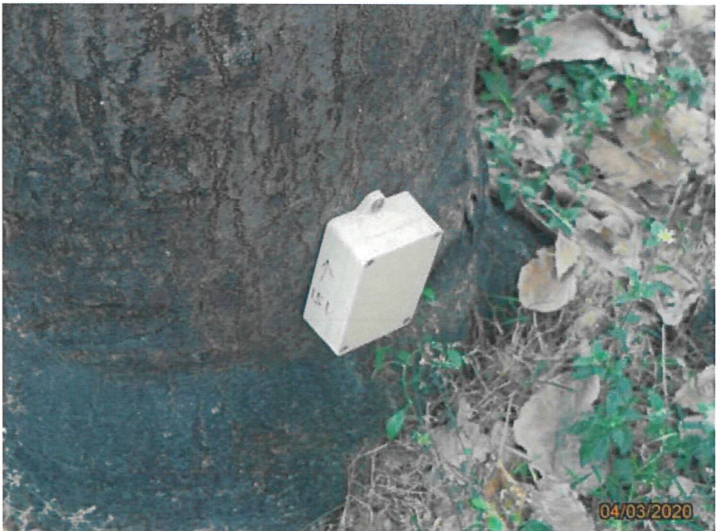
0507 - Tilt sensor attached on root collar

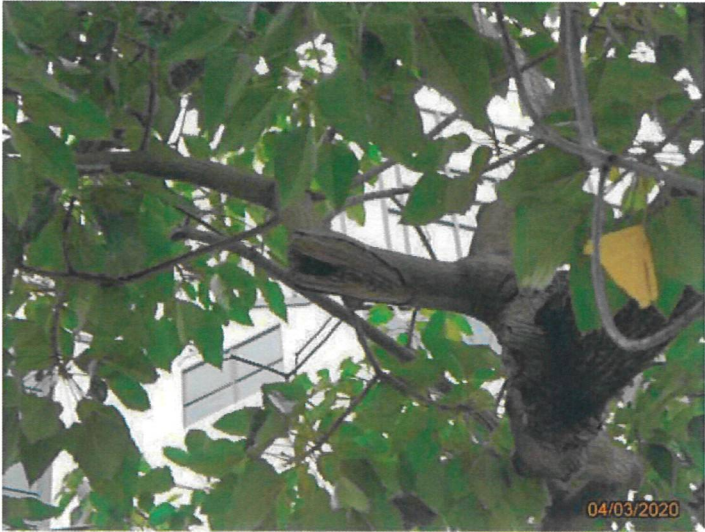
0507 - Wound on branch (2)

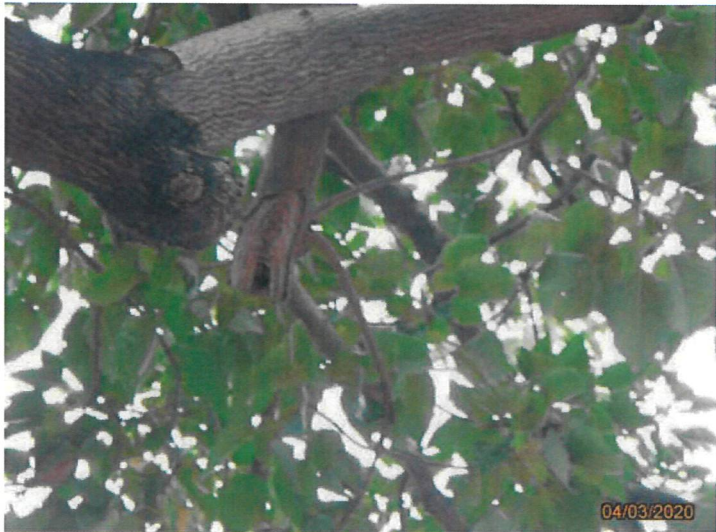
0507 - Wound on branch

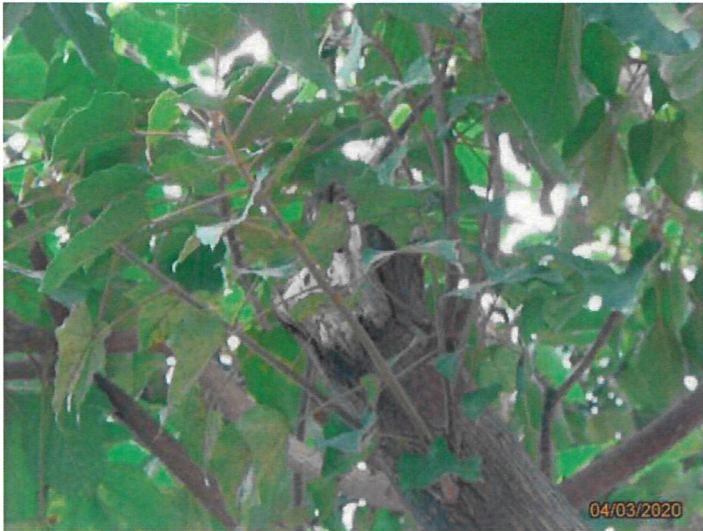
0508 - Broken branch

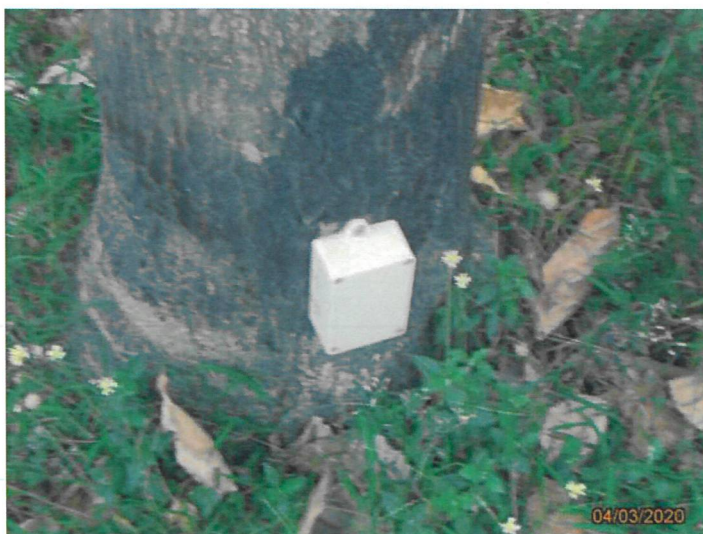
0508 - Tilt sensor attached on root collar

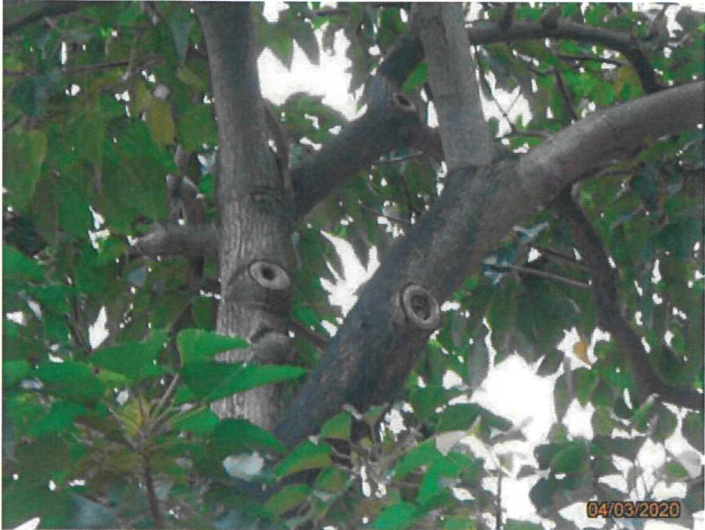
0508 - Wound on branch

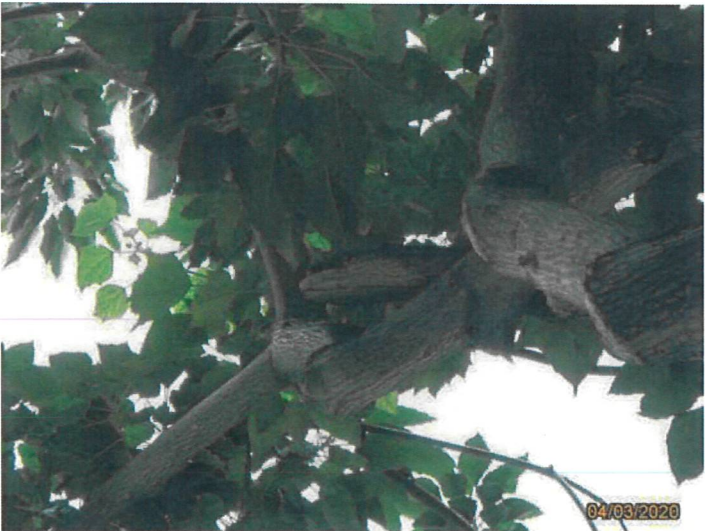
0509 - Broken branch (2)

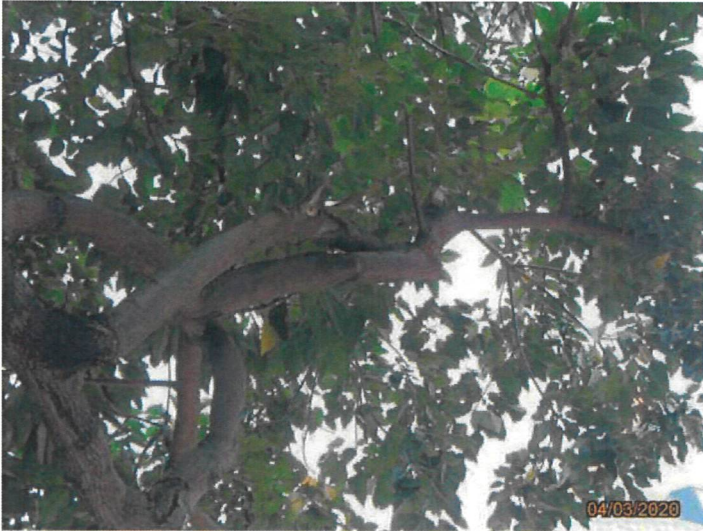
0509 - Broken branch

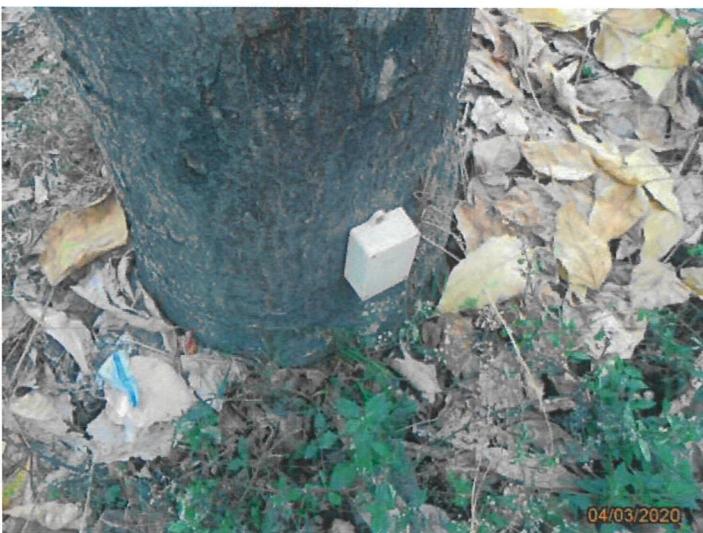
0509 - Tilt sensor attached on root collar

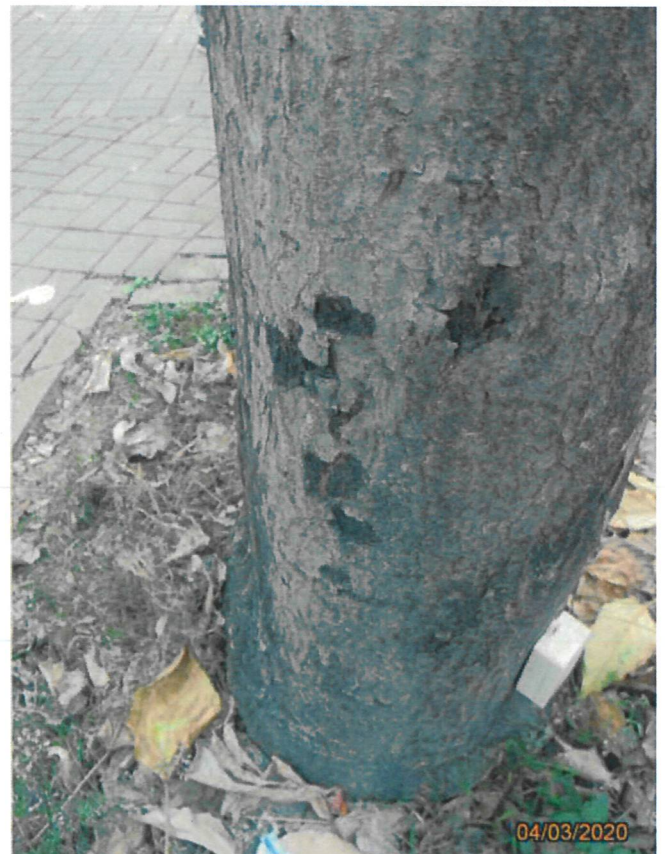
0509 - Wound on trunk (2)

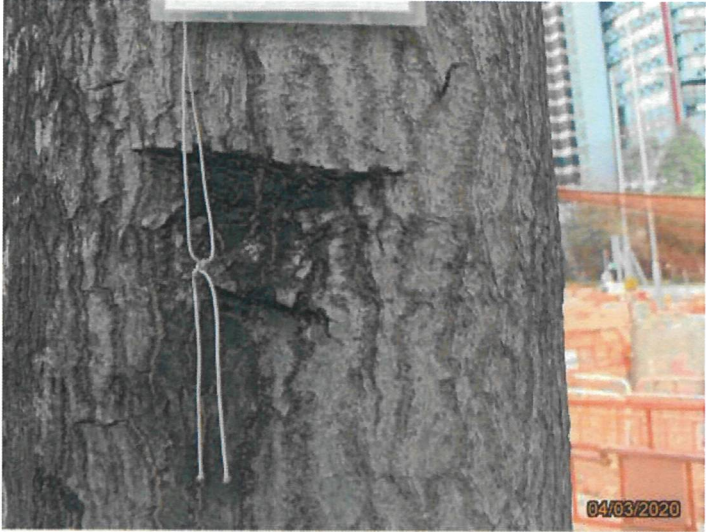
0509 - Wound on trunk

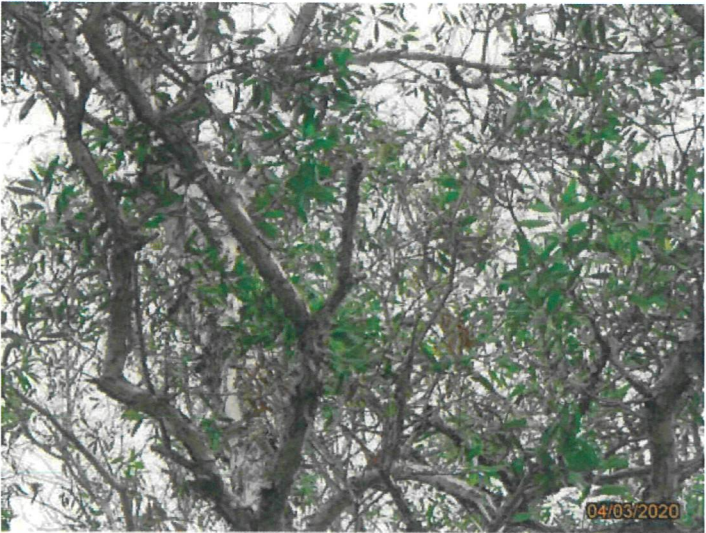
0557 - Dead branch (1)

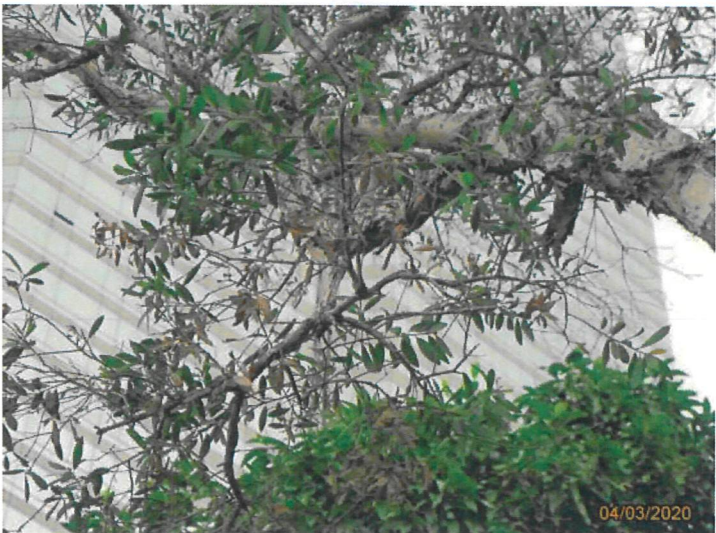
0557 - Dead branch (2)

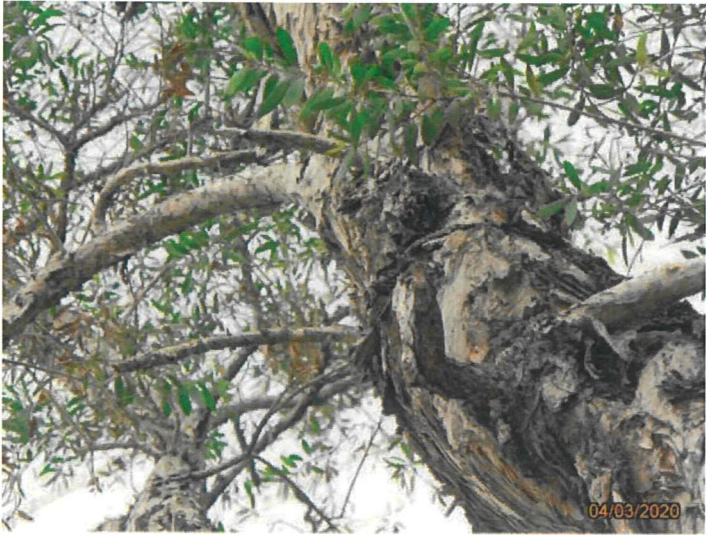
0557 - Dead branch (3)

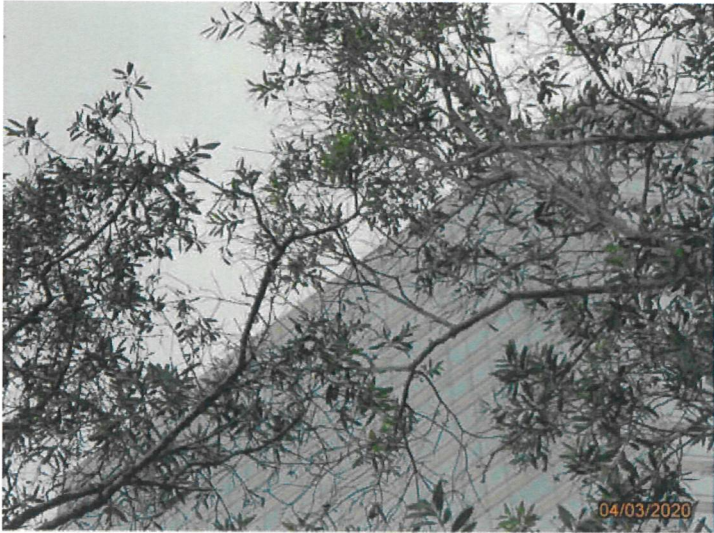
0557 - Diebacks

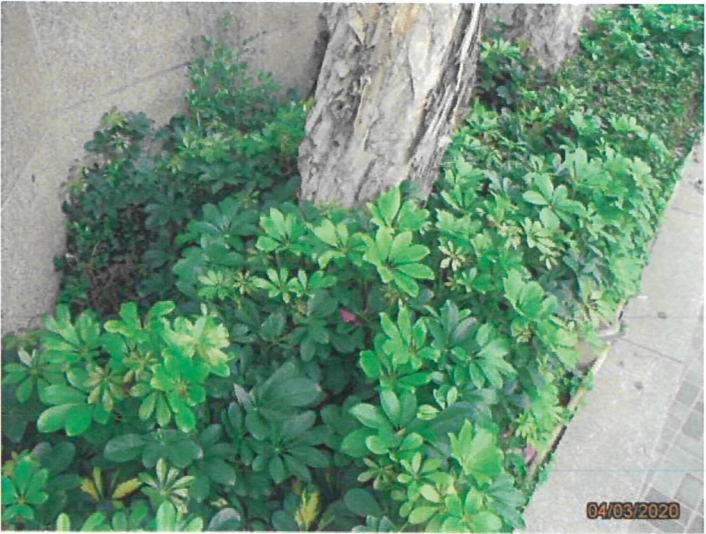
0557 - Planted in planter

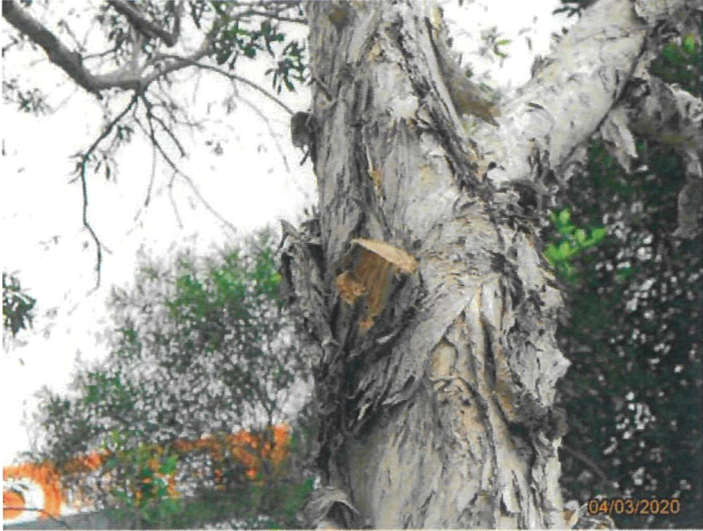
0559 - Broken branch

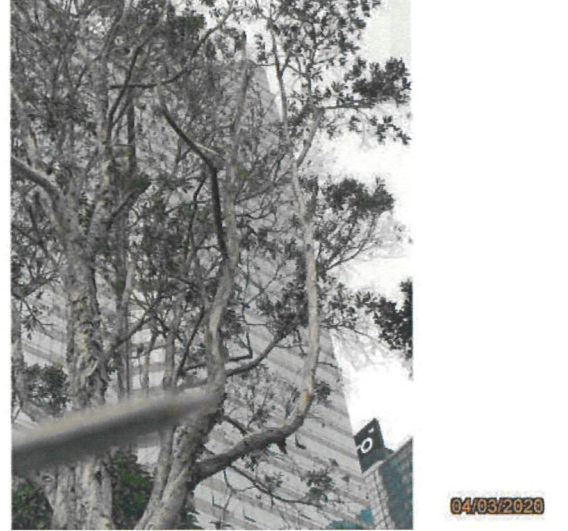
0559 - Dead branches (1)

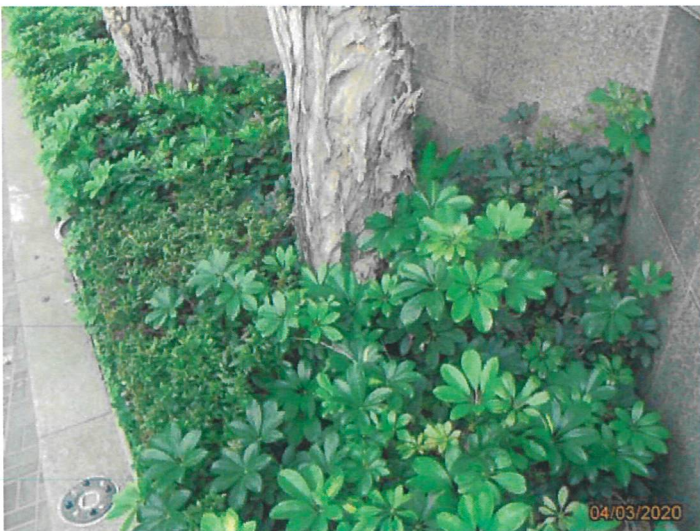
0559 - Planted in planter
