**Shatin to Central Link
Contract 1123 – Exhibition Station and Western Approach Tunnel
Submission of Landscape Plan for Further Environmental Permit No. FEP-13/364/2009/H
and FEP-03/376/2009**

**Shatin to Central Link –
Exhibition Station & Western Approach
Tunnel**

Landscape Plan
for
FEP-13/364/2009/H & FEP-03/376/2009

LS/20426 Contract 1123_H2624 - Exhibition Station and Western Approach Runnel
Initial Tree Survey Report

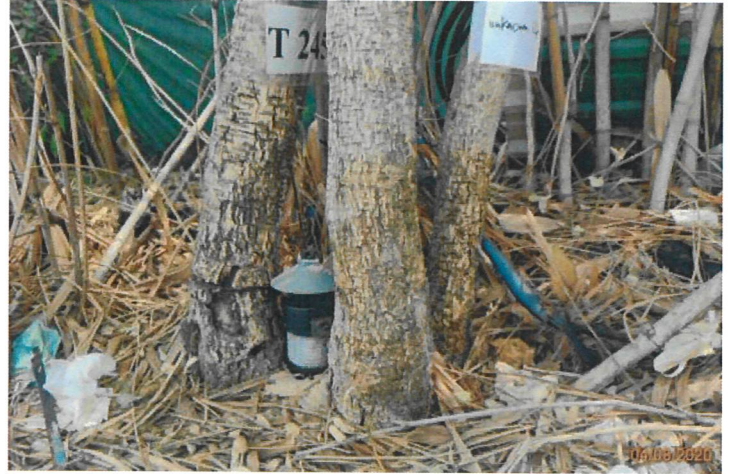
A2 - Mult-Stems

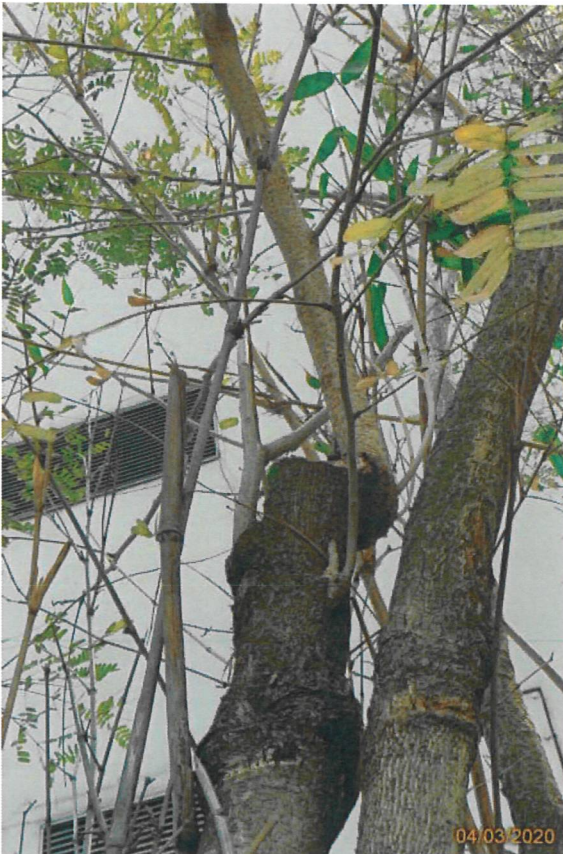
A2 - Pruned wound

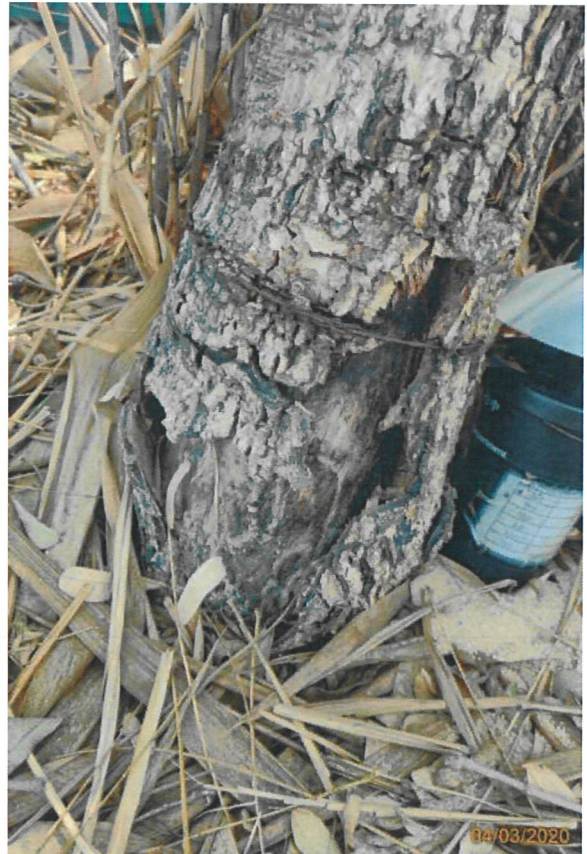
A2 - Wound on root collar

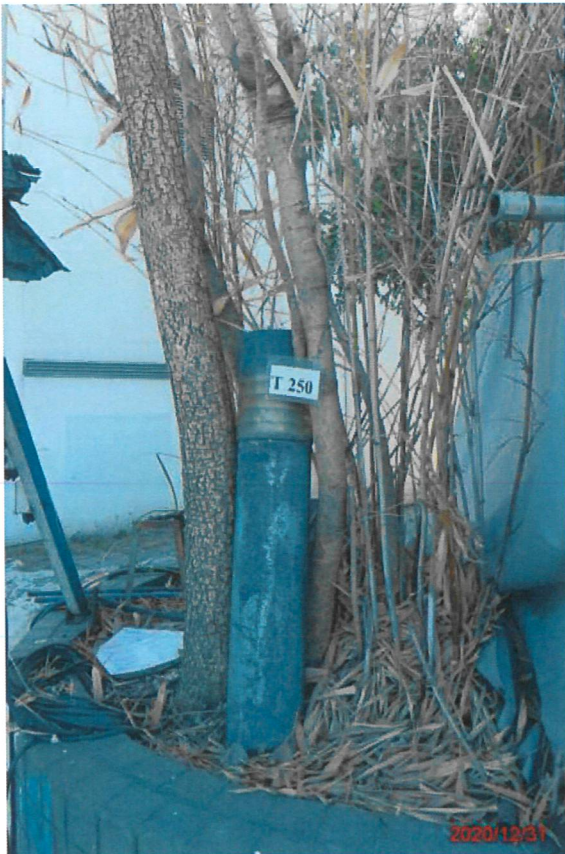
A4 - Restricted rooting area

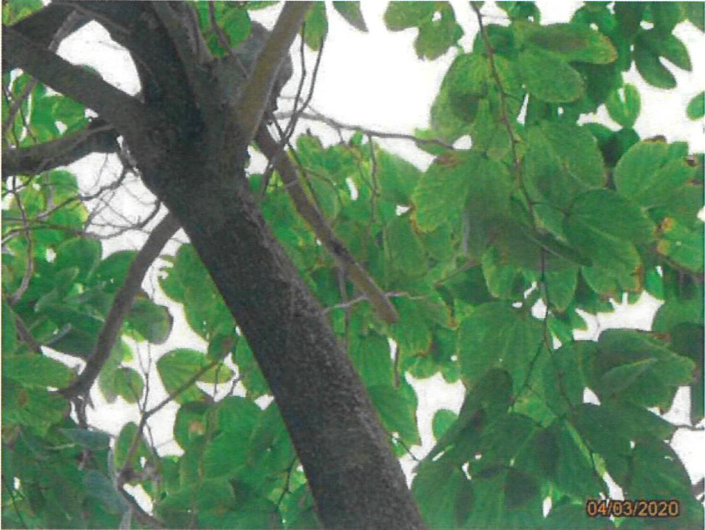
A154 - Broken branch

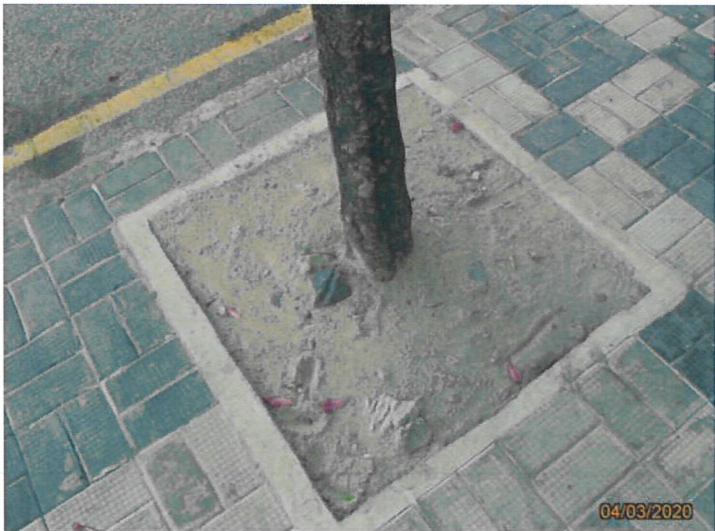
A154 - Restricted rooting area

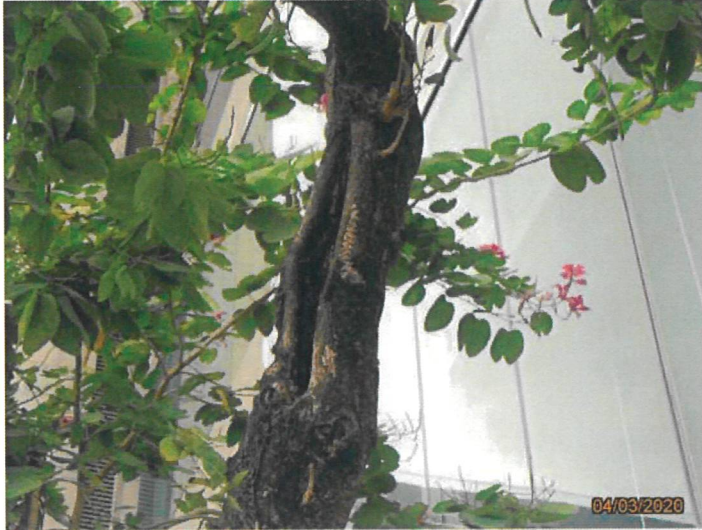
A154 - Wound on trunk (2)

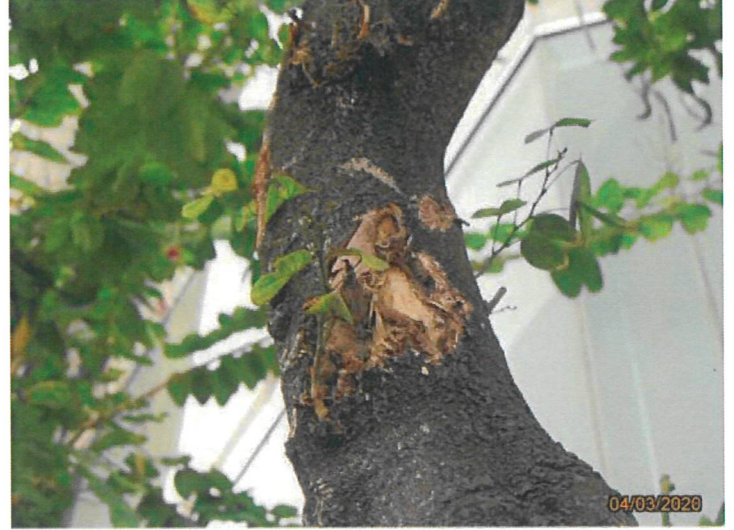
A154 - Wound on trunk

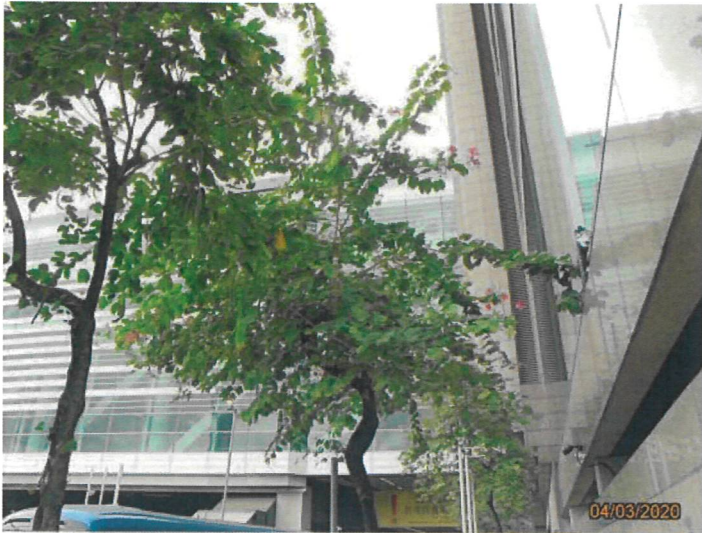
A155 - Crown condition

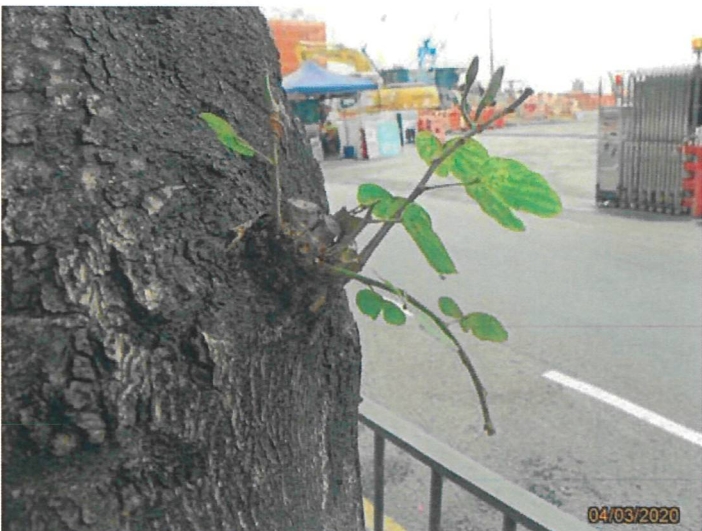
A155 - Epicormics

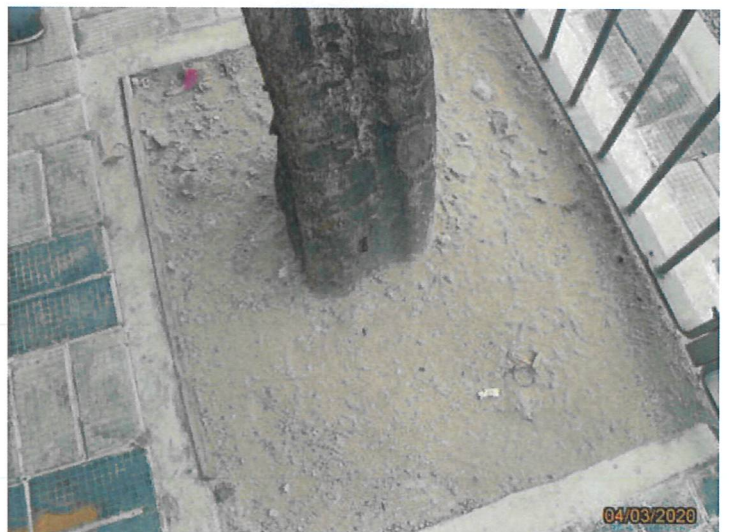
A155 - Restricted rooting area

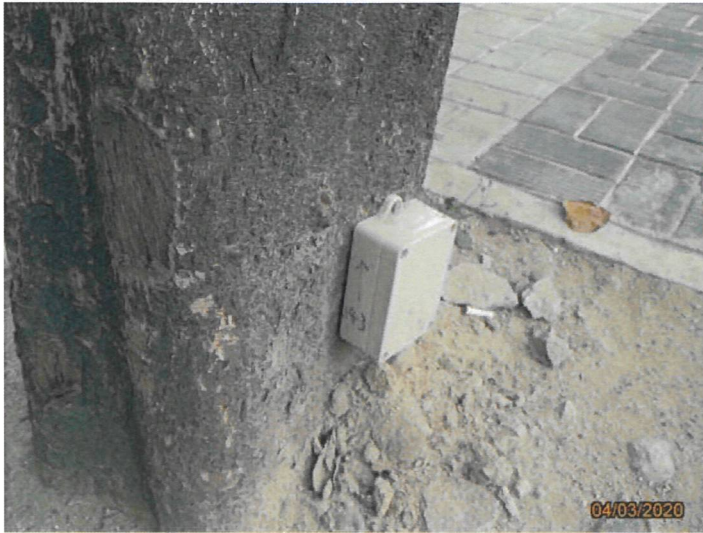
A155 - Tilt sensor attached on root collar

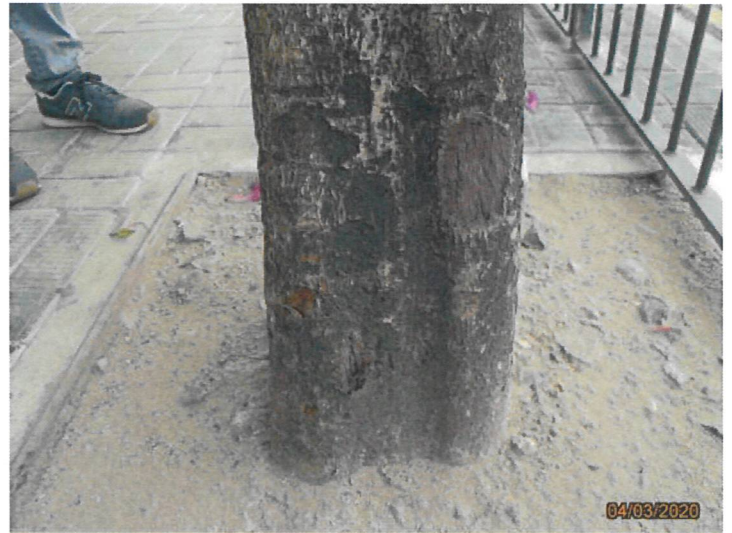
A155 - Wound on trunk

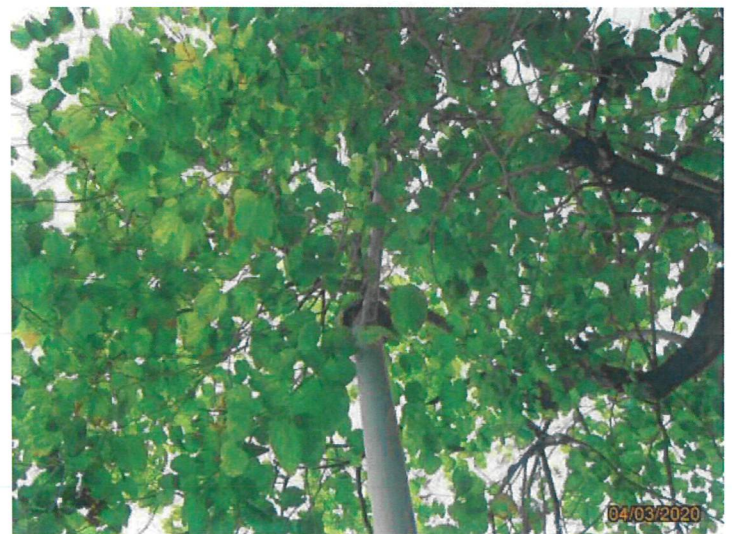
A156 - Conflict with flagpole

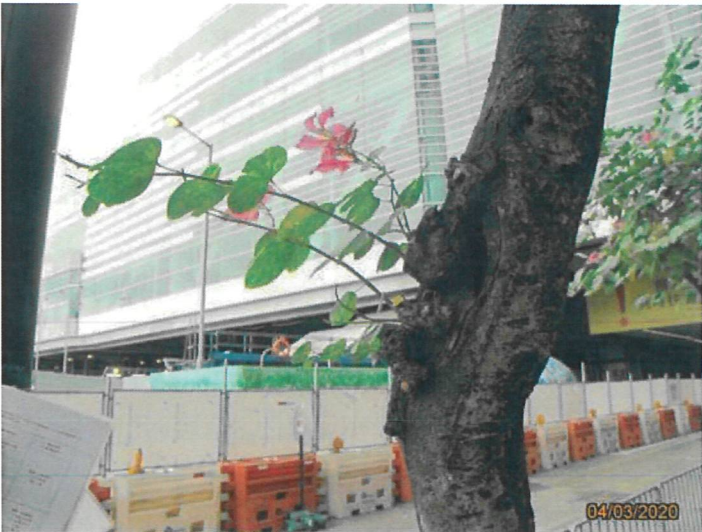
A156 - Epicormics

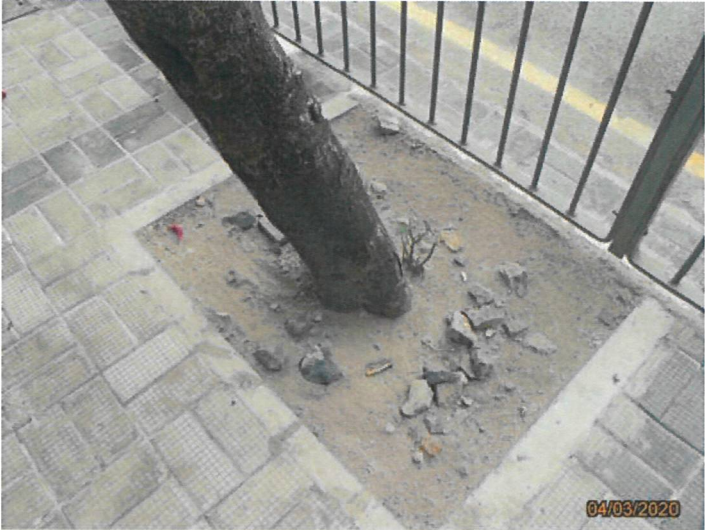
A156 - Restricted rooting area

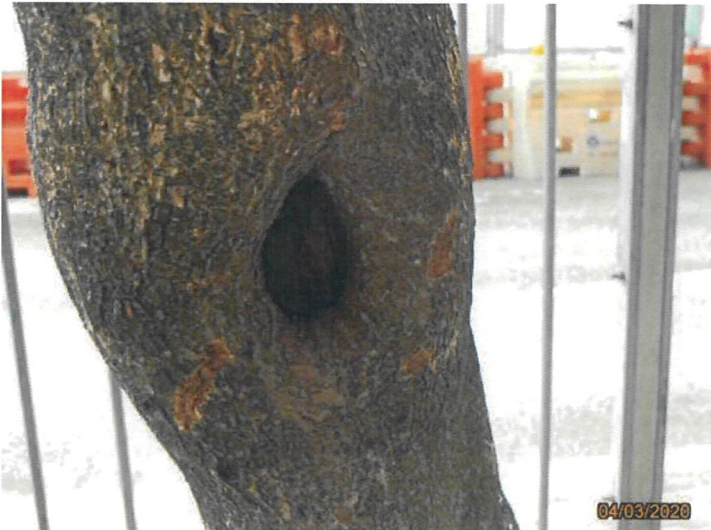
A156 - Wound on trunk (1)

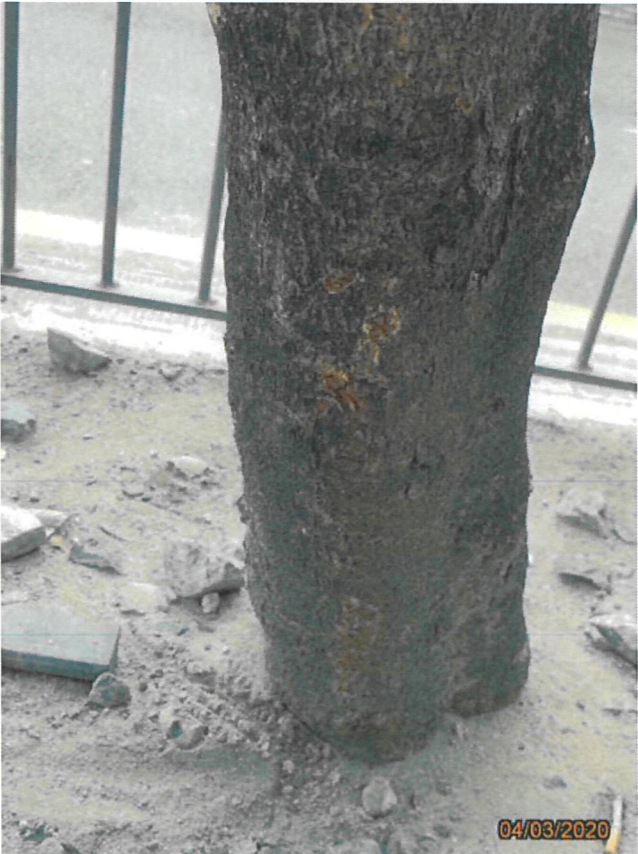
A156 - Wound on trunk (2)

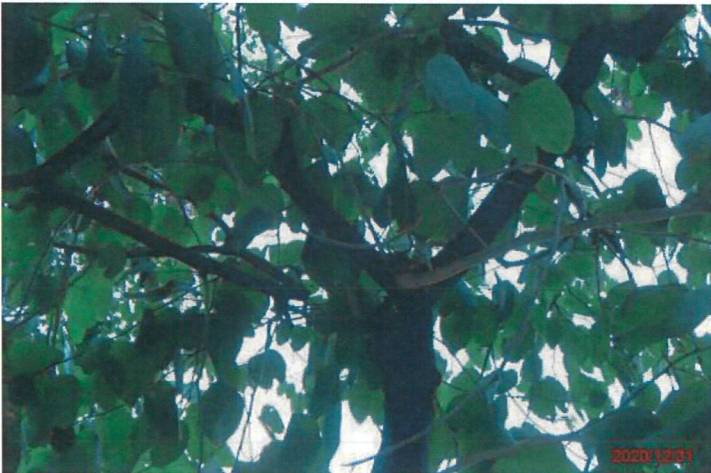
A158 - Dead branches

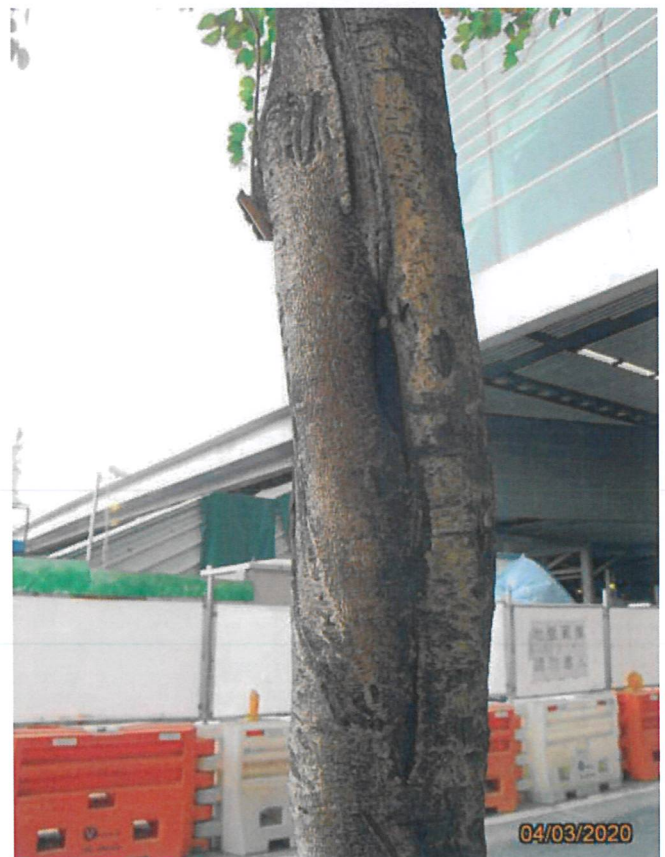
A159 - Old wound on trunk

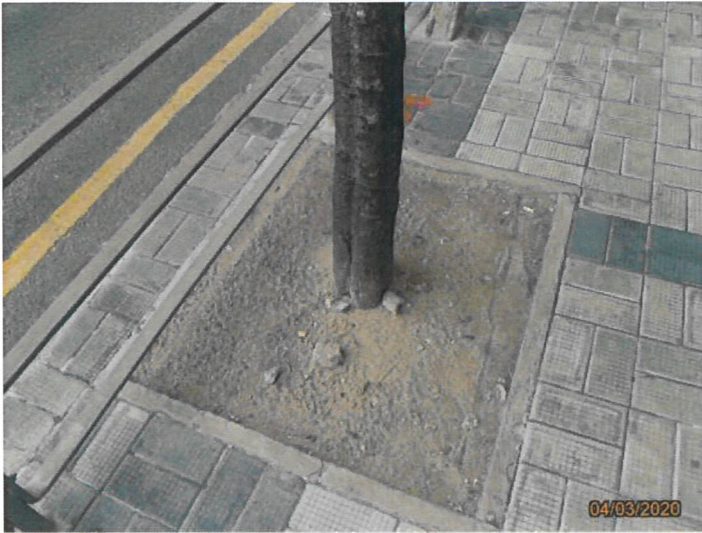
A159 - Restricted rooting area

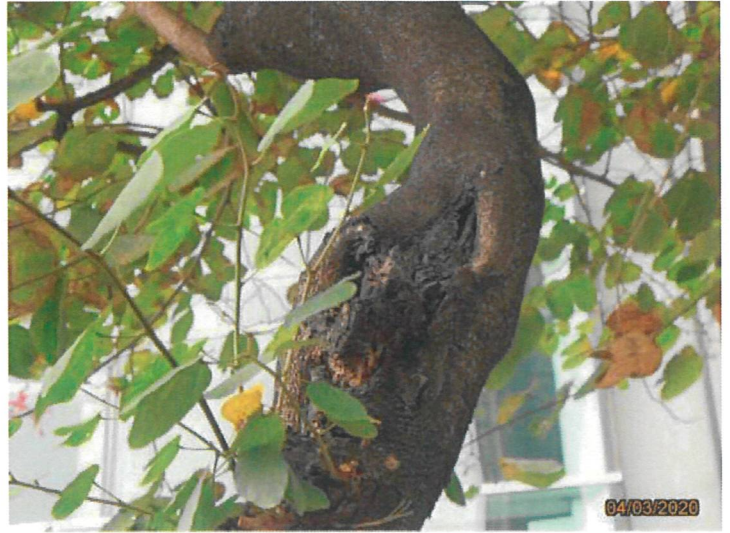
A159 - Wound on trunk

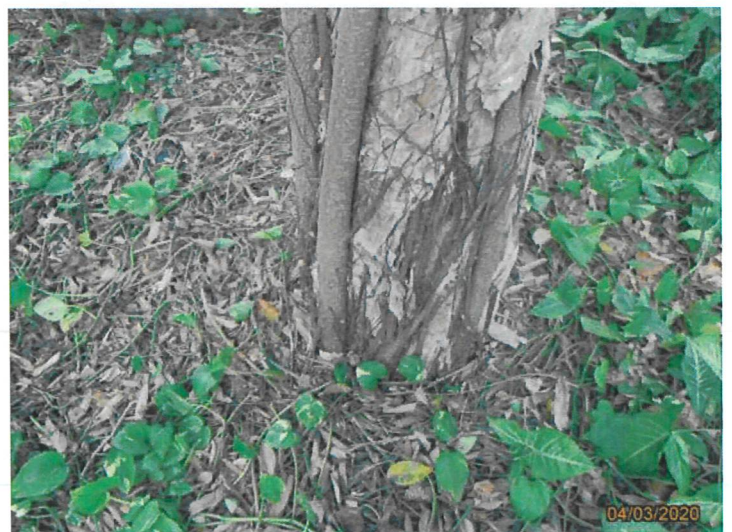
AT003 Coexisting with another tree

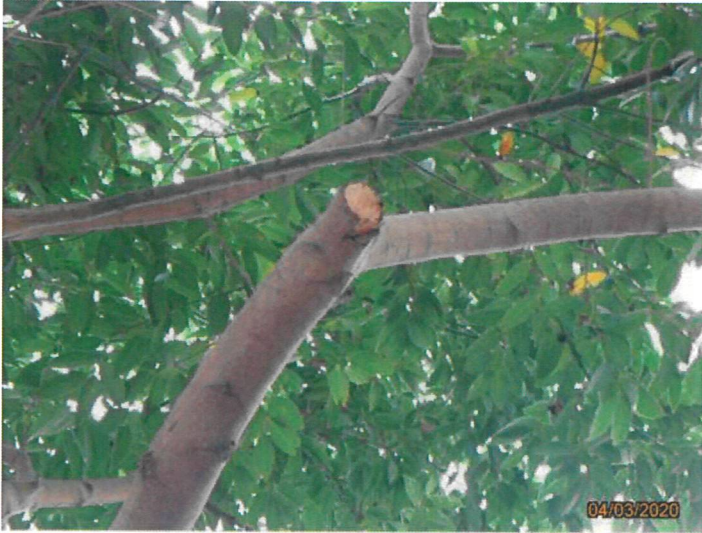
S001 - Pruned wound (2)

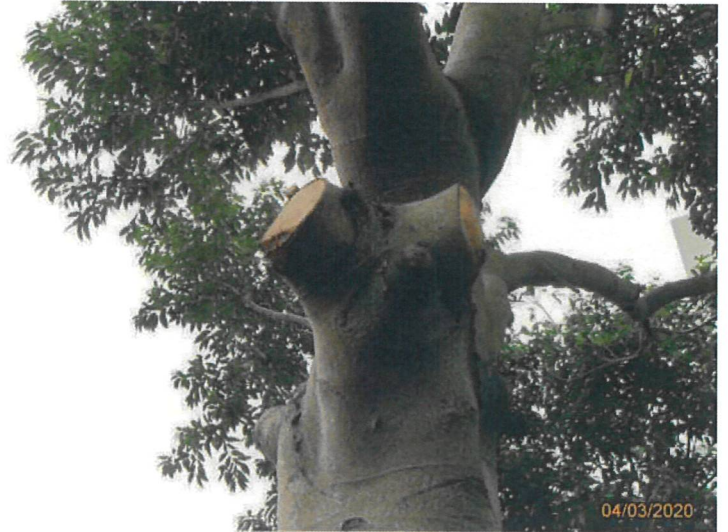
S001 - Pruned wound

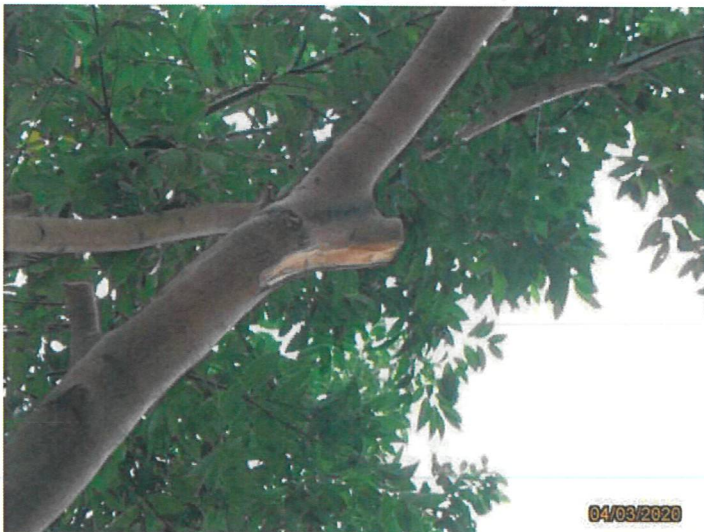
S001 - Wound on branch

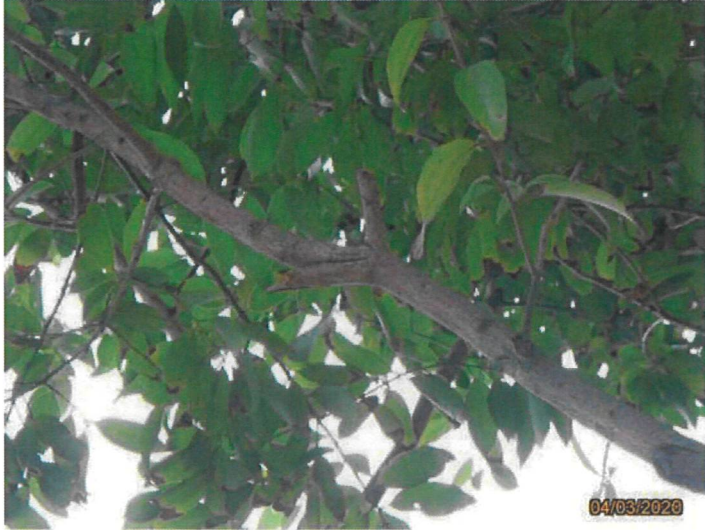
S002 - Broken branch (2)

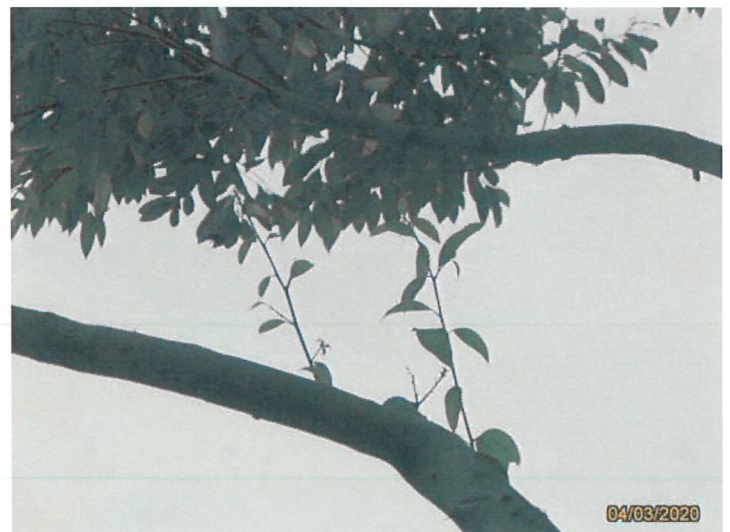
S003 - Epicormics

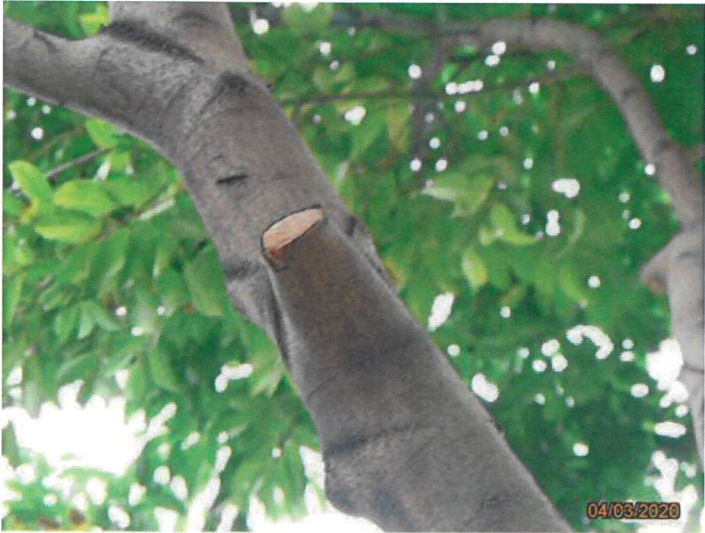
S003 - Pruned wound

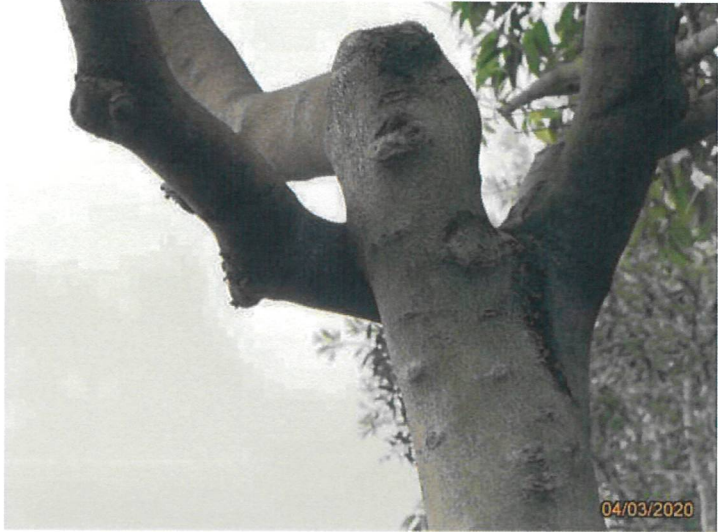
S003 - Wound on branch

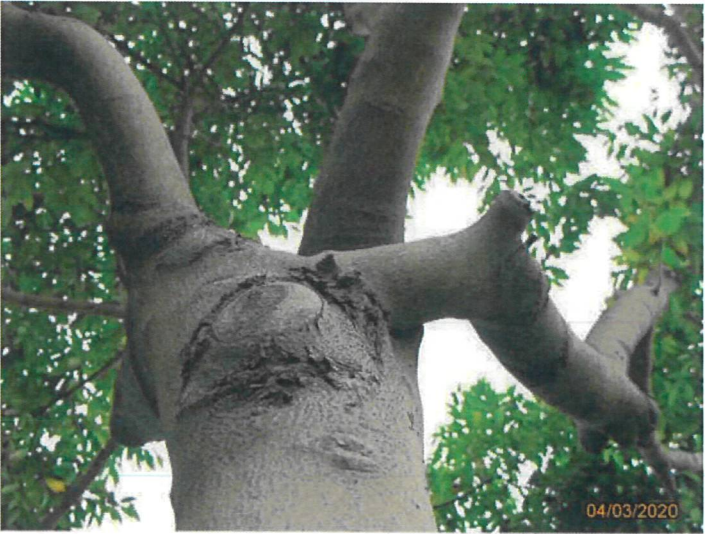
S003 - Wound on trunk

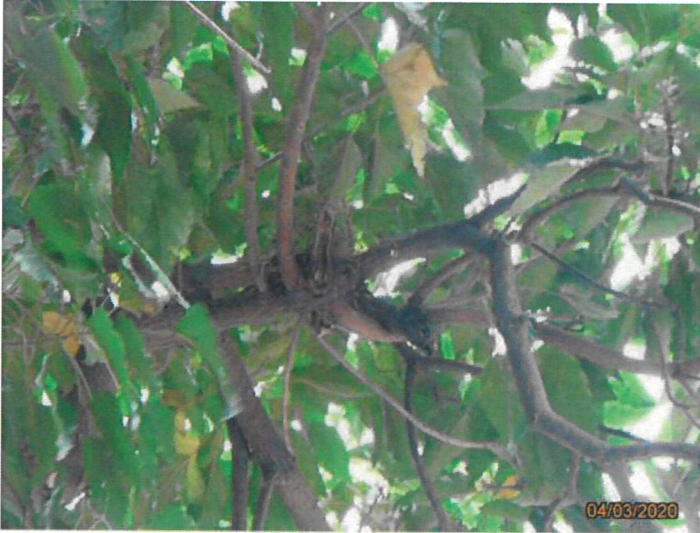
S005 - Broken branch

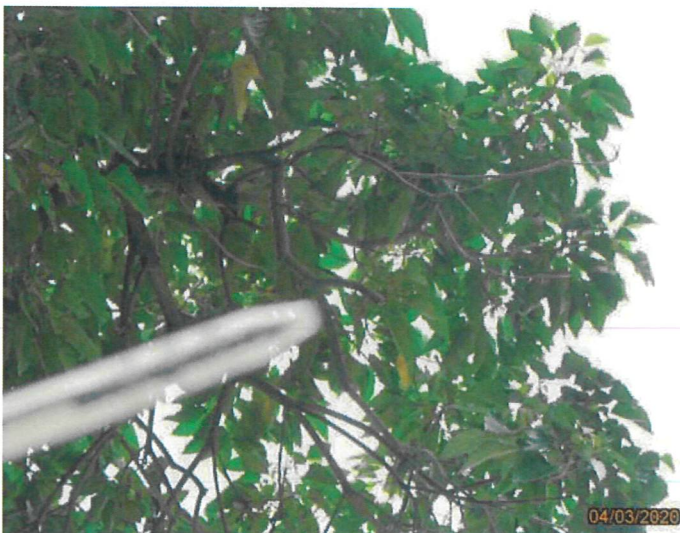
S005 - Dead branch

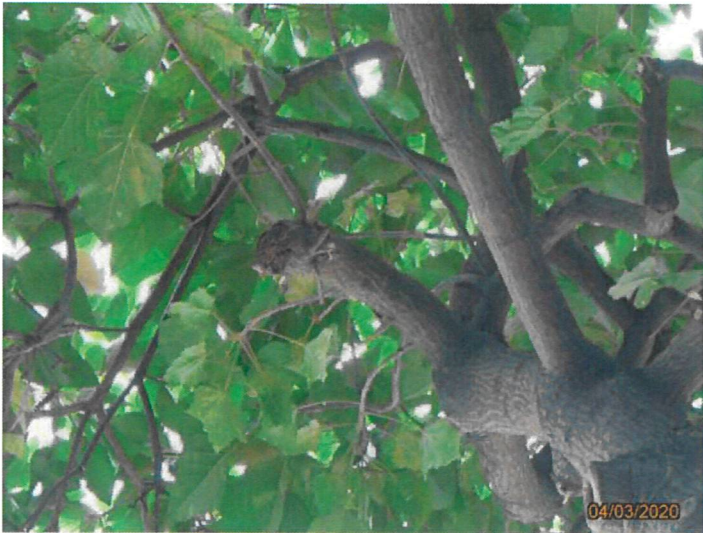
S005 - Pruned wound

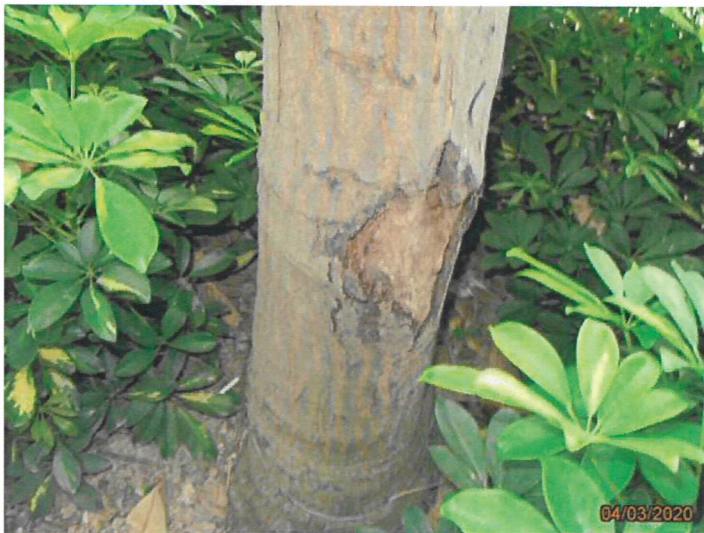
S005 - Wound on trunk

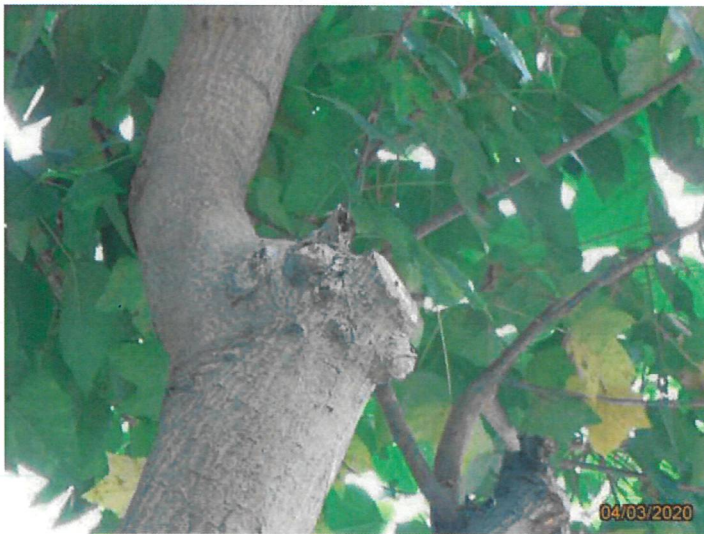
S006 - Pruned wound

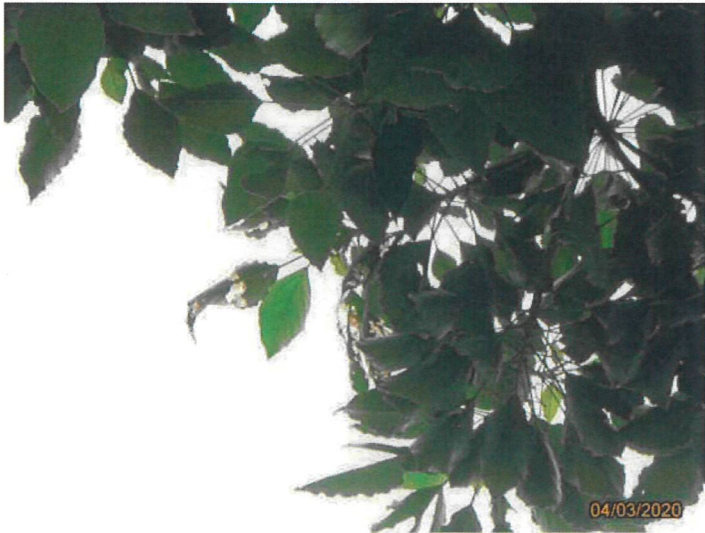
S006 - Sign of insects

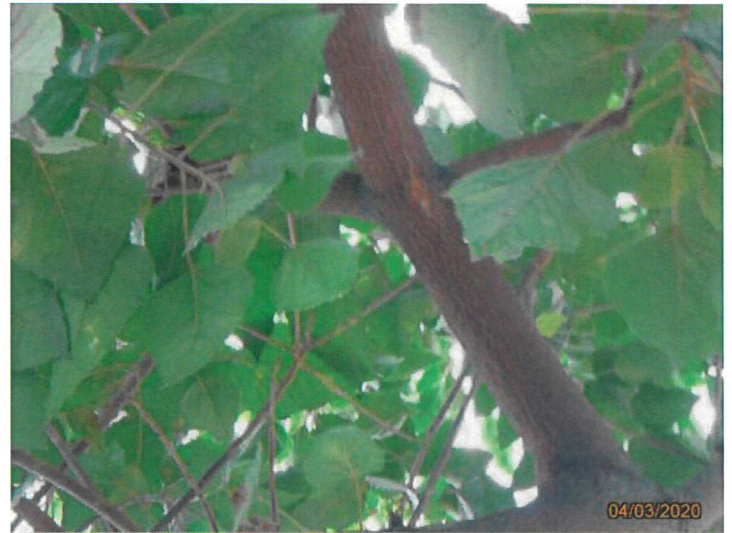
S006 - Wound on branch (2)

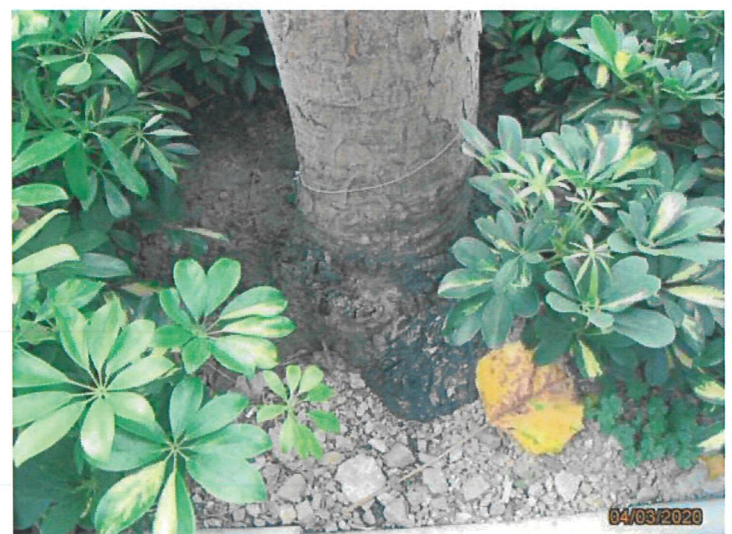
S006 - Wound on root collar

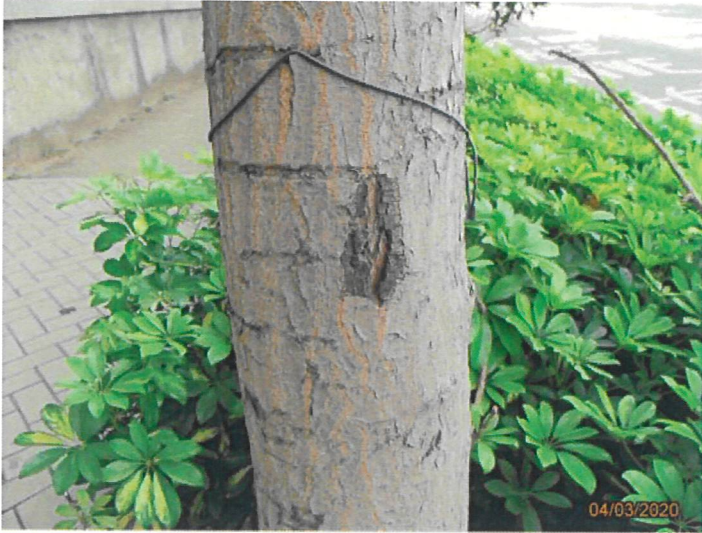
S006 - Wound on trunk (2)

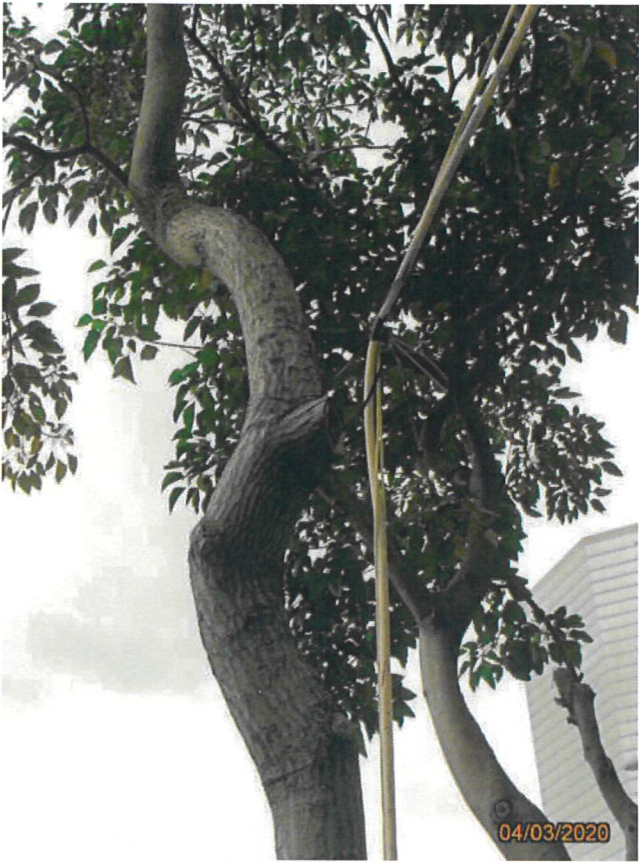
S008 - Electirc wire tyng on trunk

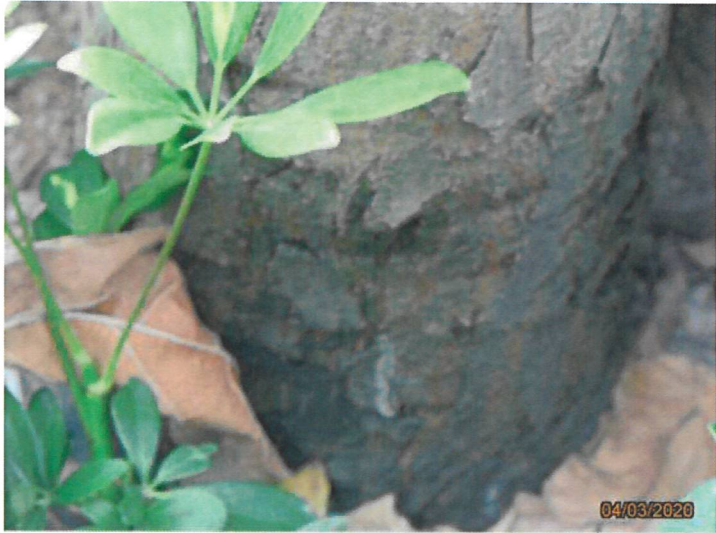
S008 - Wound on root collar

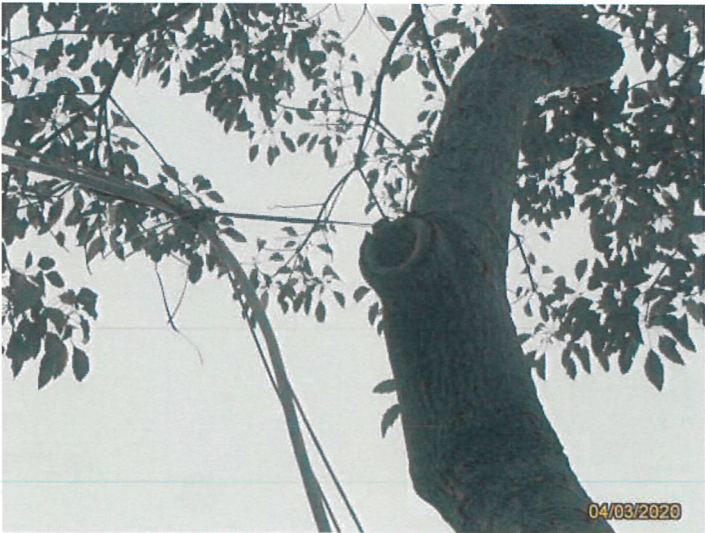
S008 - Wound on trunk

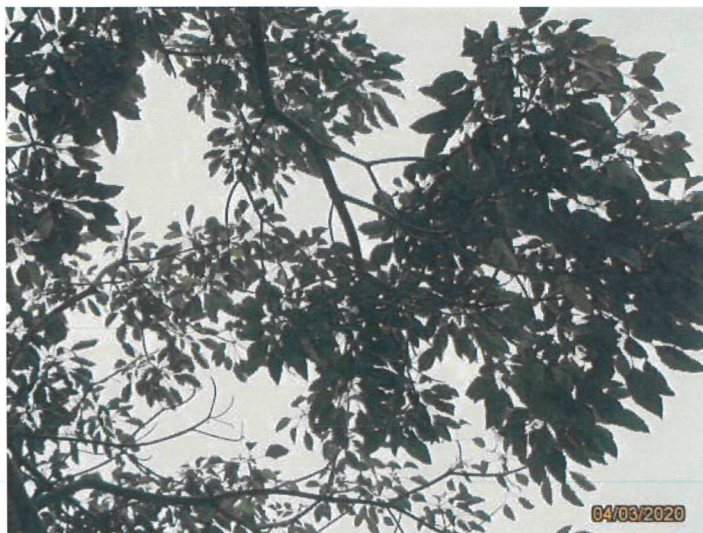
S009 - Dieback

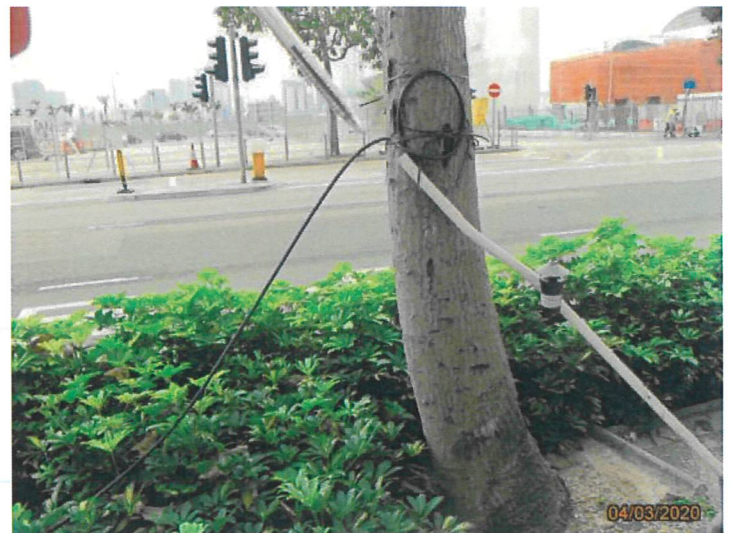
S009 - Electric wire tying on trunk

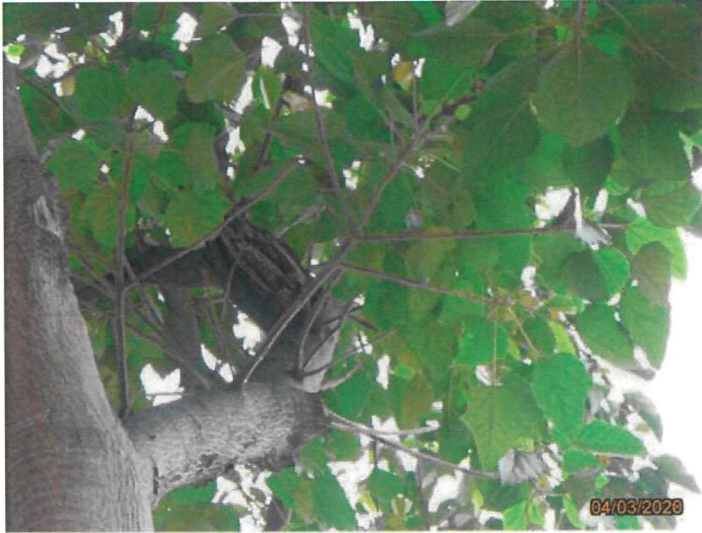
S009 - Wound on branch (2)

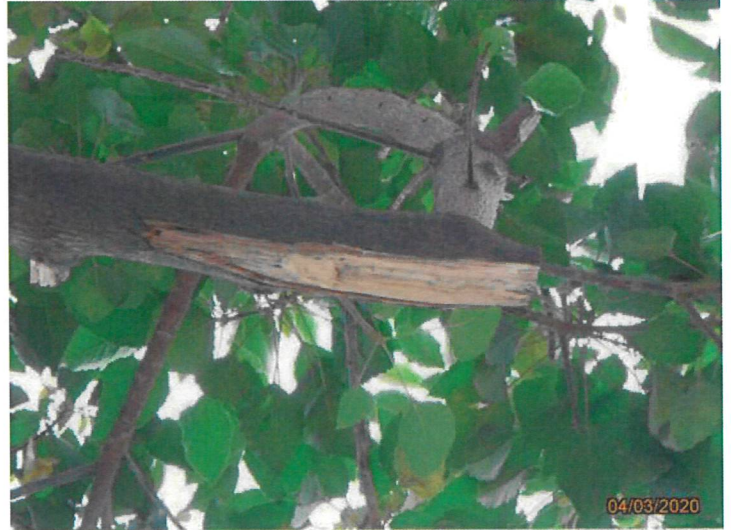
S009 - Wound on branch

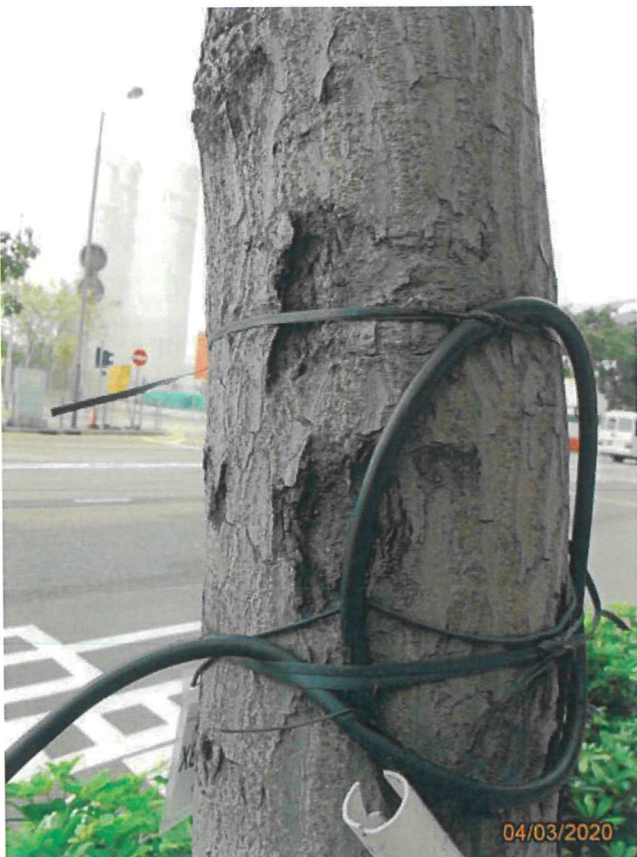
S009 - Wound on trunk (2)

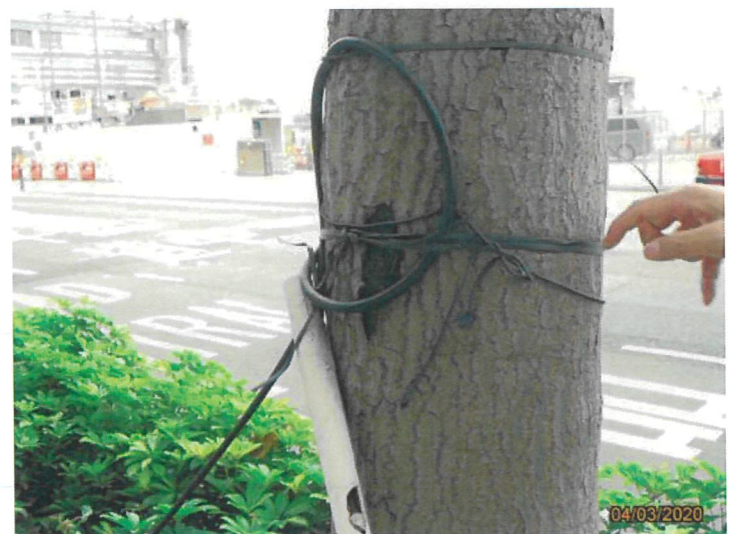
S009 - Wound on trunk

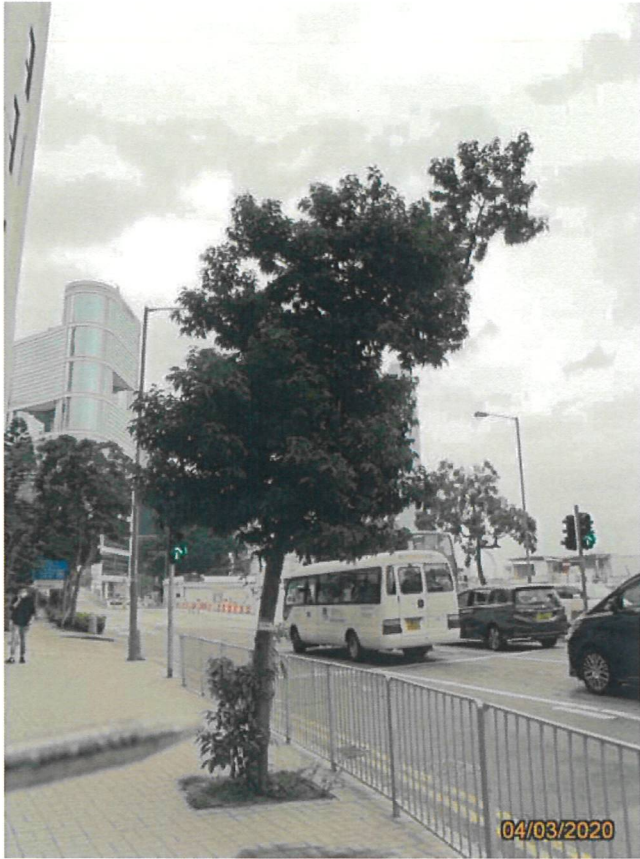
S012 - Overview

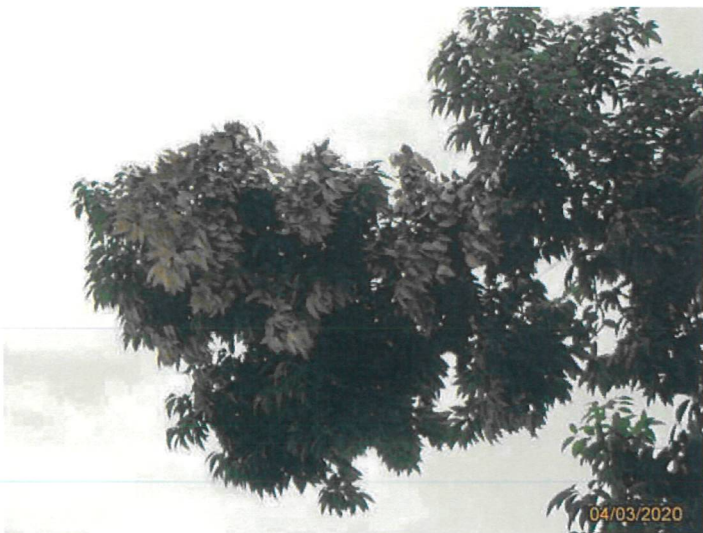
S012 - Foliage wilting

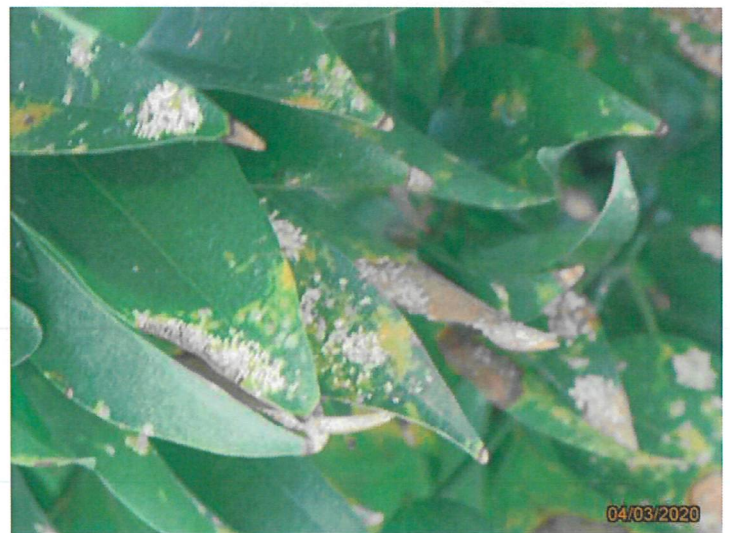
S012 - Insects invasion (2)

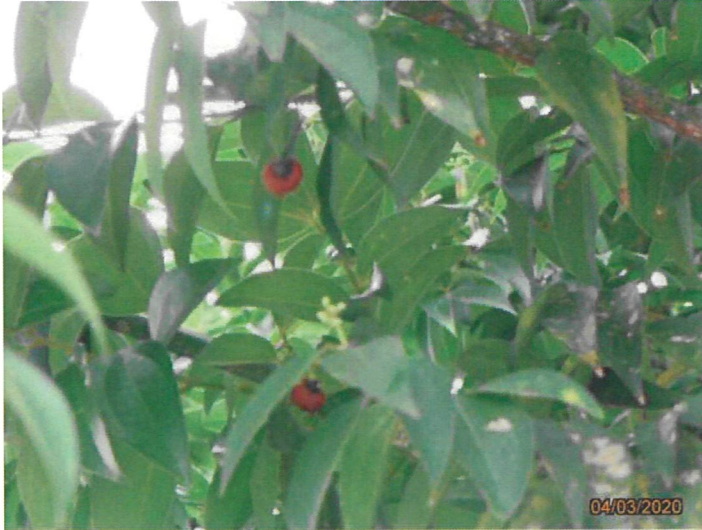
S012 - Insects invasion (3)

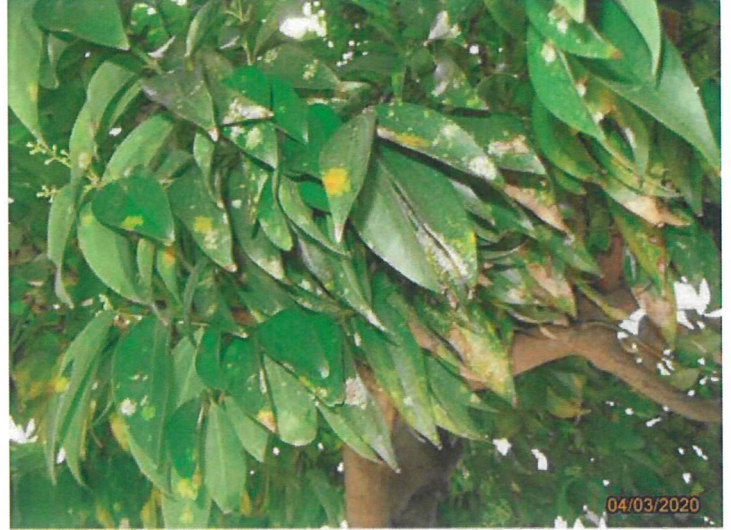
S012 - Insects invasion

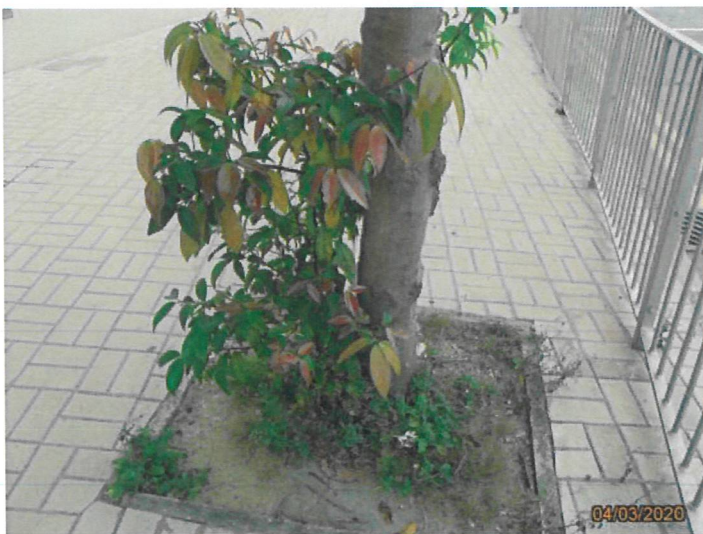
S012 - Restricted rooting area and weeds

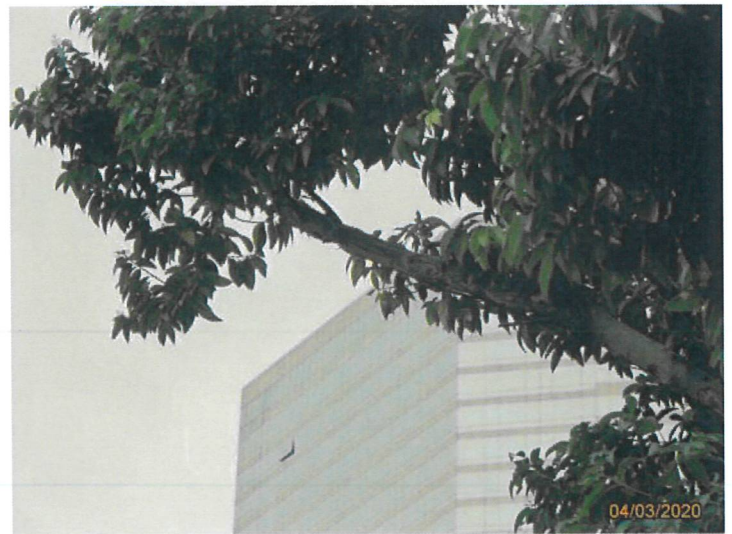
S012 - Wound on branch
