**Shatin to Central Link
Contract 1123 – Exhibition Station and Western Approach Tunnel
Submission of Landscape Plan for Further Environmental Permit No. FEP-13/364/2009/H
and FEP-03/376/2009**

**Shatin to Central Link –
Exhibition Station & Western Approach
Tunnel**

Landscape Plan
for
FEP-13/364/2009/H & FEP-03/376/2009

LS/20426 Contract 1123_H2624 - Exhibition Station and Western Approach Runnel
Initial Tree Survey Report

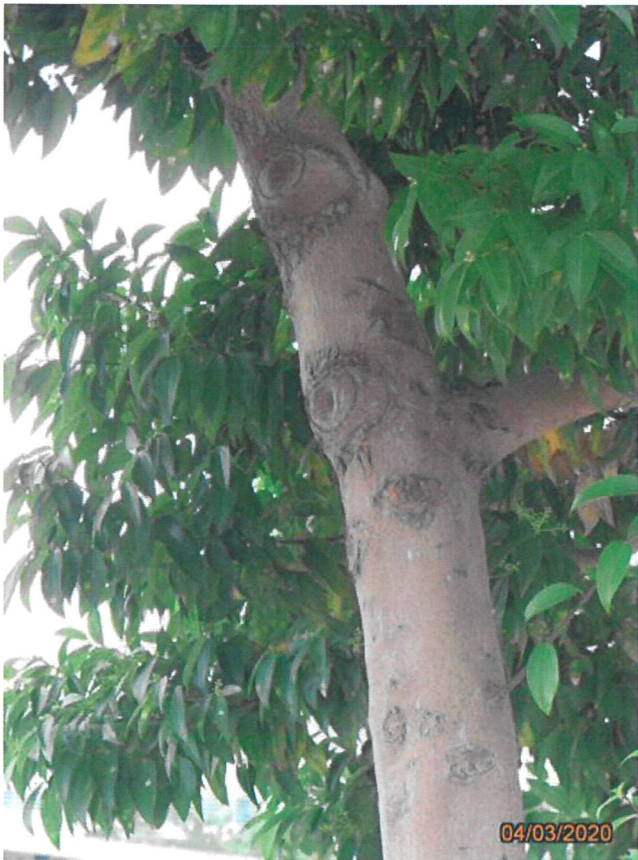
S012 - Wound on trunk (2)

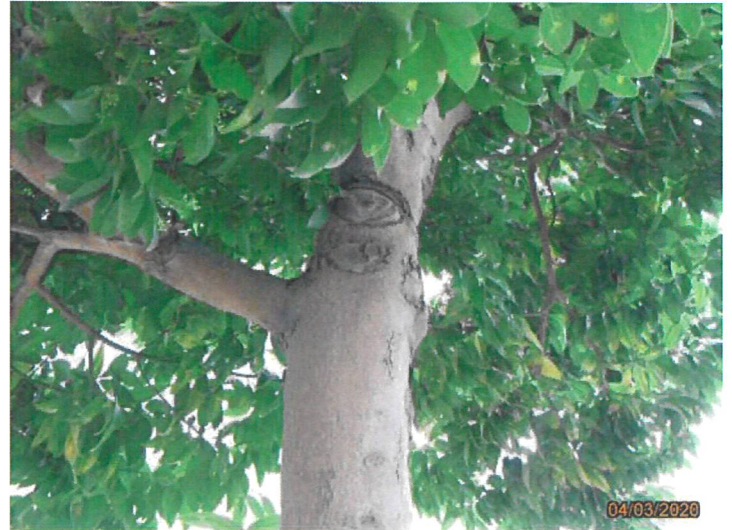
S012 - Wound on trunk

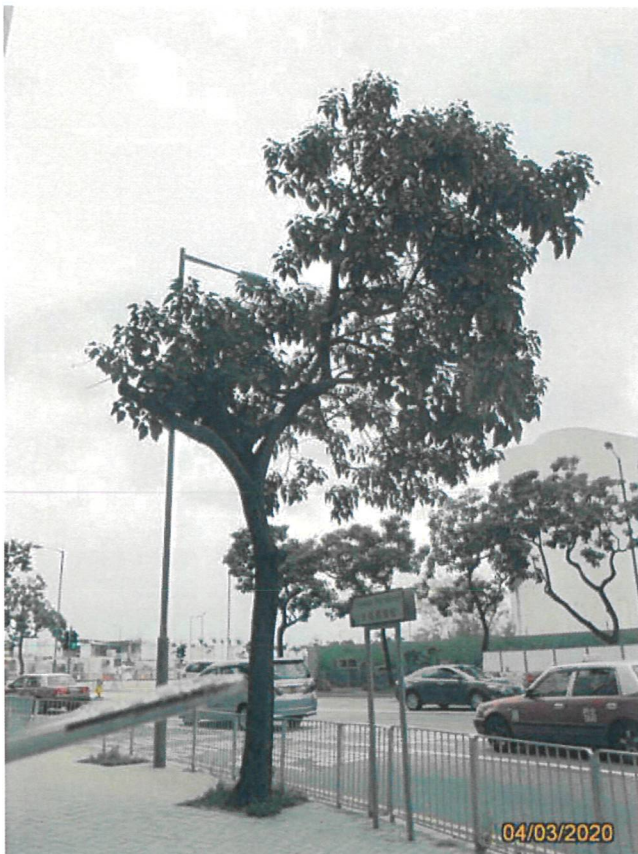
S015 - Overview

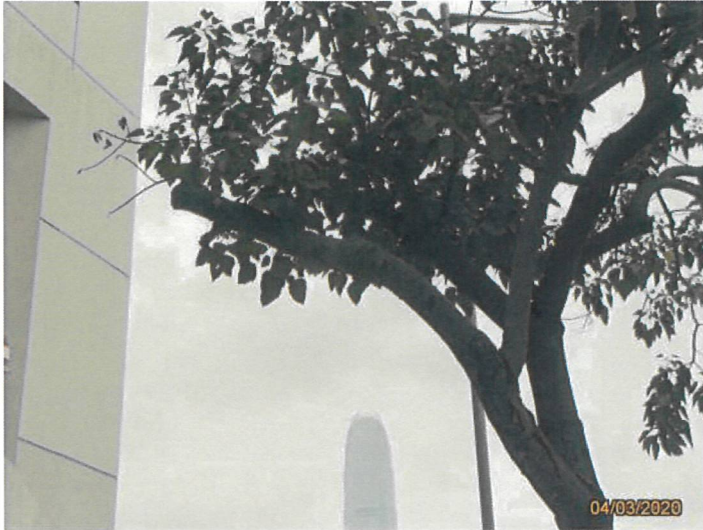
S015 - Broken branch

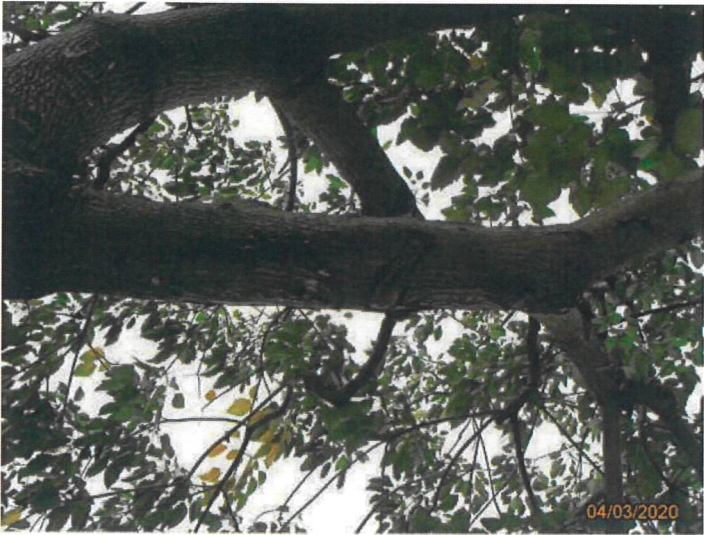
S015 - Wound on branch (3)

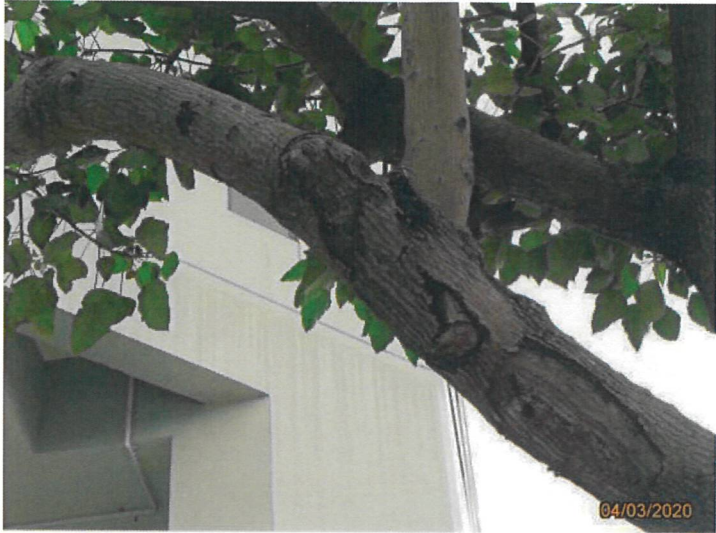
S015 - Wound on branch

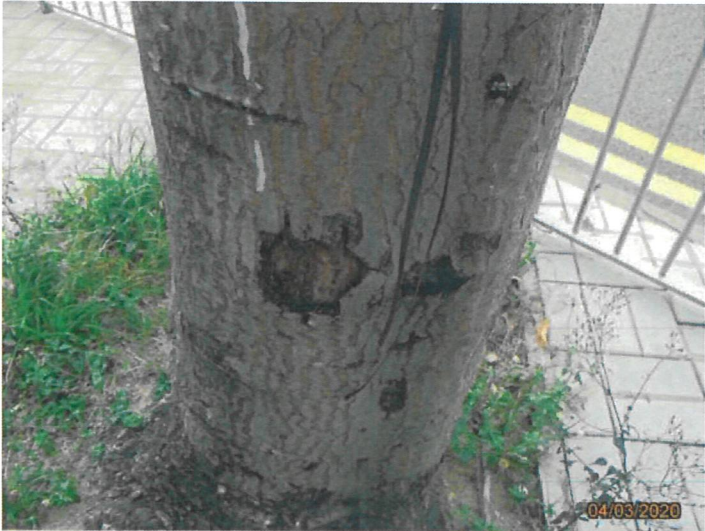
S015 - Wound on trunk

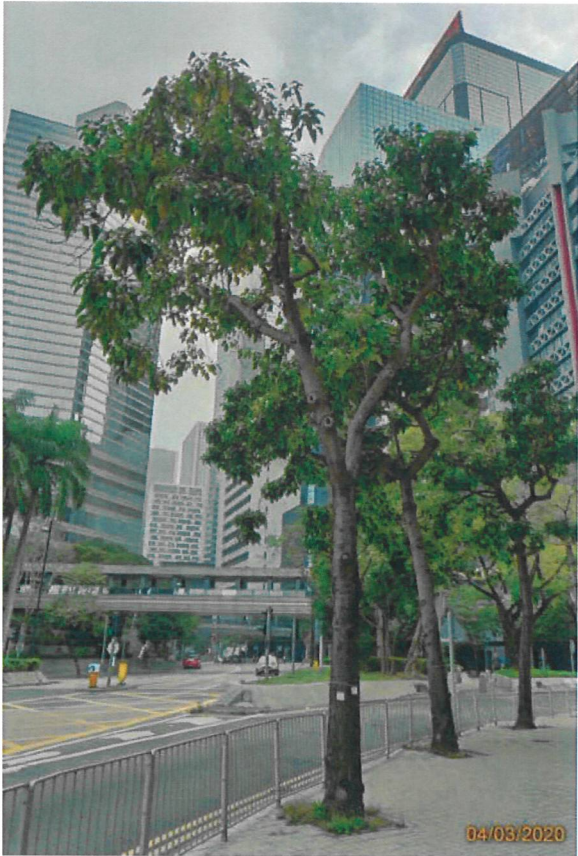
S016 - Overview

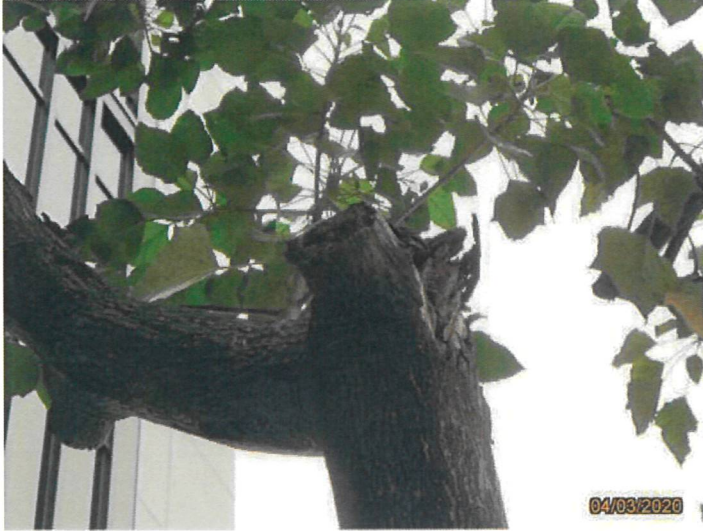
S016 - Broken branch and wound on branch

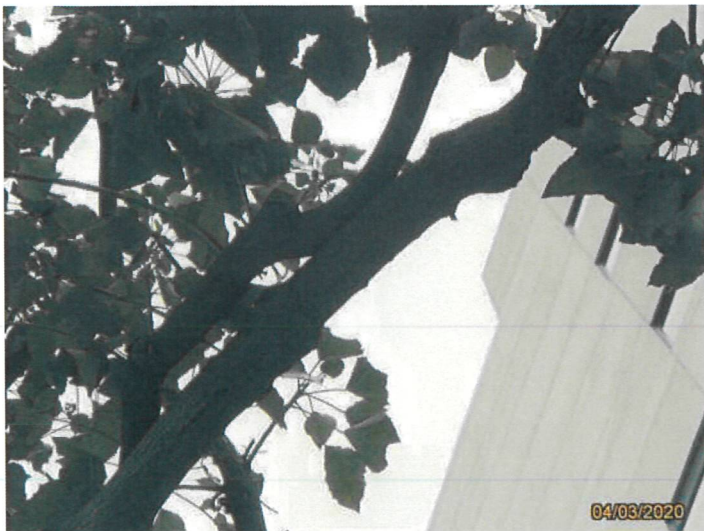
S016 - Crossed branches

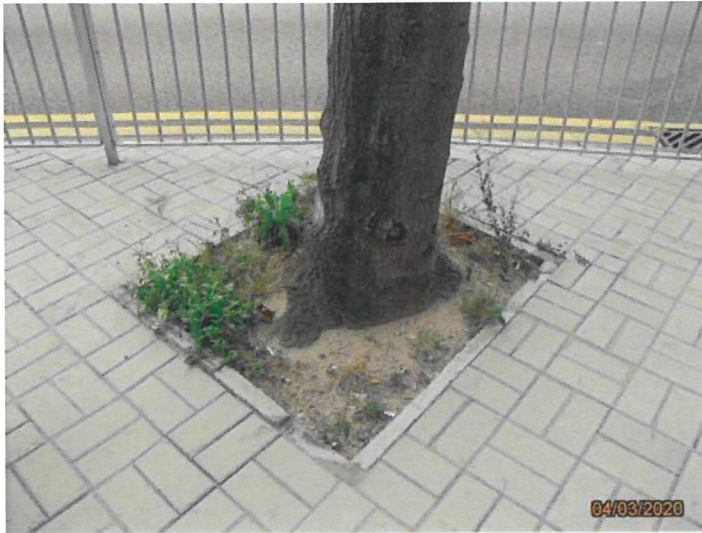
S016 - Restricted rooting area

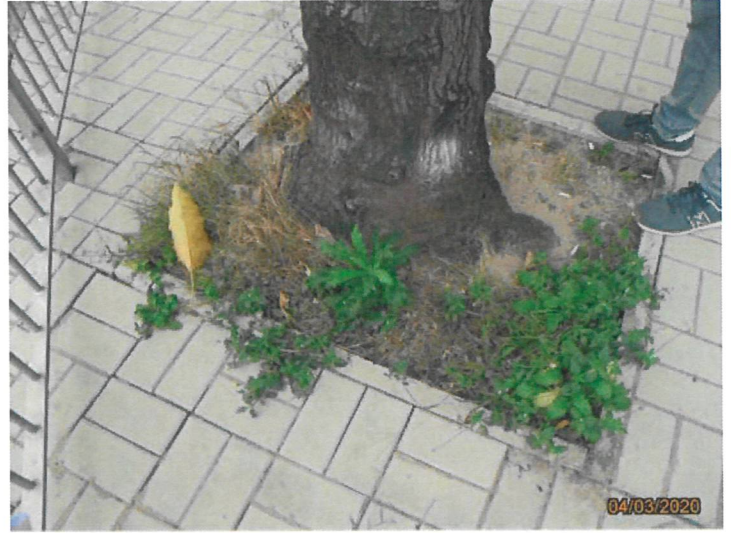
S016 - White Paint on root collar

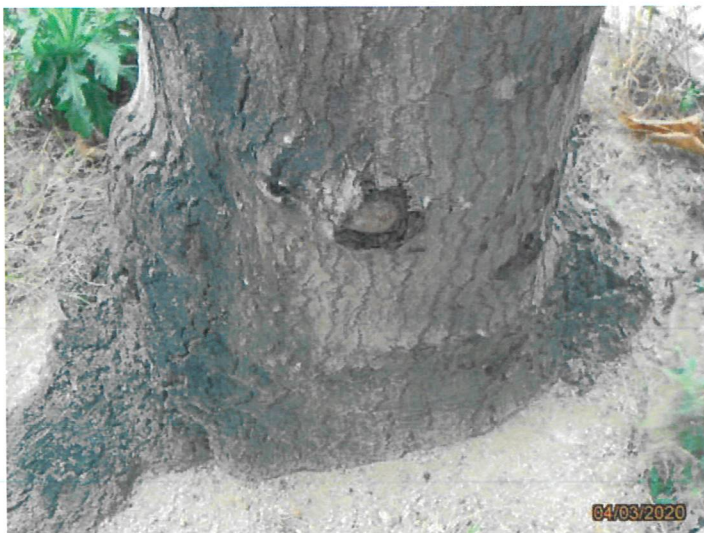
S016 - Wound on root collar

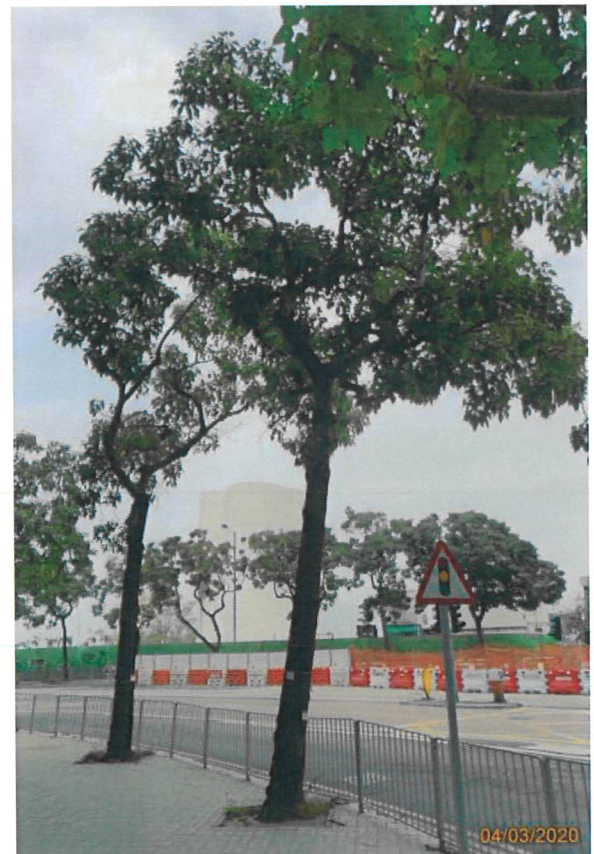
S017 - Overview

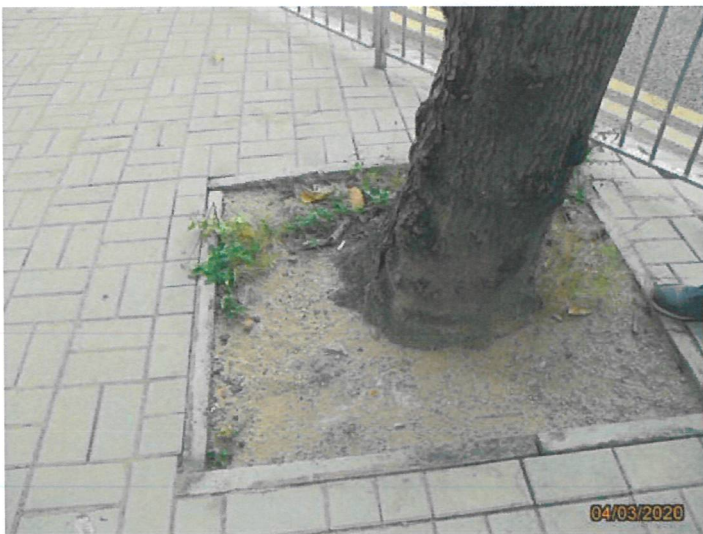
S017 - Restricted rooting area

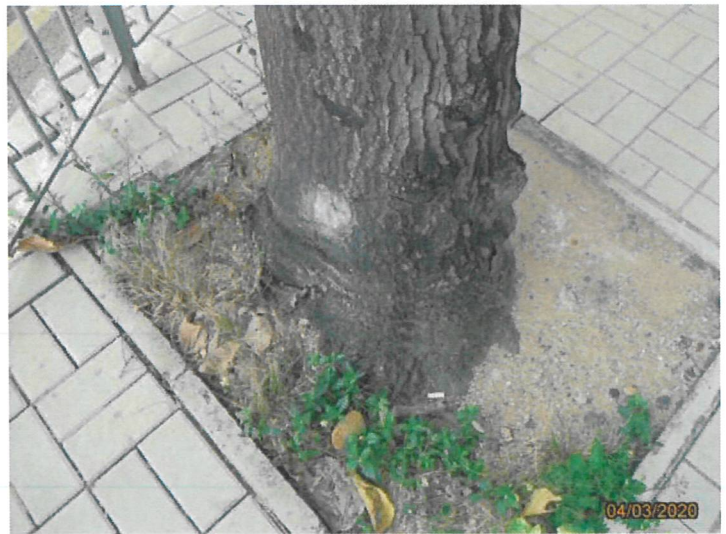
S017 - White paint on root collar

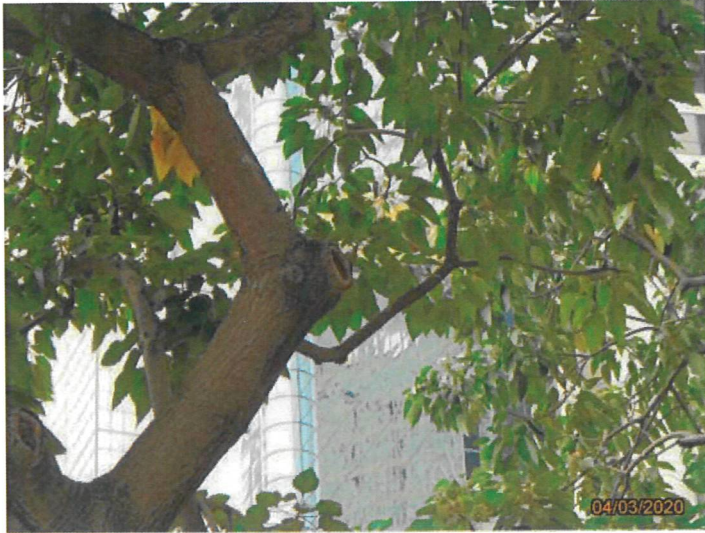
S017 - Wound on branch (2)

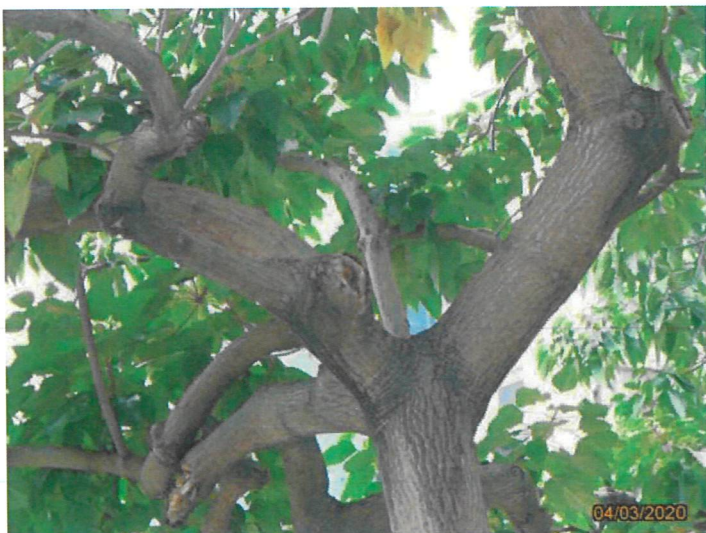
S017 - Wound on branch

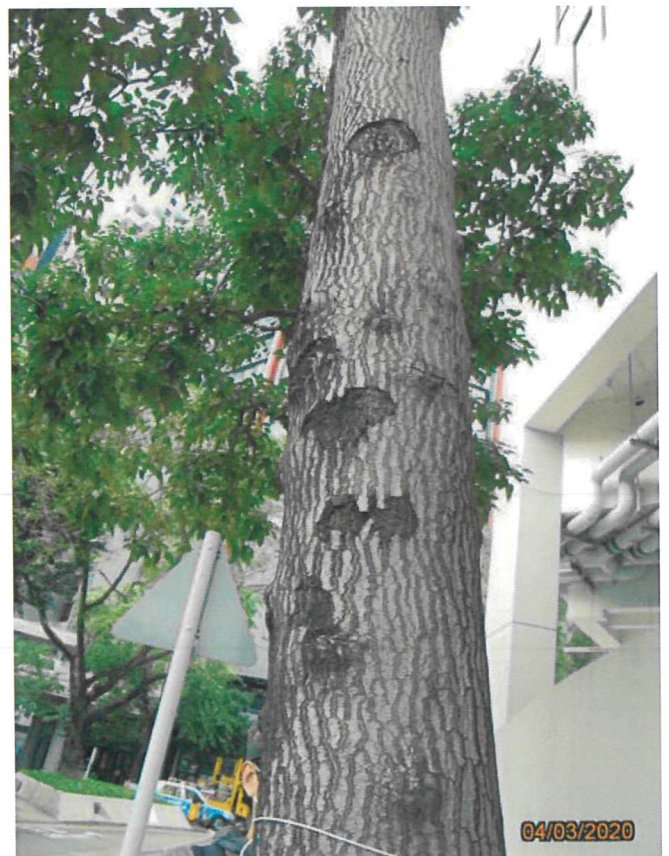
S017 - Wound on trunk

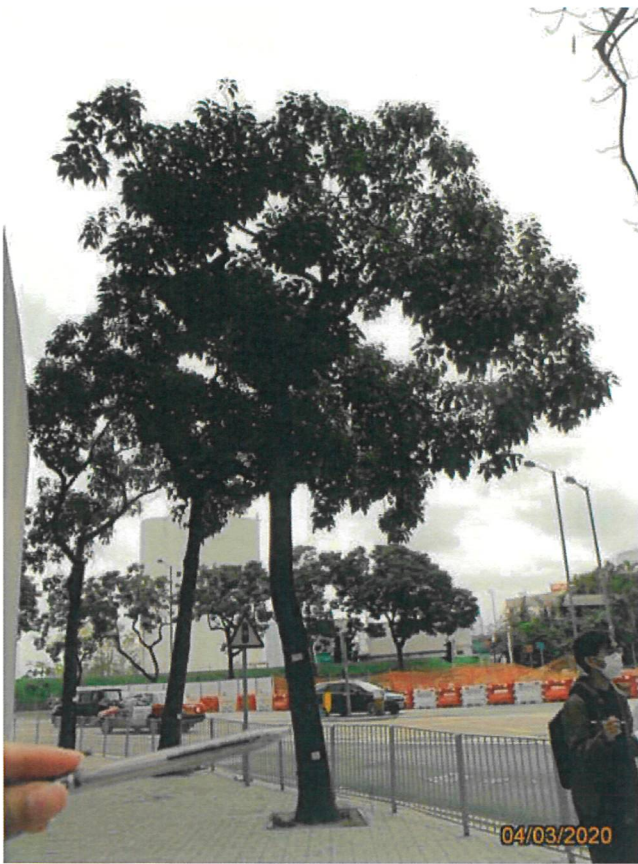
S018 - Overview

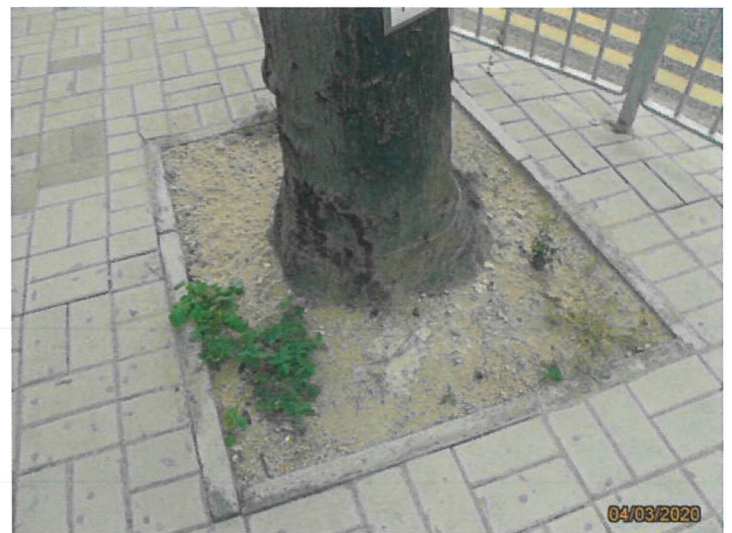
S018 - Restricted rooting area

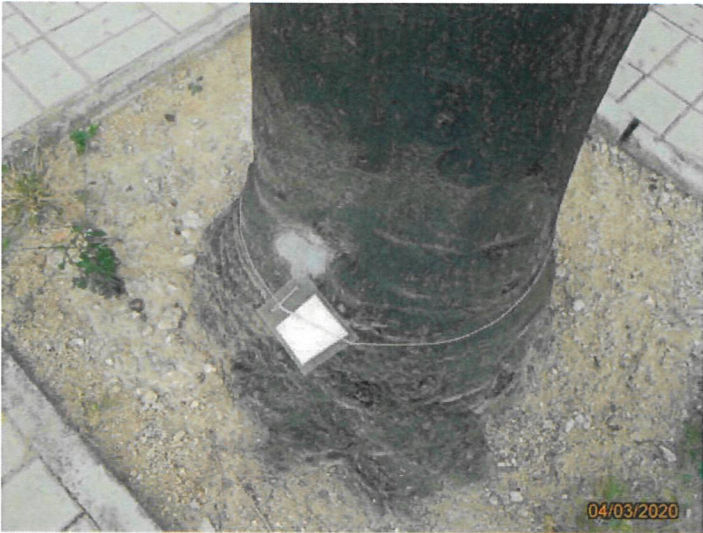
S018 - White paint on root collar

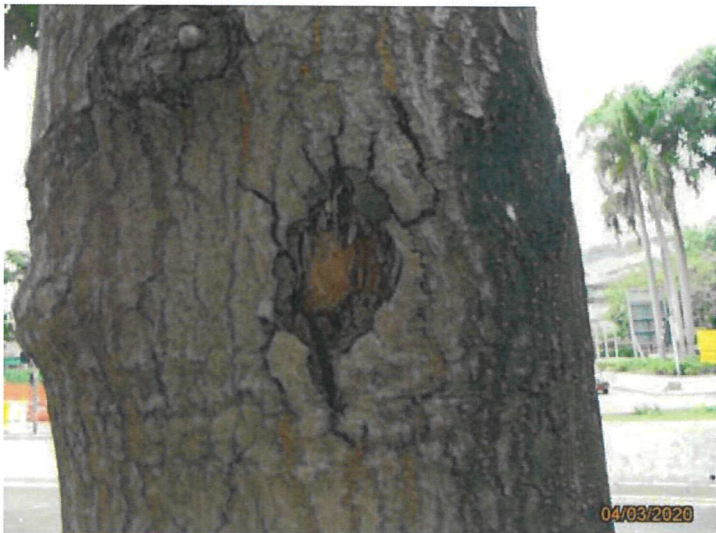
S018 - Wound on trunk

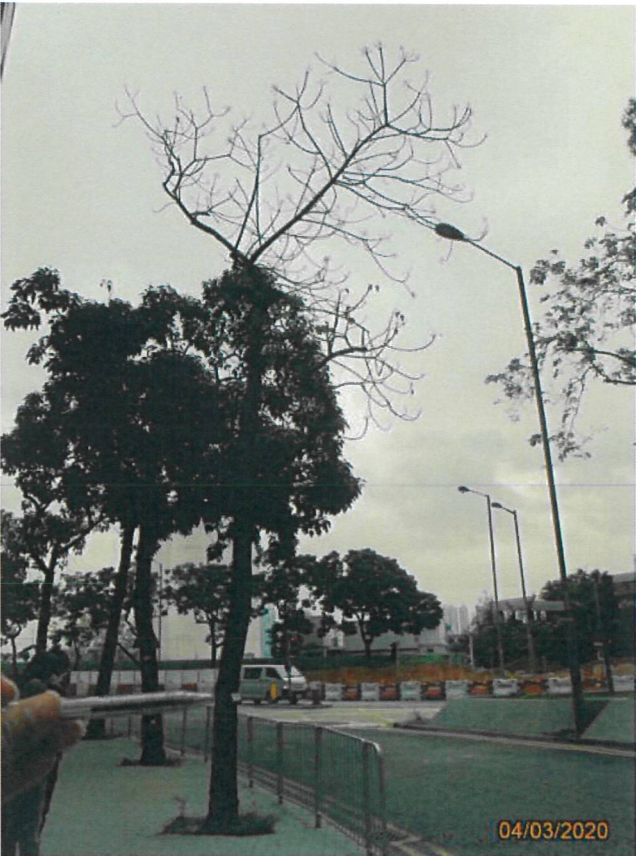
S020 - Overview

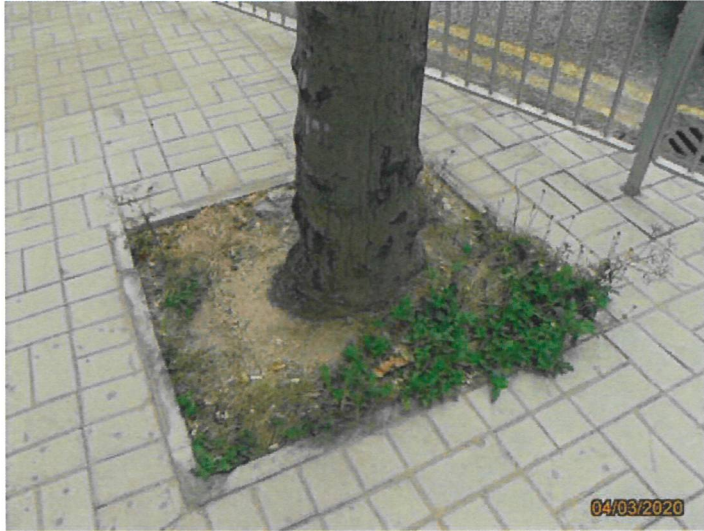
S020 - Restricted rooting area

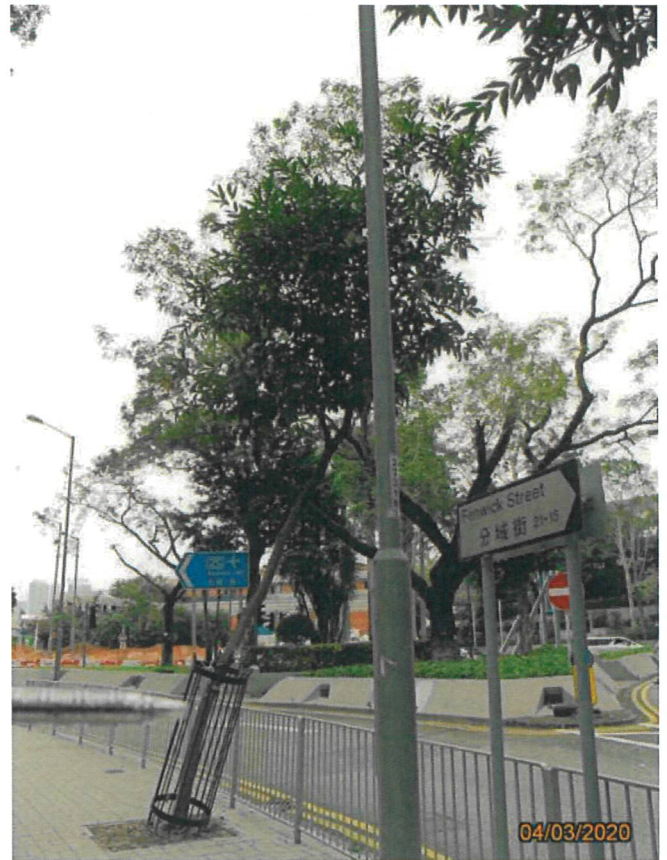
S023 - Overview

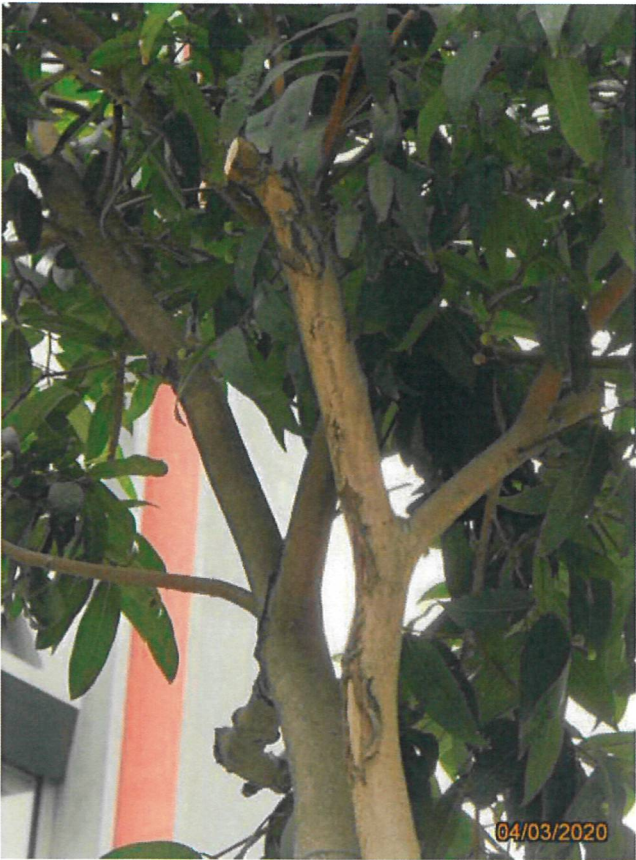
S023 - Wound on branch

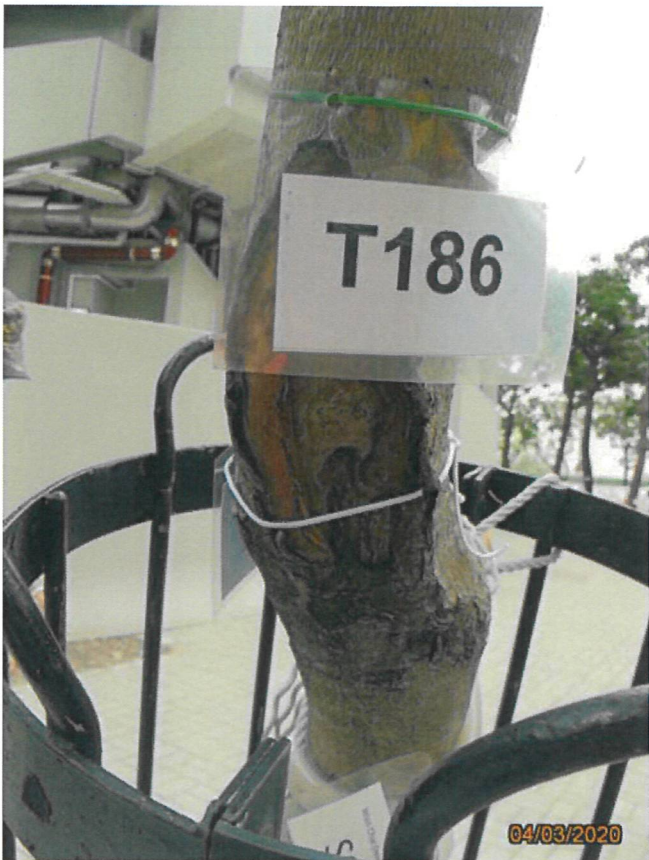
S023 - Wound on trunk

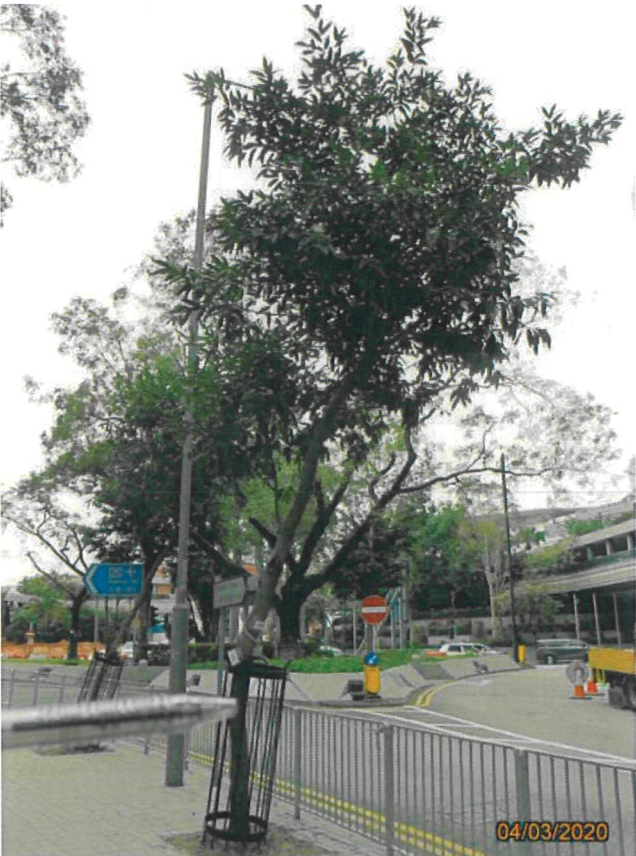
S024 - Overview

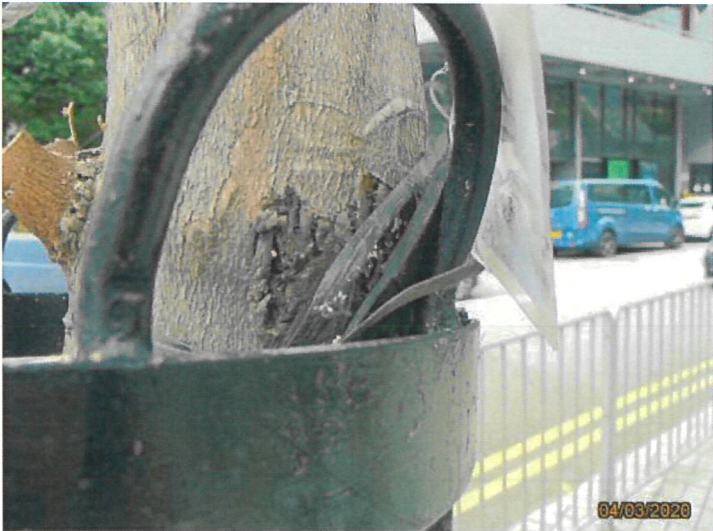
S024 - Conflict with metal fence and wound on trunk

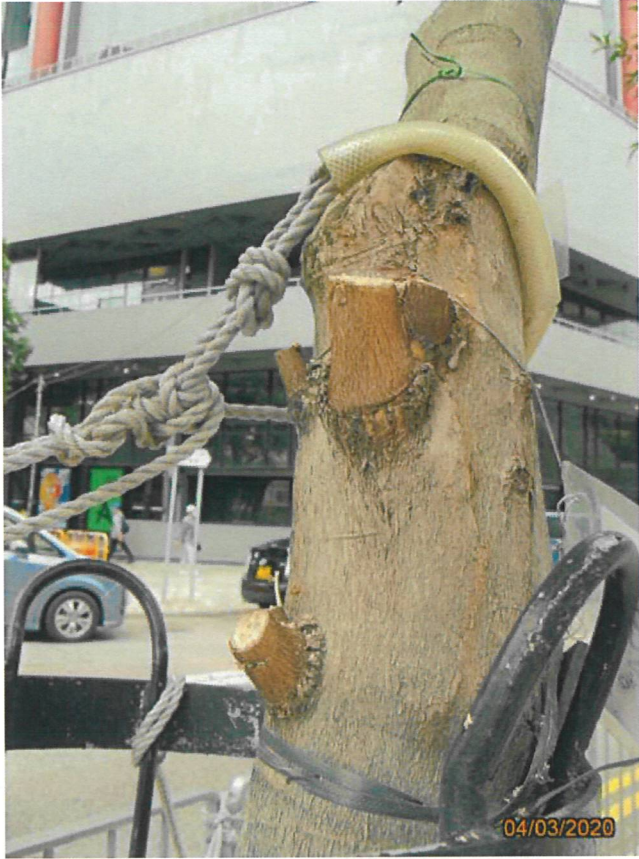
S024 - Pruned wound

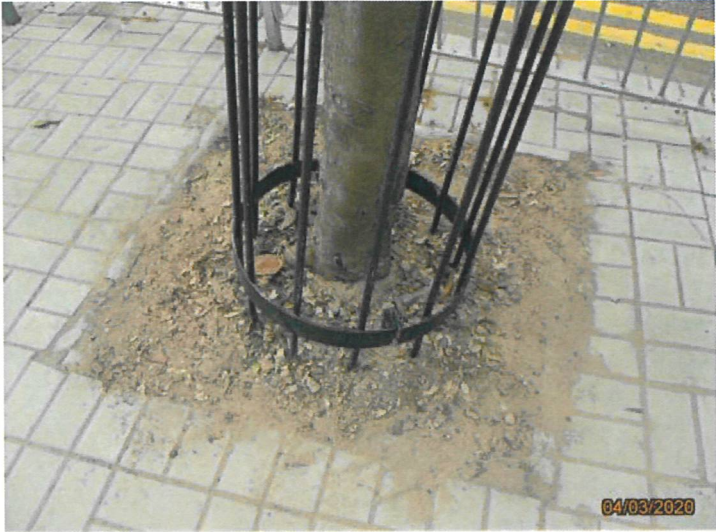
S024 - Restricted rooting area

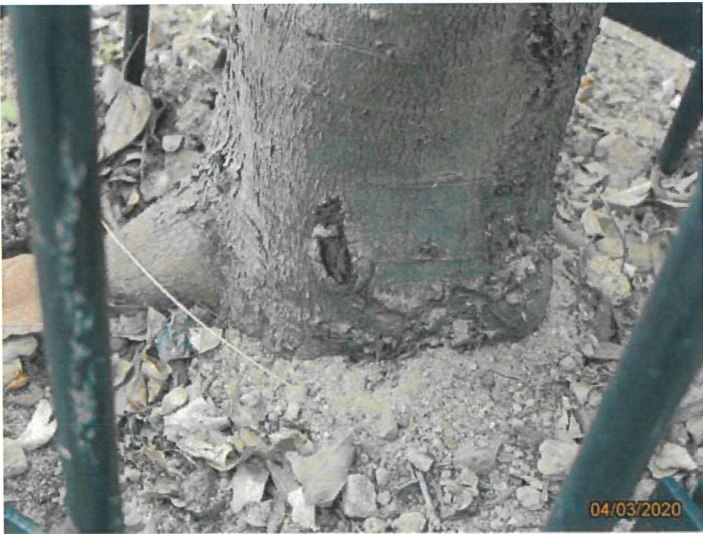
S024 - Wound on root collar

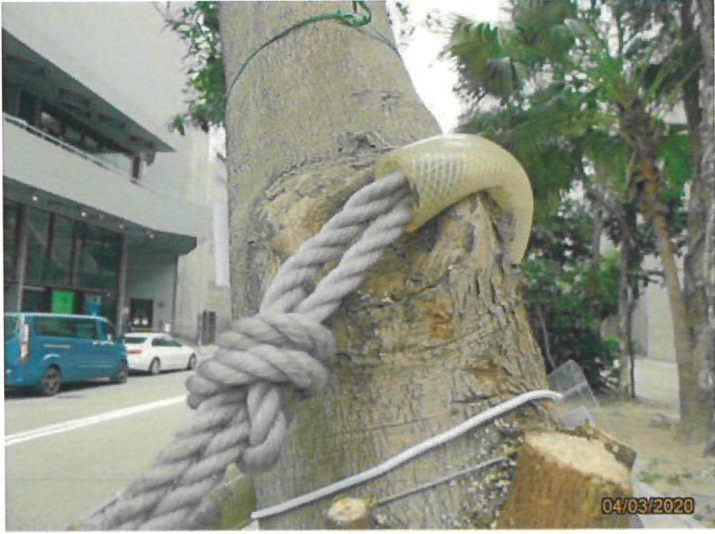
S024 - Wound on trunk (3)

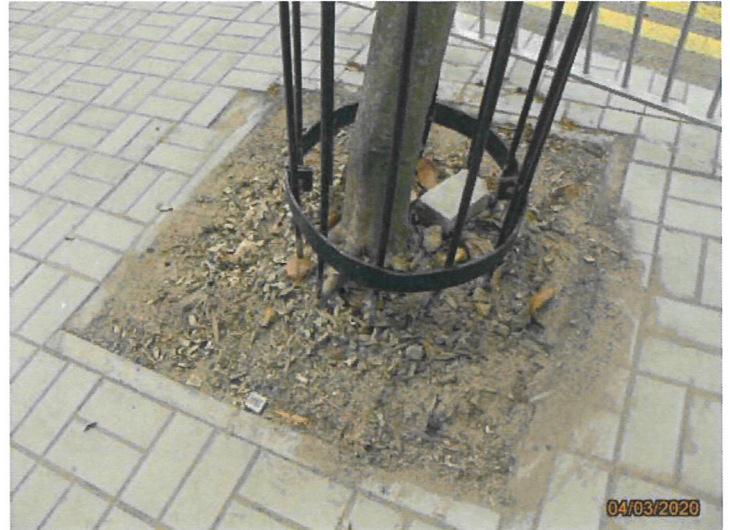
S025 - Restricted rooting area

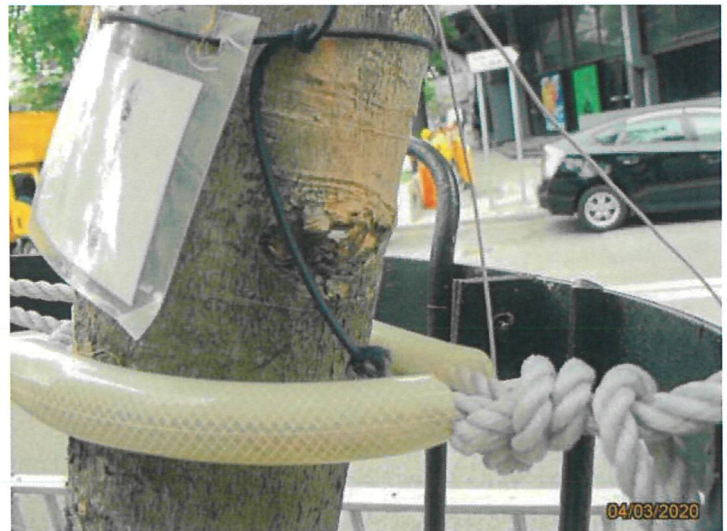
S025 - Wound on trunk

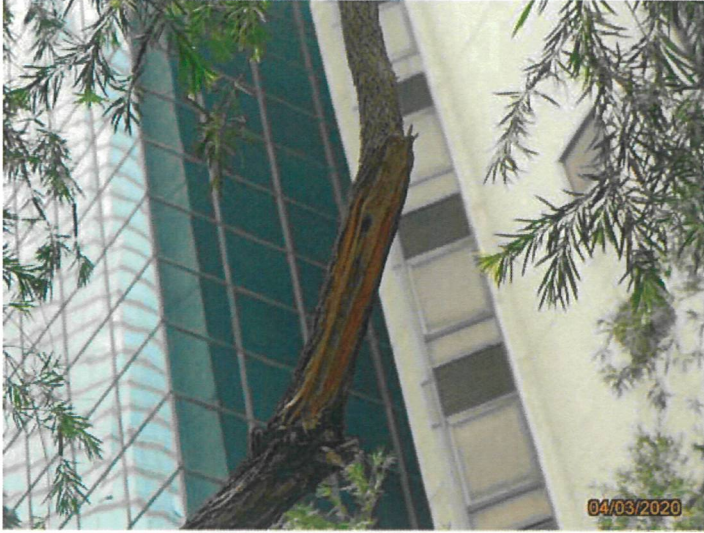
S026 - Wound on branch

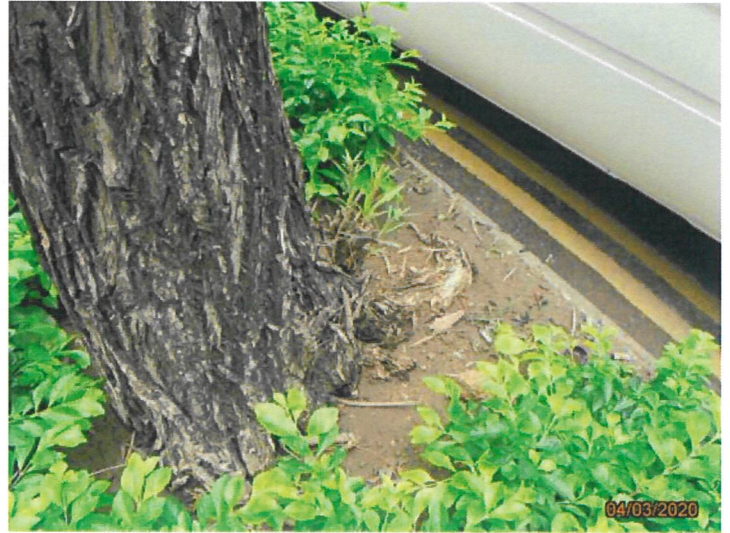
S026 - Wound on root collar

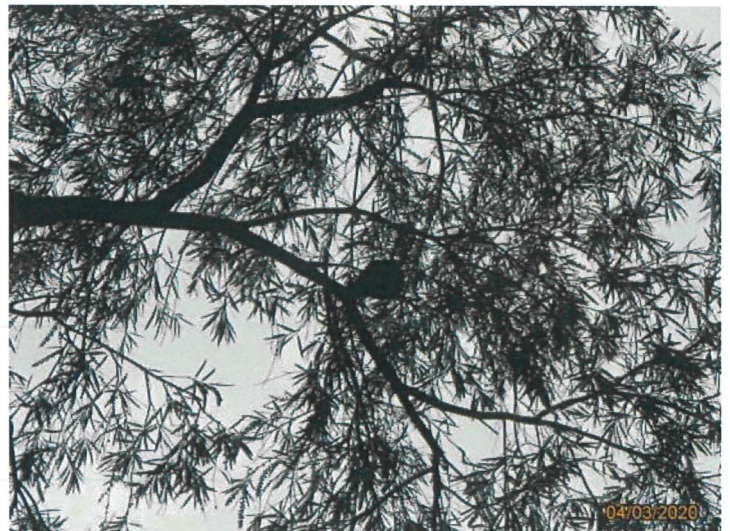
S027 - Animal nest

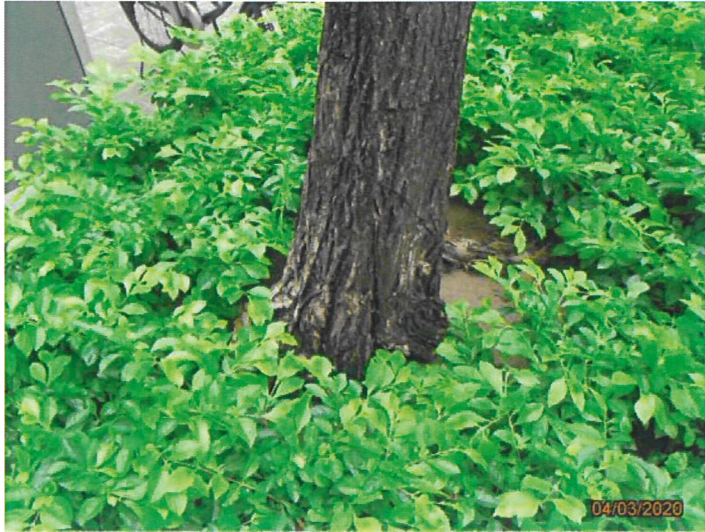
S027 - Planted in raised planter

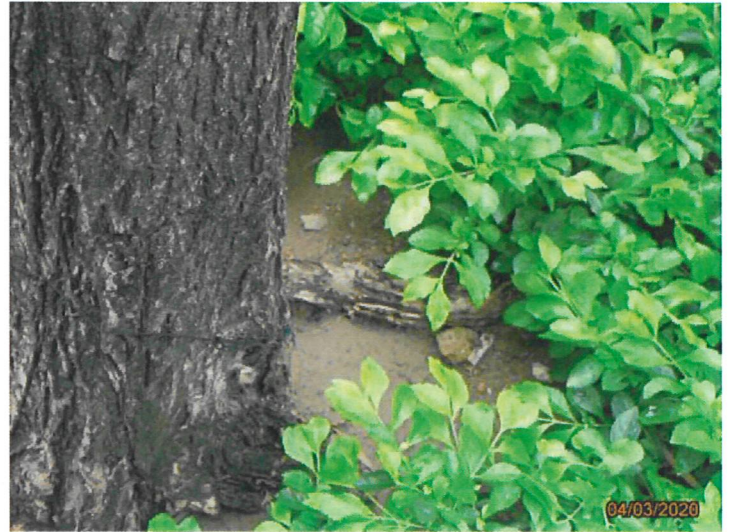
S027 - Wound on root collar

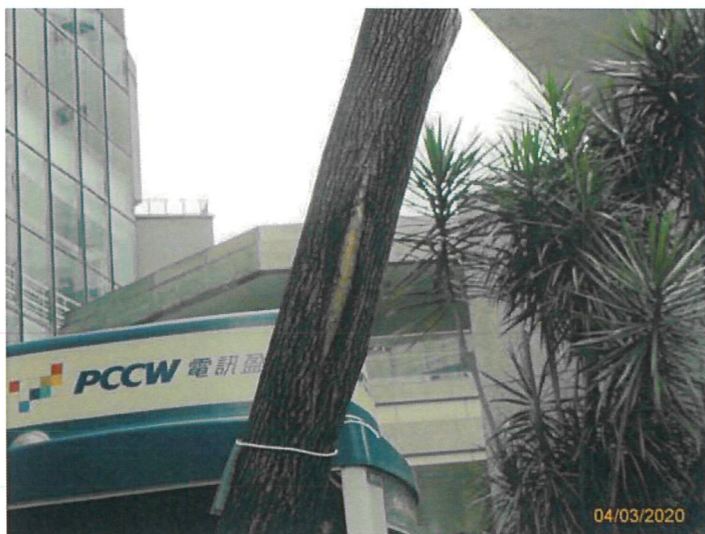
S027 - Wound on trunk

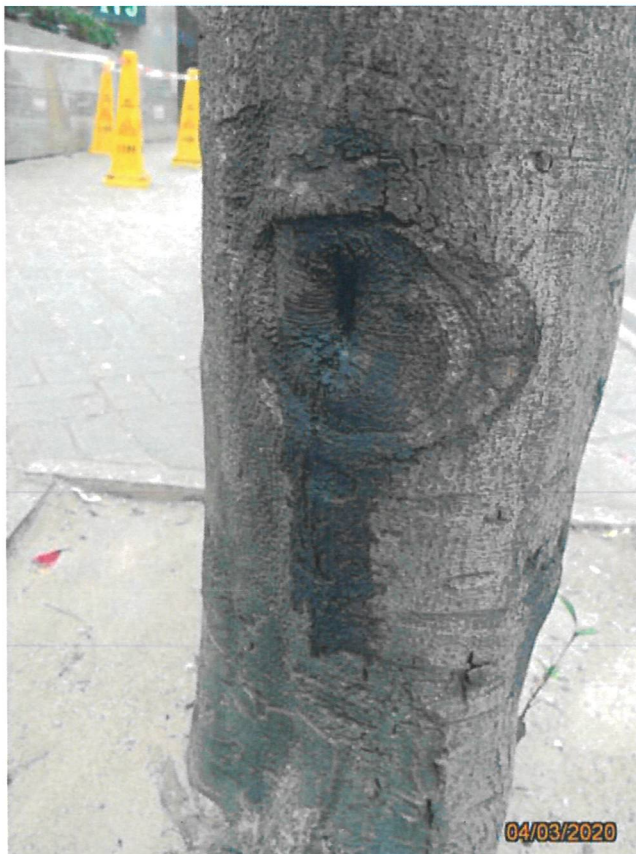
S028	<i>Cinnamomum burmannii</i>	陰香	239	7	6	Fair	Fair	Retain	Crack on branch, Crack on trunk, Restricted rooting area, Wound on trunk, Tree sap
S029	<i>Cinnamomum burmannii</i>	陰香	123	4	3	Fair	Fair	Retain	Broken branch, Bulge, Restricted rooting area, Invisible root collar, Stone piece on root zone, Wound on branch, Wound on root collar, Wound on trunk
S030	<i>Cinnamomum burmannii</i>	陰香	143	4	3	Fair	Fair	Retain	Cavity, Restricted rooting area, Invisible root collar, Pruned wound, Wound on trunk
S031	<i>Bauhinia x blakeana</i>	洋紫荊	247	10	6	Poor	Fair	Retain	Cavity, Conflict with structure, Crack on branch, Crack on trunk, Epicormics, Restricted rooting area, Wound on branch, Wound on trunk
S033	<i>Cinnamomum burmannii</i>	陰香	246	7	6	Poor	Fair	Retain	Animal nest, Conflict with flagpole, Dieback, Restricted rooting area, Gridling root, Wound on branch, Wound on root collar, Wound on trunk
S034	<i>Bauhinia x blakeana</i>	洋紫荊	254	10	7	Poor	Fair	Retain	Conflict with footbridge, Crack on branch, Epicormics, Restricted rooting area, Invisible root collar, Wound on trunk

S028 - Wound on trunk and tree sap

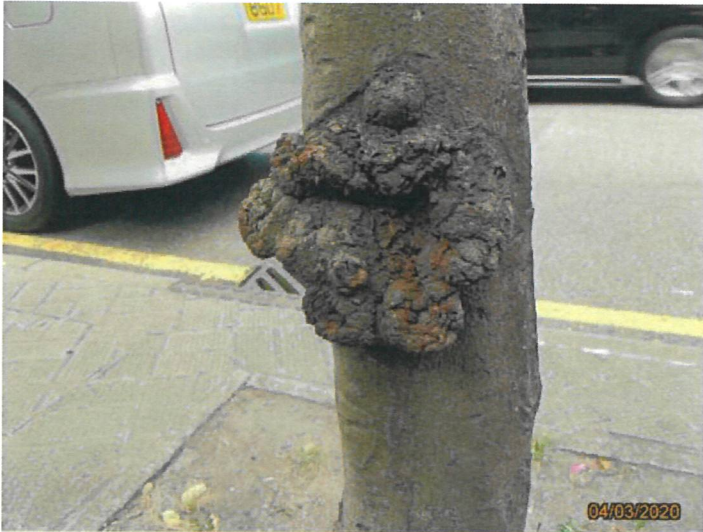
S029 - Bulge

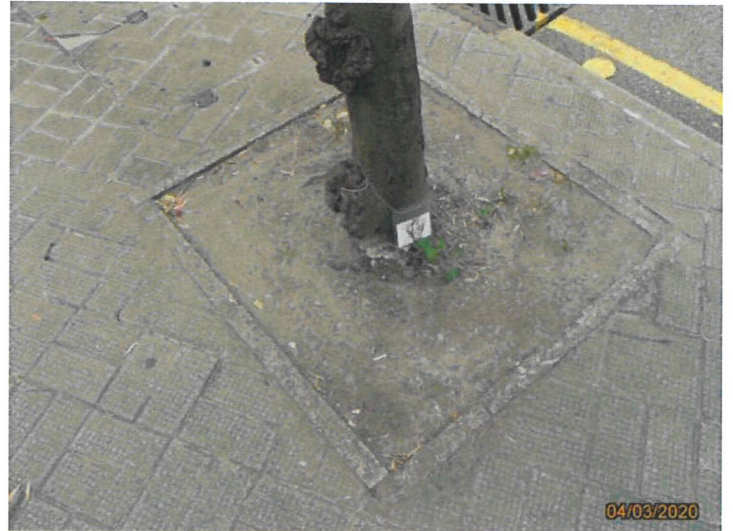
S029 - Invisible root collar and restricted rooting area

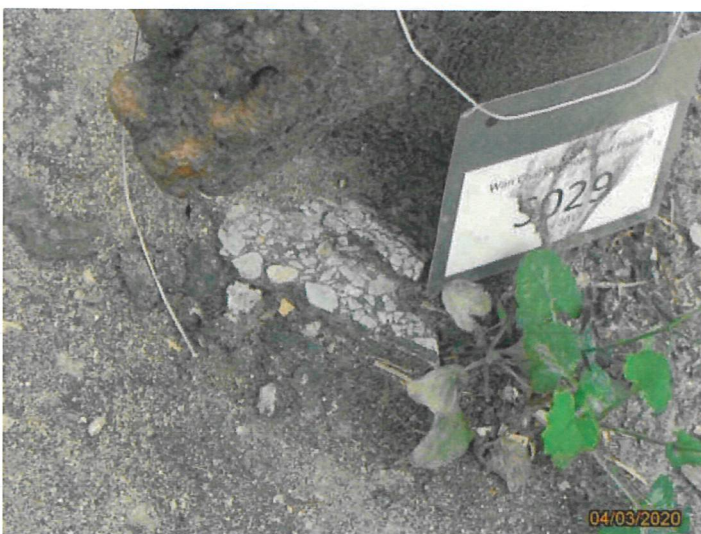
S029 - Stone piece on root zone

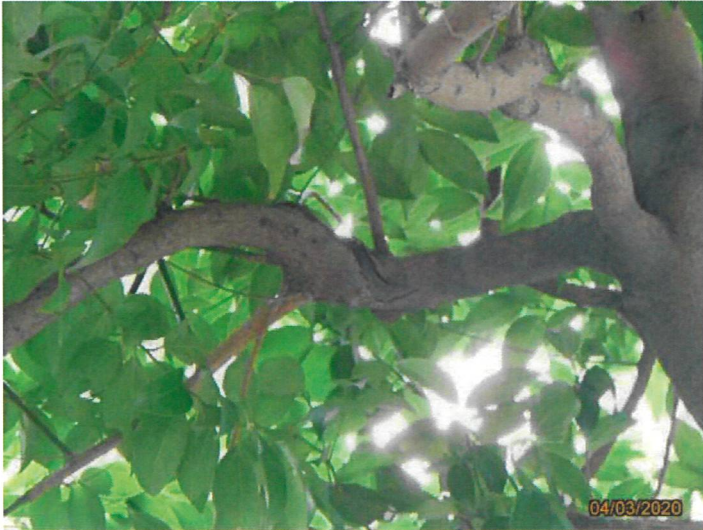
S029 - Wound on branch (3)

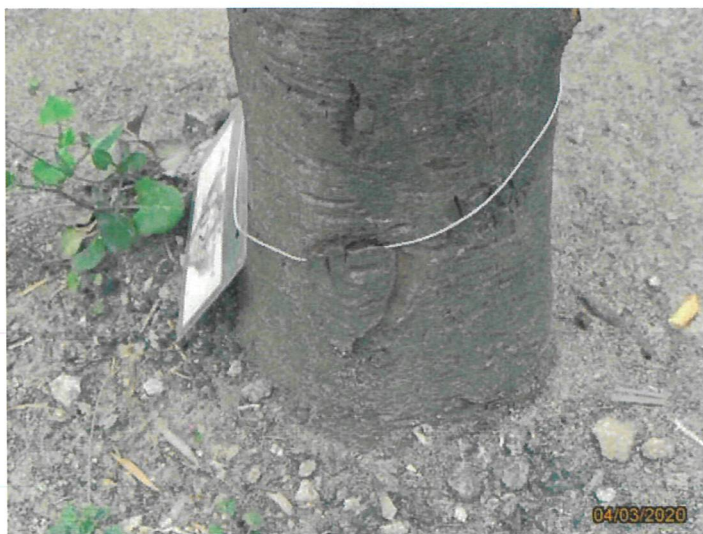
S029 - Wound on root collar

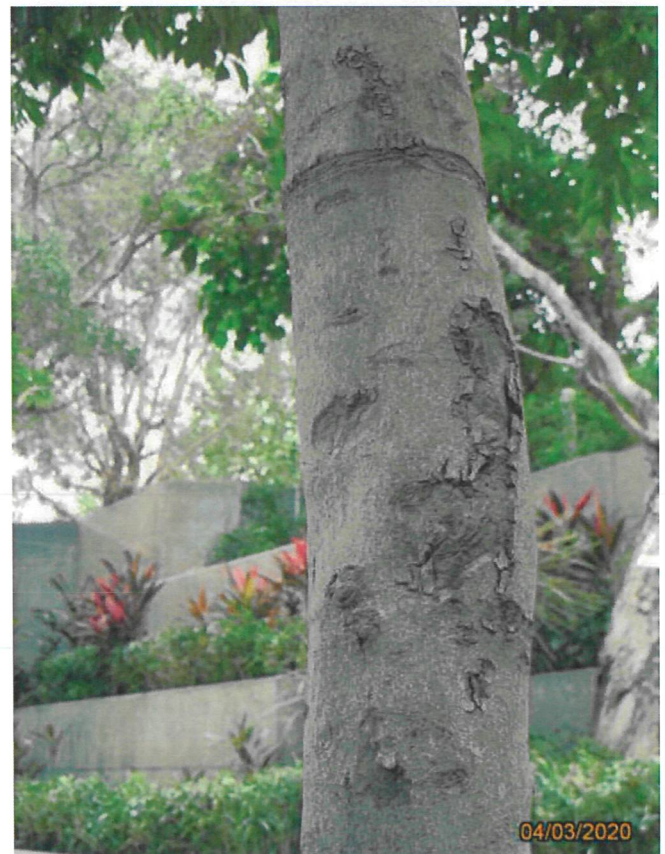
S029 - Wound on trunk

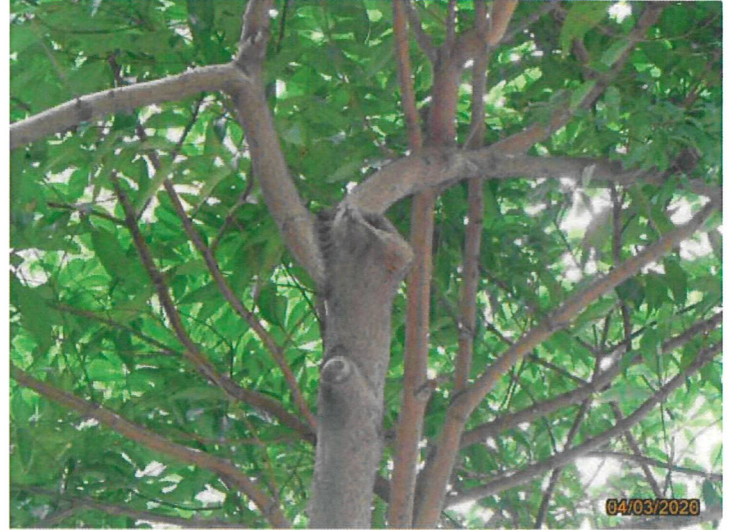
S030 - Cavity

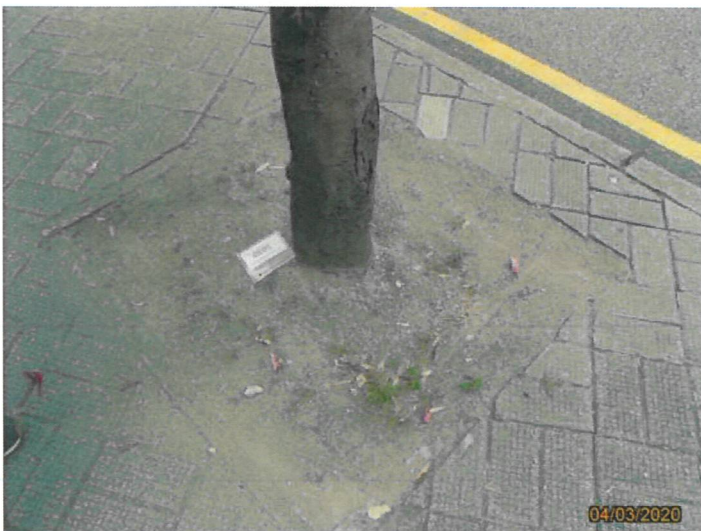
S030 - Invisible root collar and restricted rooting area

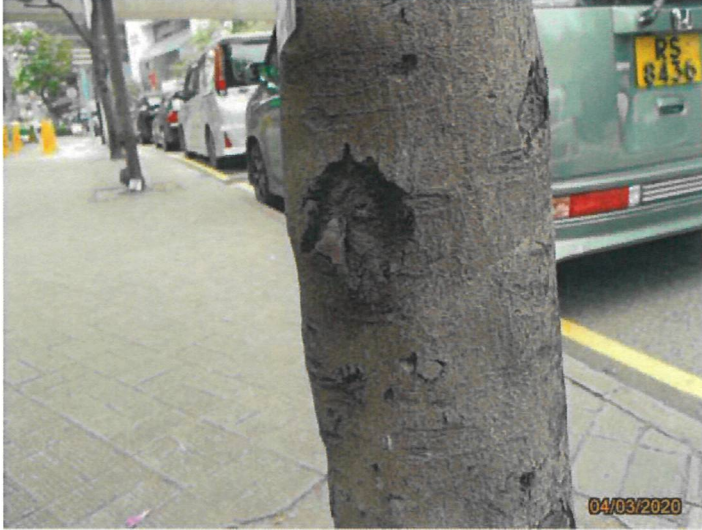
S030 - Wound on trunk (2)

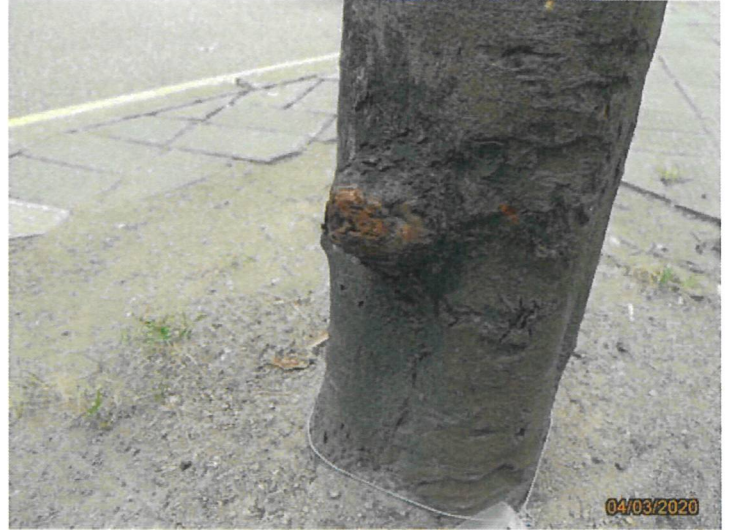
S030 - Wound on trunk (3)
