**Shatin to Central Link
Contract 1123 – Exhibition Station and Western Approach Tunnel
Submission of Landscape Plan for Further Environmental Permit No. FEP-13/364/2009/H
and FEP-03/376/2009**

**Shatin to Central Link –
Exhibition Station & Western Approach
Tunnel**

Landscape Plan
for
FEP-13/364/2009/H & FEP-03/376/2009

LS/20426 Contract 1123_H2624 - Exhibition Station and Western Approach Runnel
Initial Tree Survey Report

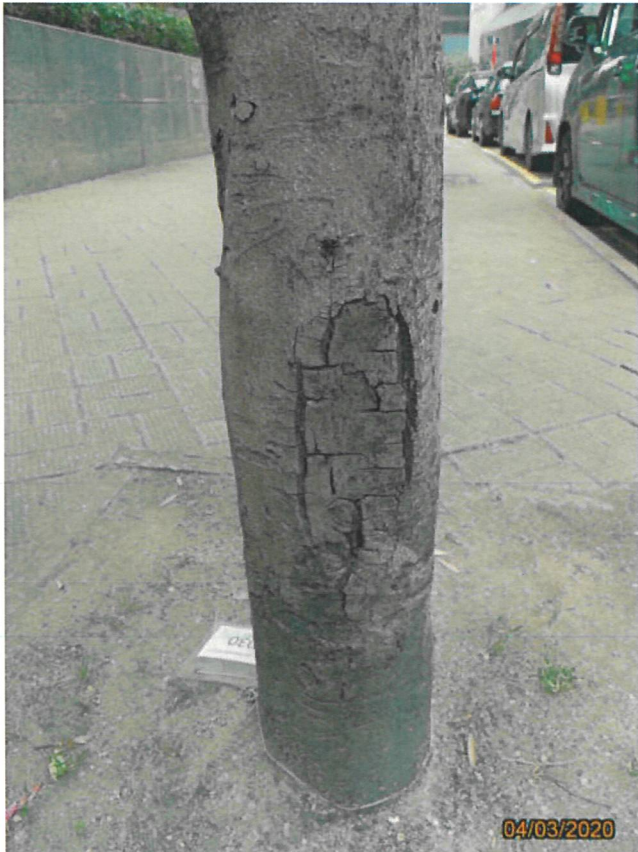
S030 - Wound on trunk

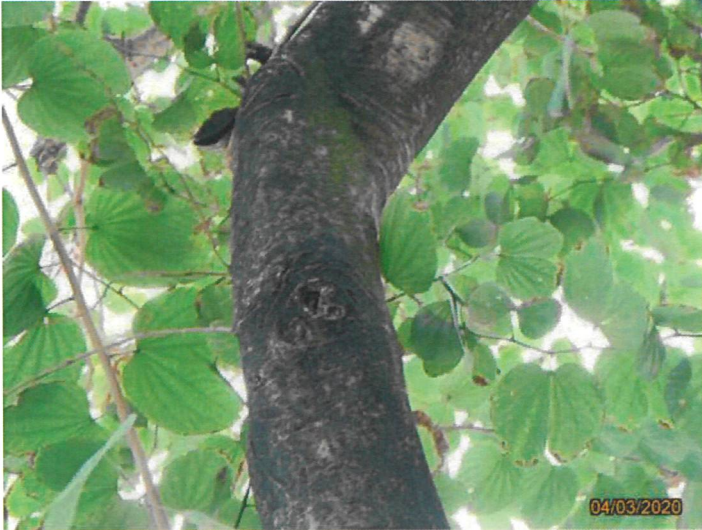
S031 - Cavity

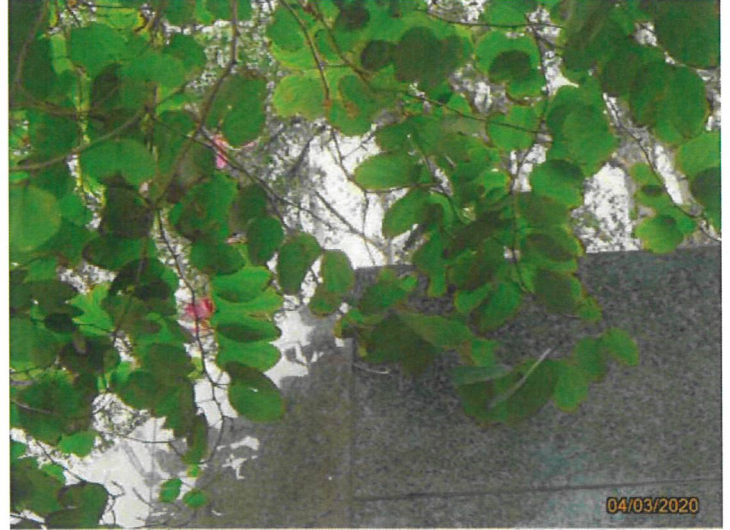
S031 - Conflict with structure

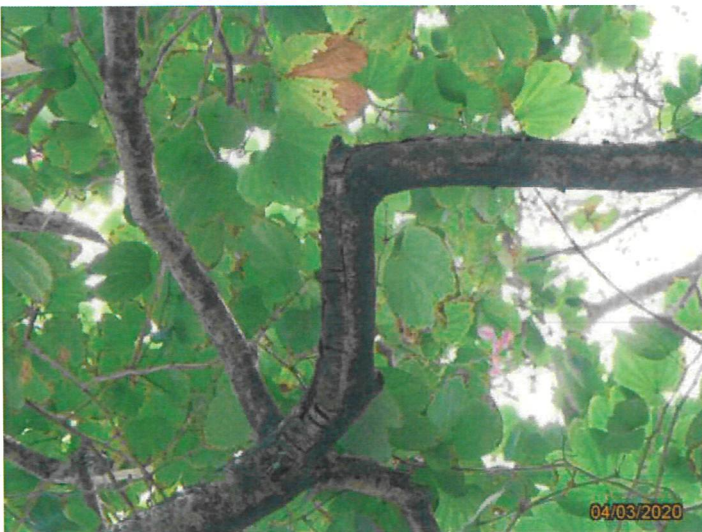
S031 - Crack on branch

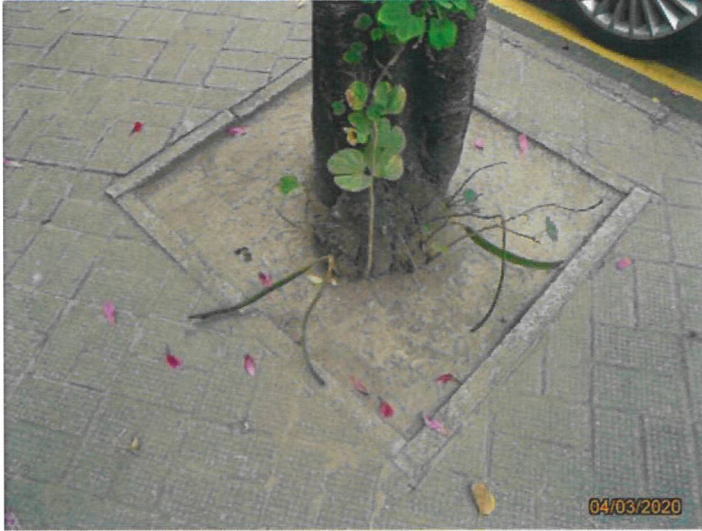
S031 - Epicormics

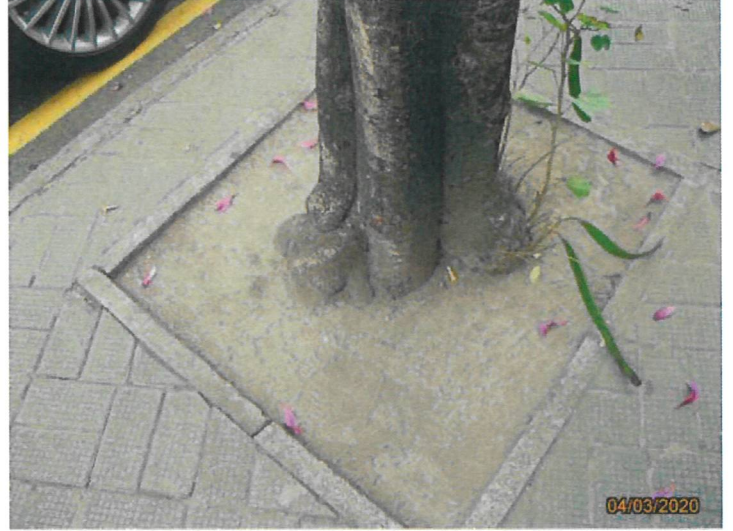
S031 - Restricted rooting area

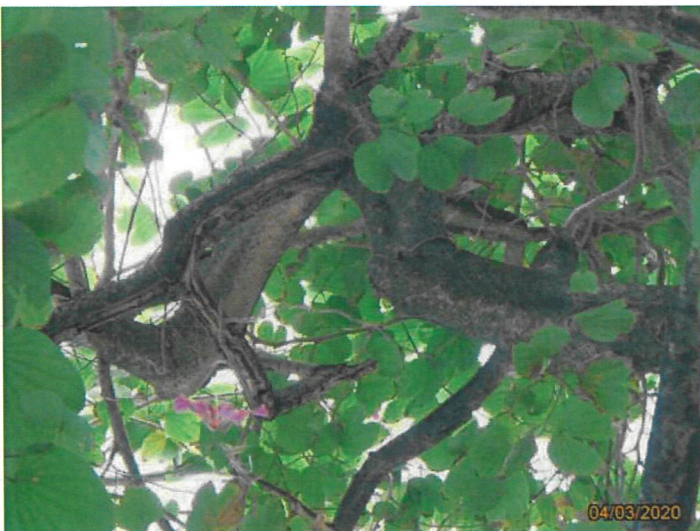
S031 - Wound on branch (2)

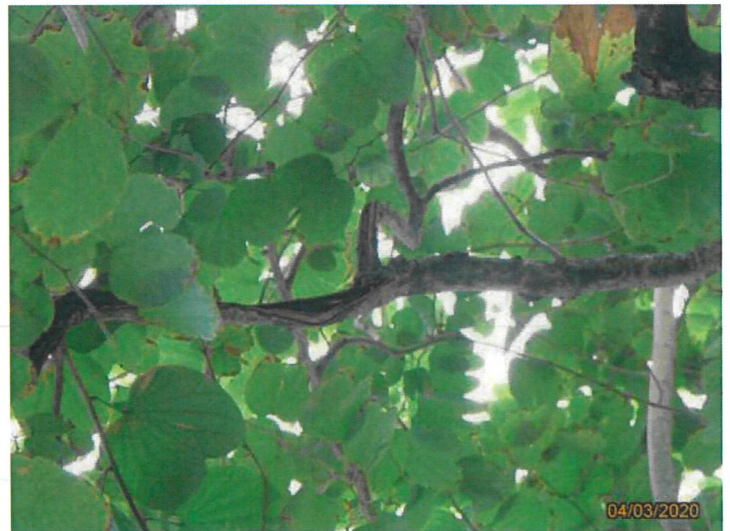
S031 - Wound on branch

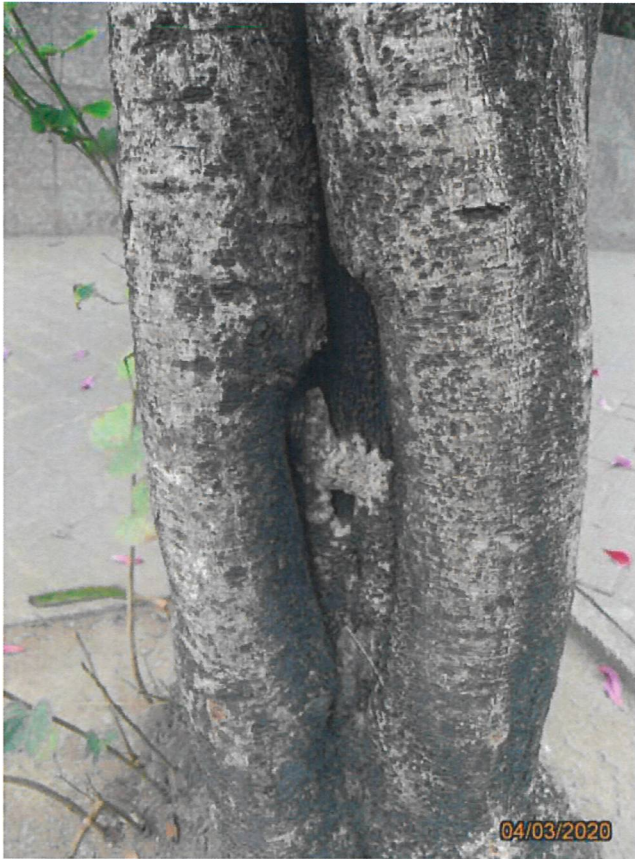
S031 - Wound on trunk

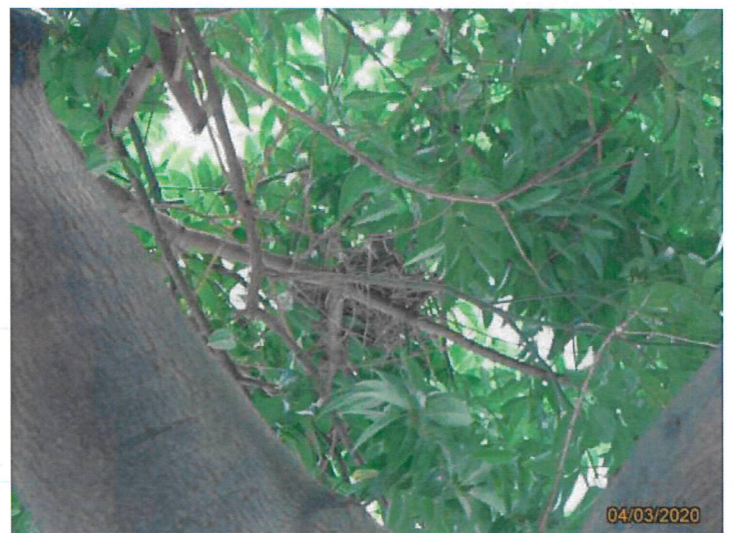
S033 - Animal nest

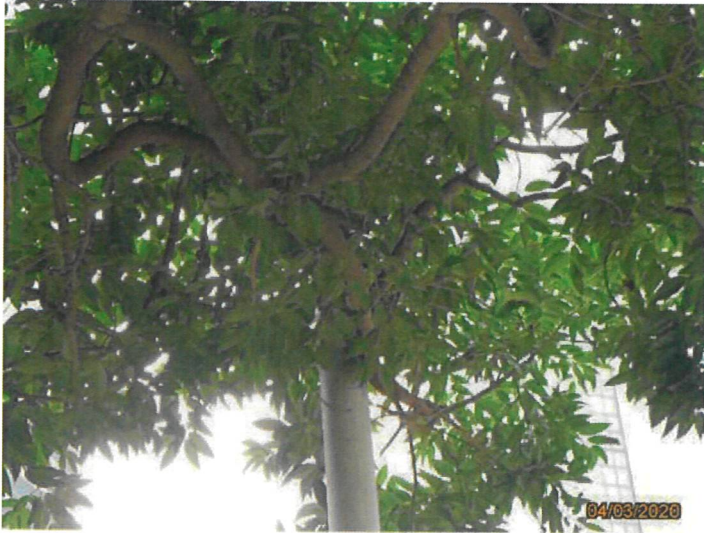
S033 - Conflict with flagpole

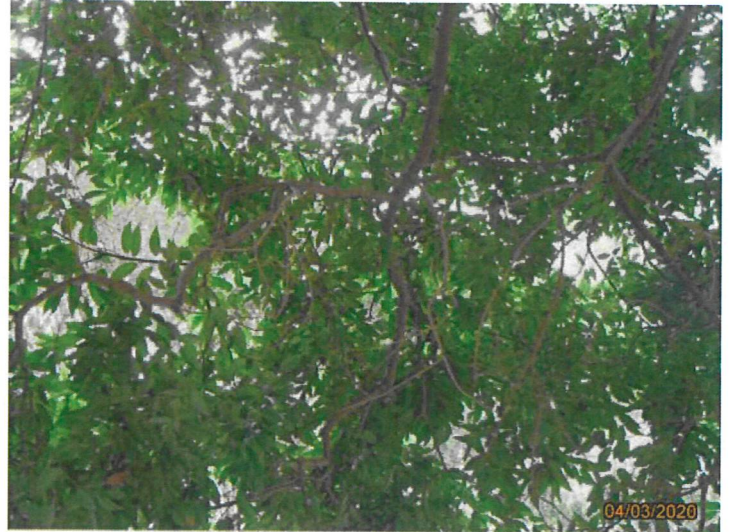
S033 - Dieback

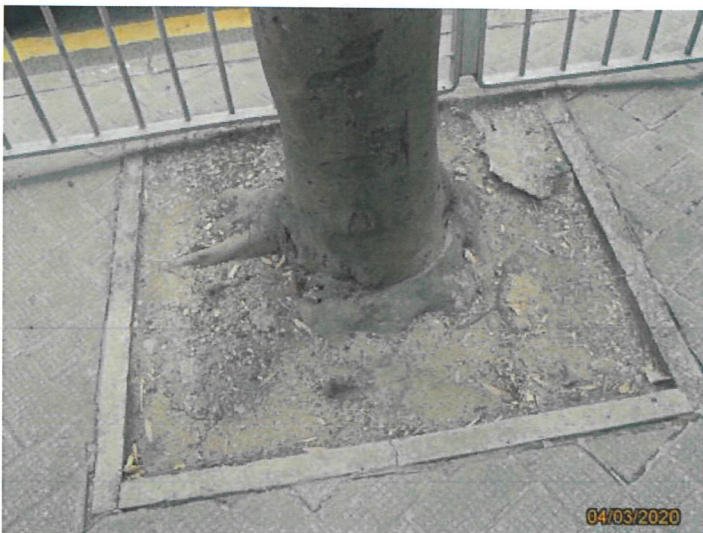
S033 - Restricted rooting area and gridling root

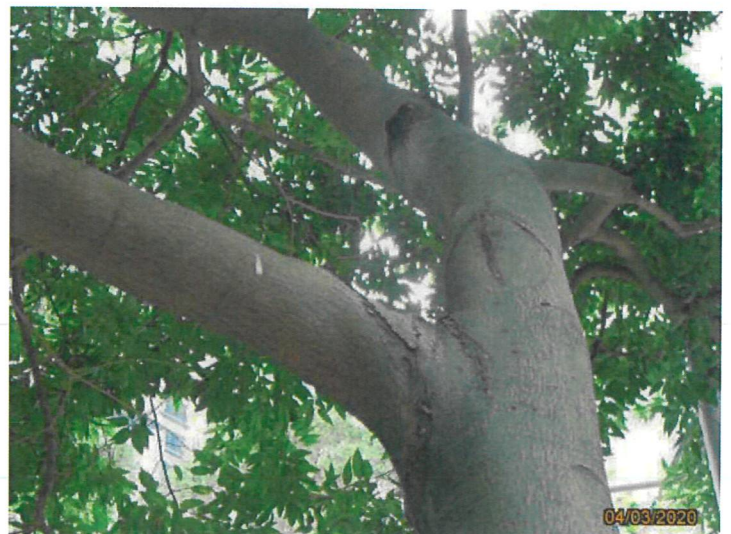
S033 - Wound on branch

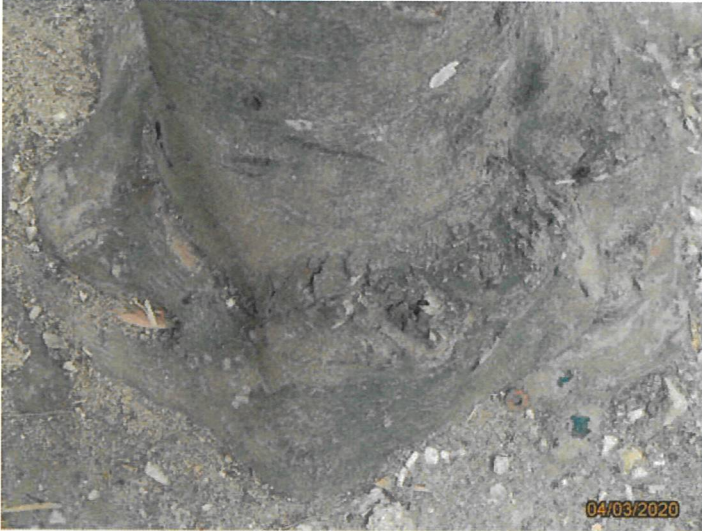
S033 - Wound on root collar

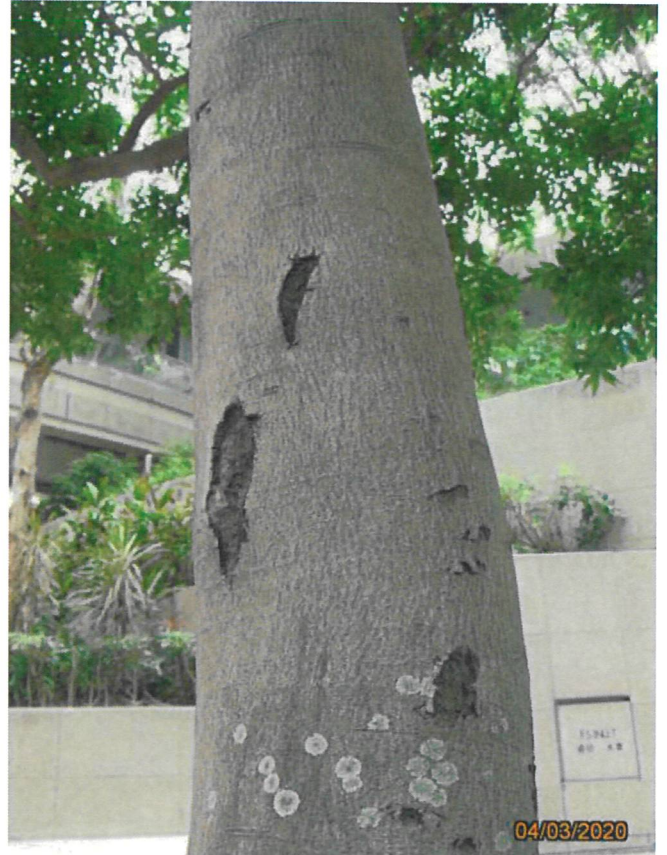
S033 - Wound on trunk (2)

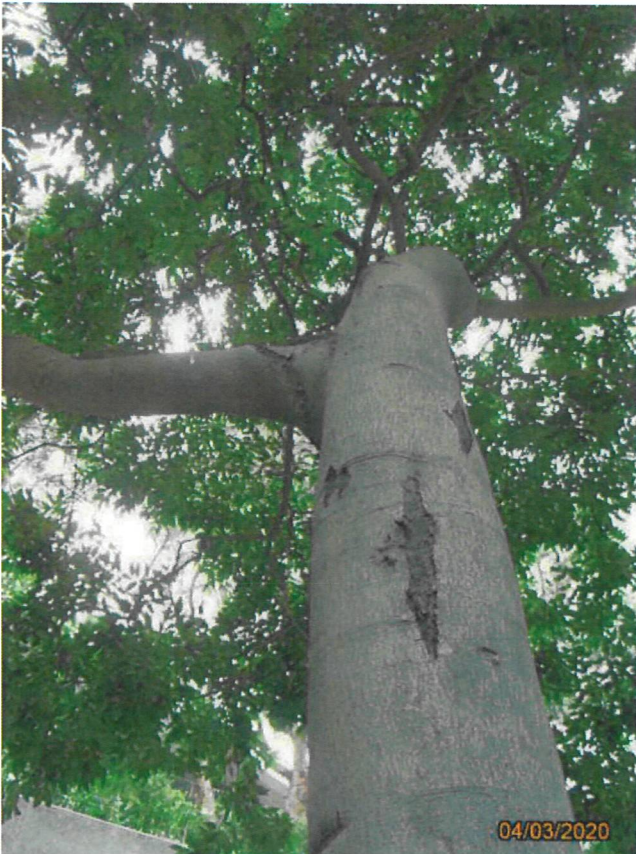
S033 - Wound on trunk (3)

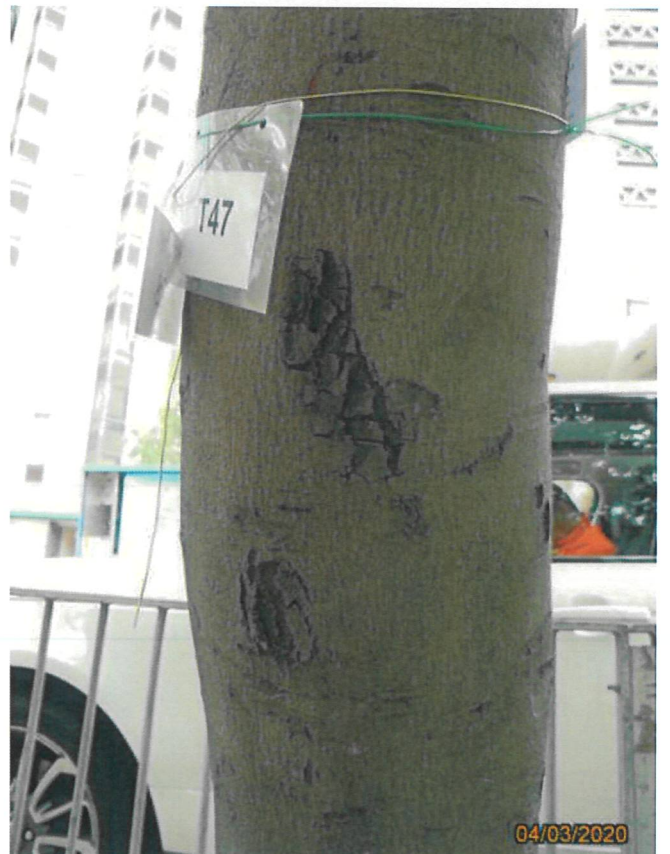
S033 - Wound on trunk

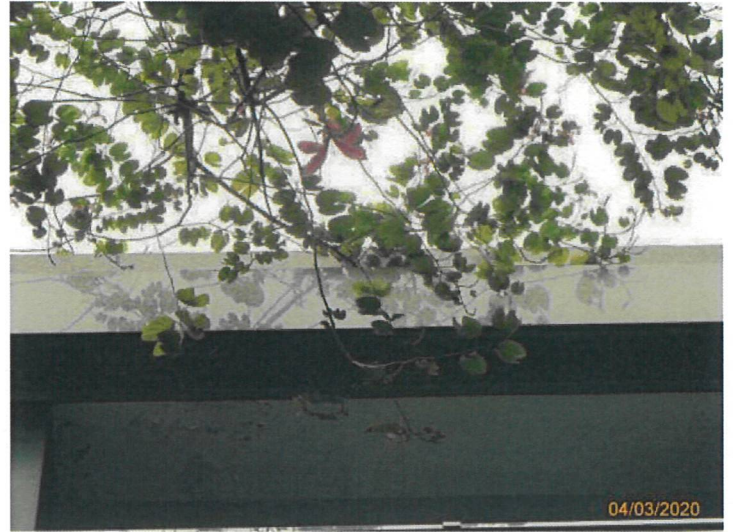
S034 - Conflict with footbridge

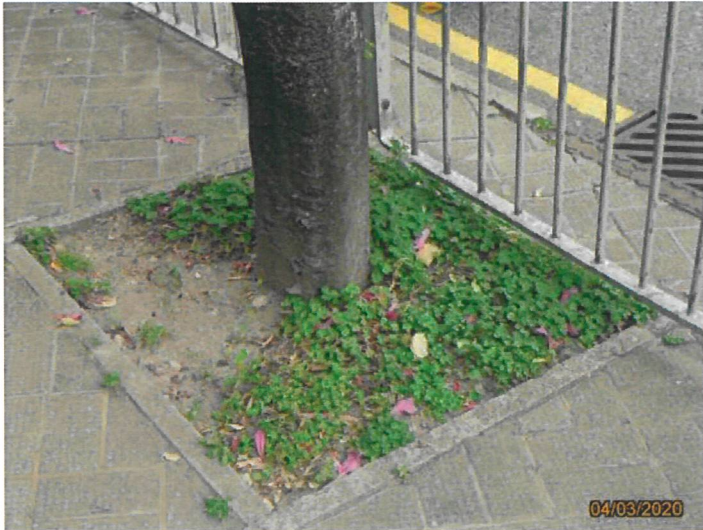
S034 - Invisible root collar and restricted rooting area

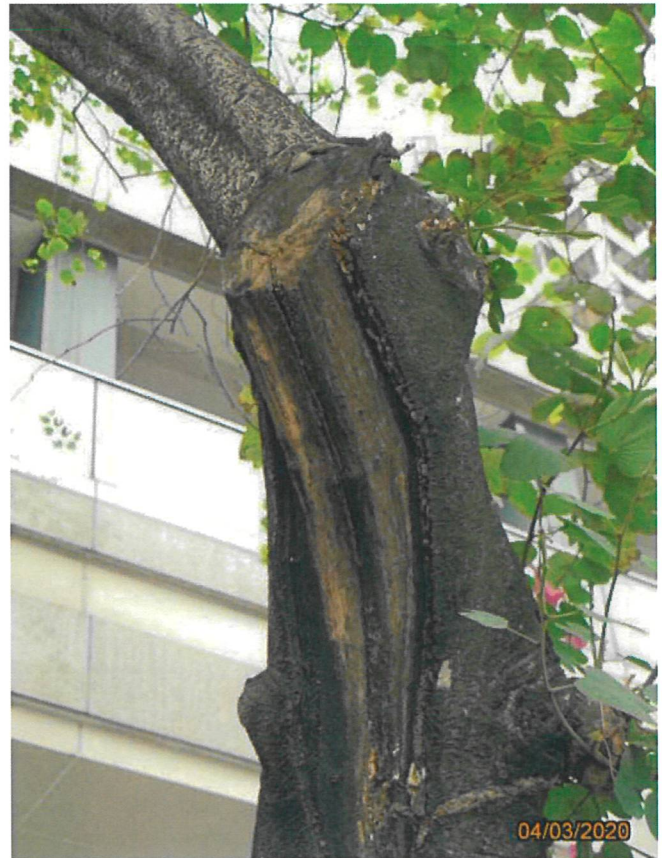
S034 - Wound on trunk (2)

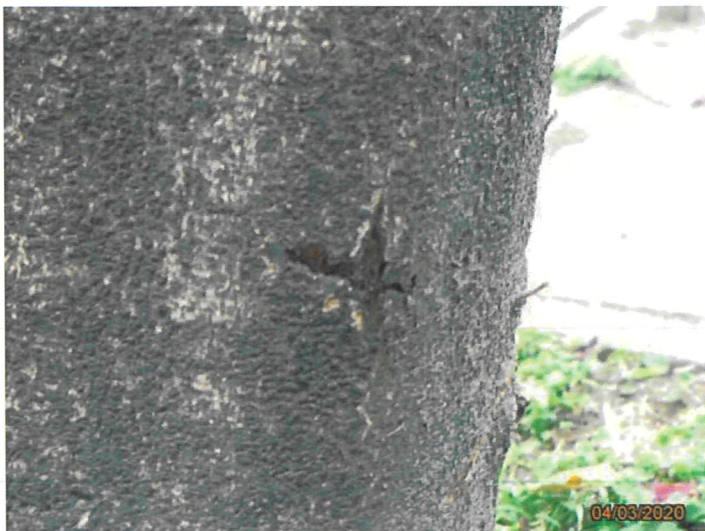
S034 - Wound on trunk (3)

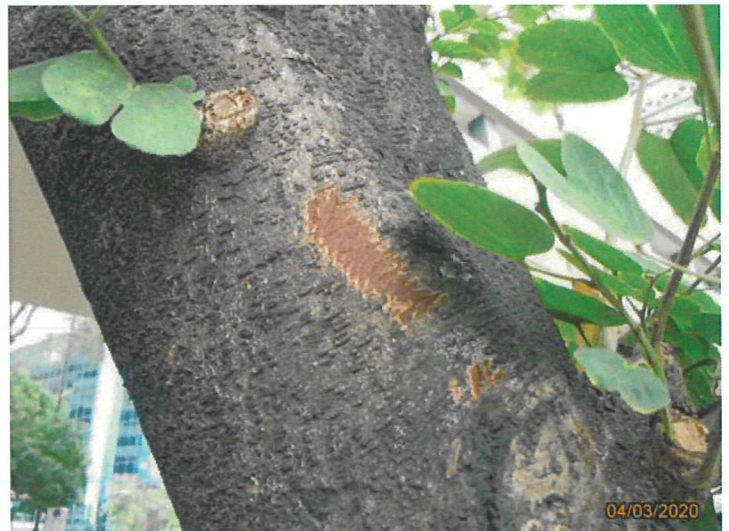
S034 - Wound on trunk

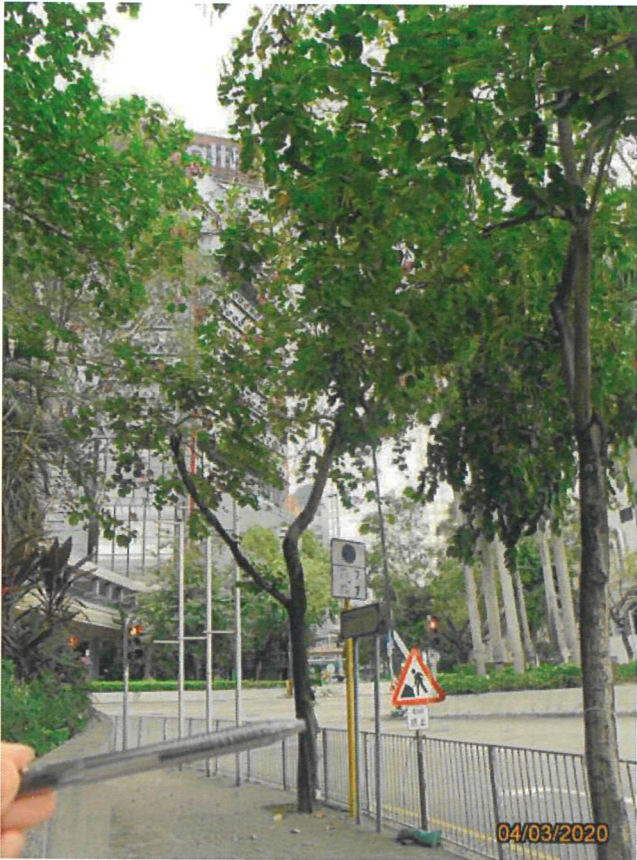
S035 - Overview

S035	<i>Bauhinia x blakeana</i>	洋紫荊	235	9	6	Fair	Fair	Retain	Co-dominant scaffolds, Broken branch, Dead branch, Dieback, Epicormics, Restricted rooting area, Invisible root collar, Tilt sensor attached on root collar, Wound on branch, Wound on trunk

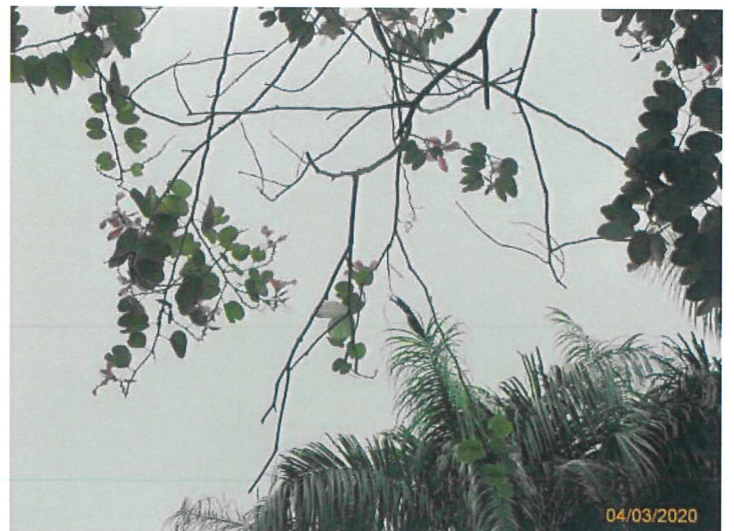
S035 - Dieback

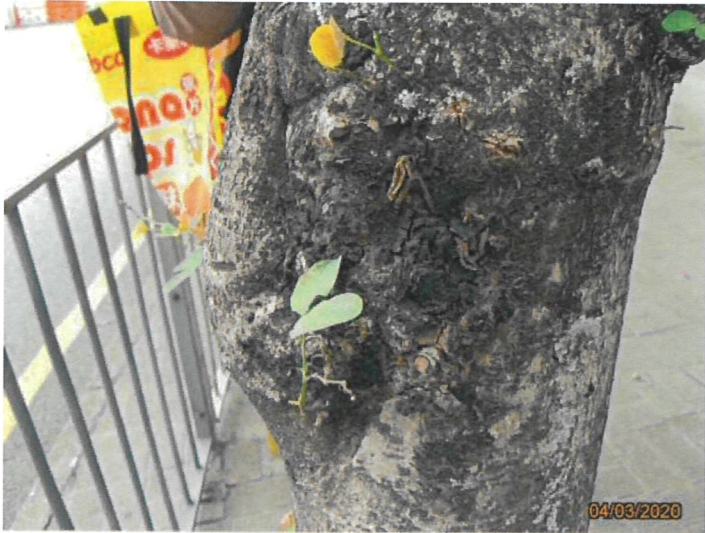
S035 - Epicormics (2)

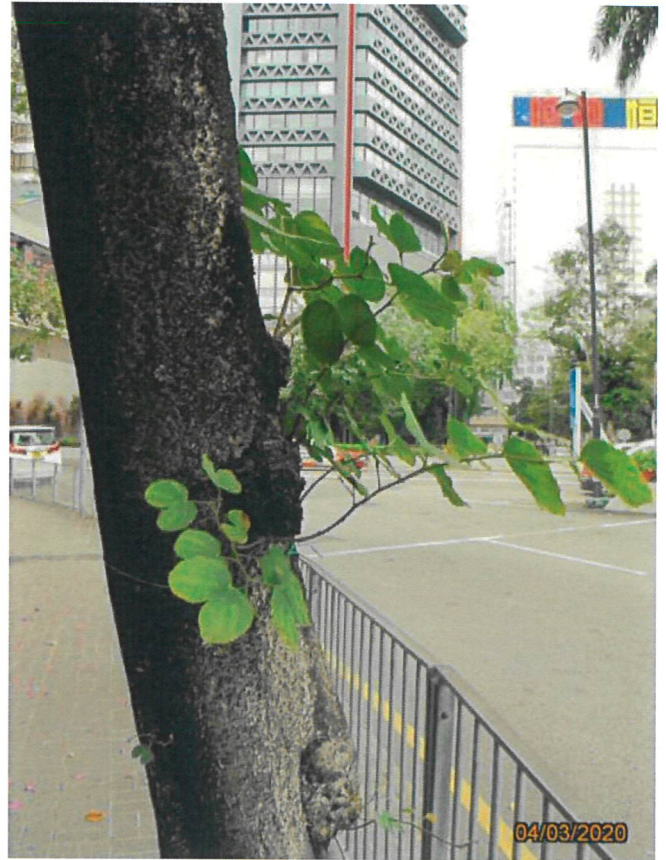
S035 - Epicormics

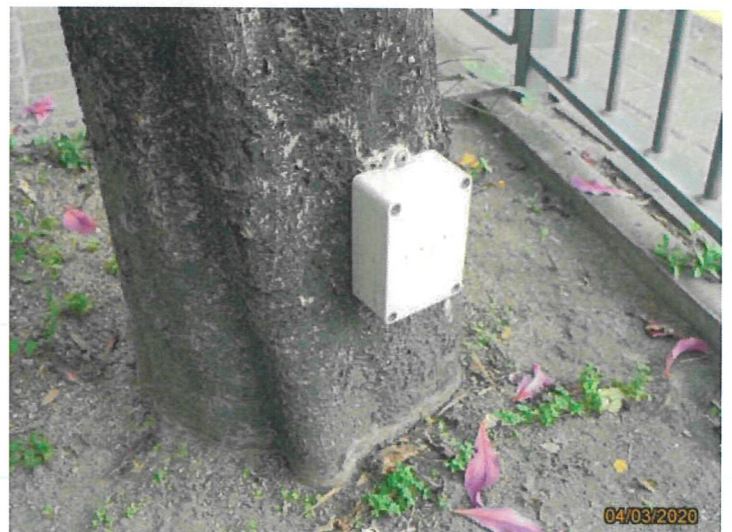
S035 - Tilt sensor attached on root collar

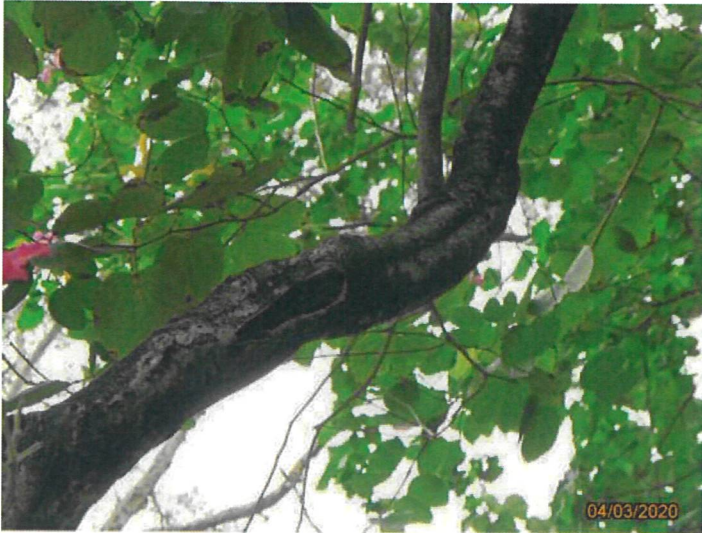
S035 - Wound on branch

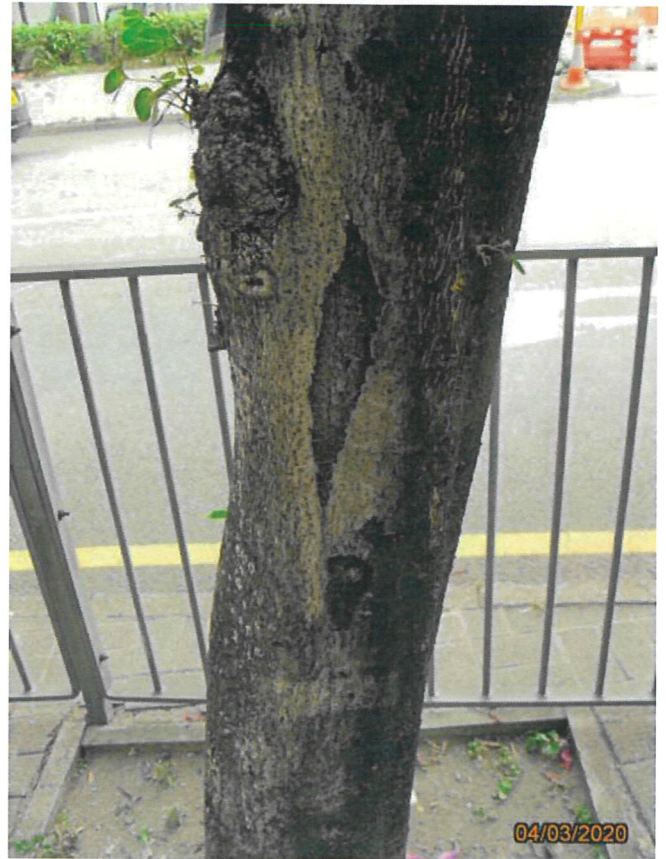
S035 - Wound on trunk (2)

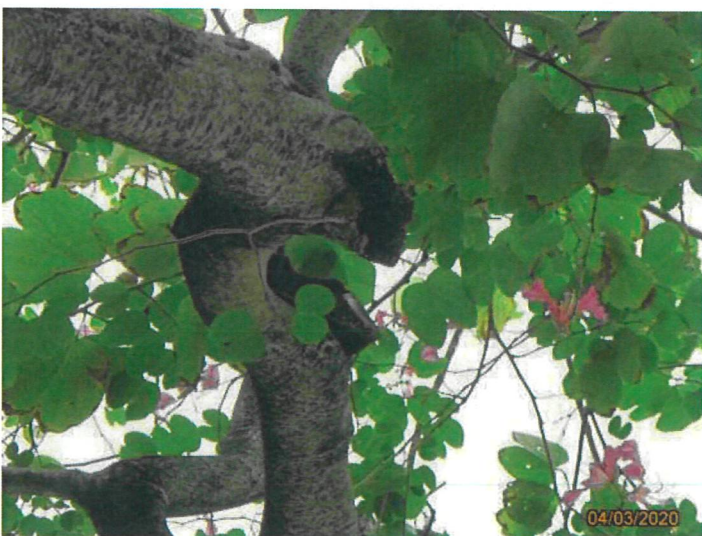
S035 - Wound on trunk

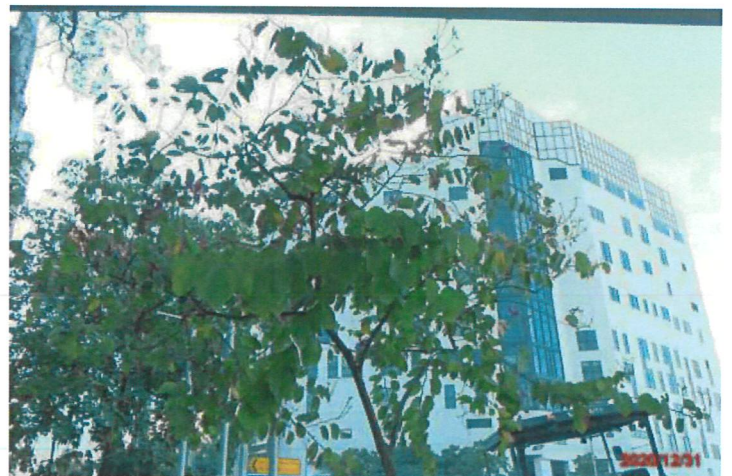
S036 - Crown and dieback

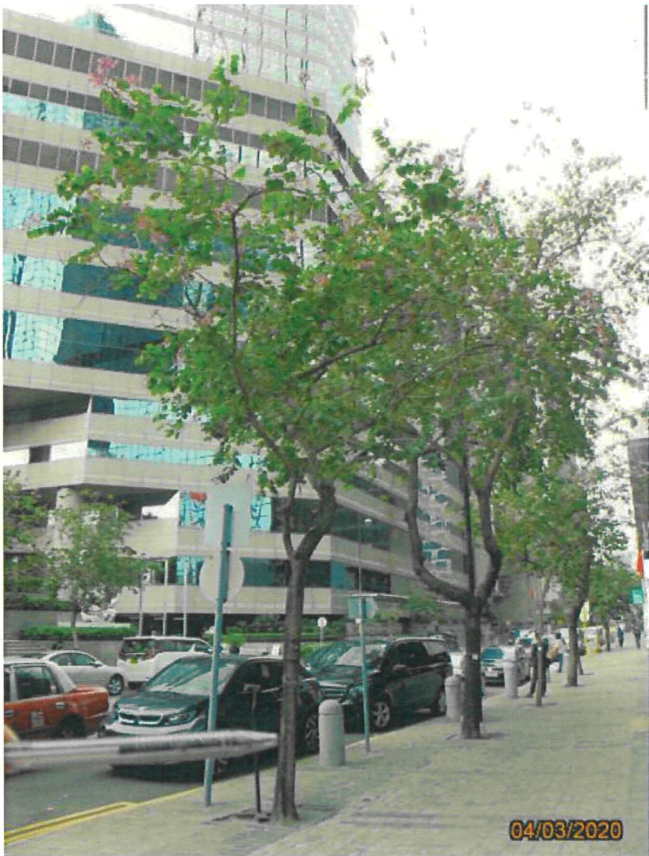
S039 - Overview

S039	<i>Bauhinia x blakeana</i>	洋紫荊	180	7	5	Fair	Fair	Retain	Broken branch, Dieback, Metal stand on root zone, Restricted rooting area, Wound on branch, Wound on root collar, Wound on trunk
S040	<i>Bauhinia x blakeana</i>	洋紫荊	287	8	8	Fair	Fair	Retain	Co-dominant scaffolds, Cavity, Conflict with lightpole, Dieback, Restricted rooting area, Tilt sensor attached on root collar, Wound on branch, Wound on trunk
S041	<i>Bauhinia x blakeana</i>	洋紫荊	97	5	2	Fair	Fair	Retain	Crossed branches, Cavity, Restricted rooting area, Invisible root collar, Wound on trunk
S042	N/A	N/A	N/A	N/A	N/A	N/A	N/A	Missing	N/A
S043	<i>Bauhinia purpurea</i>	紅花羊蹄甲	178	7	6	Fair	Fair	Retain	Broken branch, Restricted rooting area, Invisible root collar, Leaning
Unknown 1	<i>Melaleuca cajuputi</i> subsp. <i>cumingiana</i>	白千層	115	4	2	Poor	Poor	TBC	N/A
Unknown 2	<i>Albizia lebbek</i>	大葉合歡	126	5	4	Poor	Fair	TBC	Planter in raised planter, Multi-stems, Pruned wound, Wound on root collar, Leaning, Having tree tag as T245

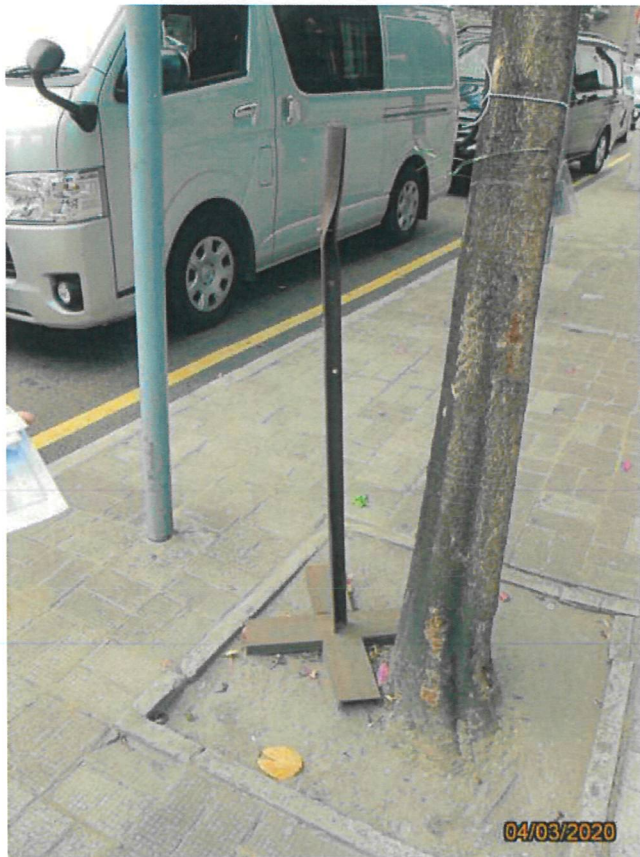
S039 - Metal stand on root zone

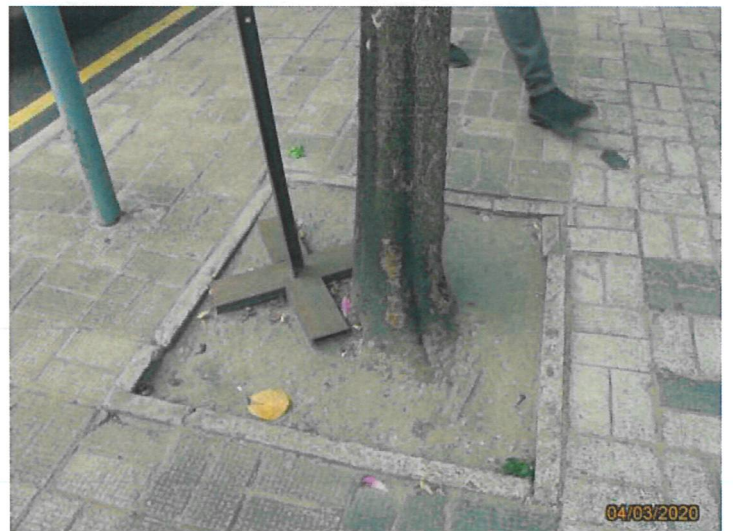
S039 - Restricted rooting area

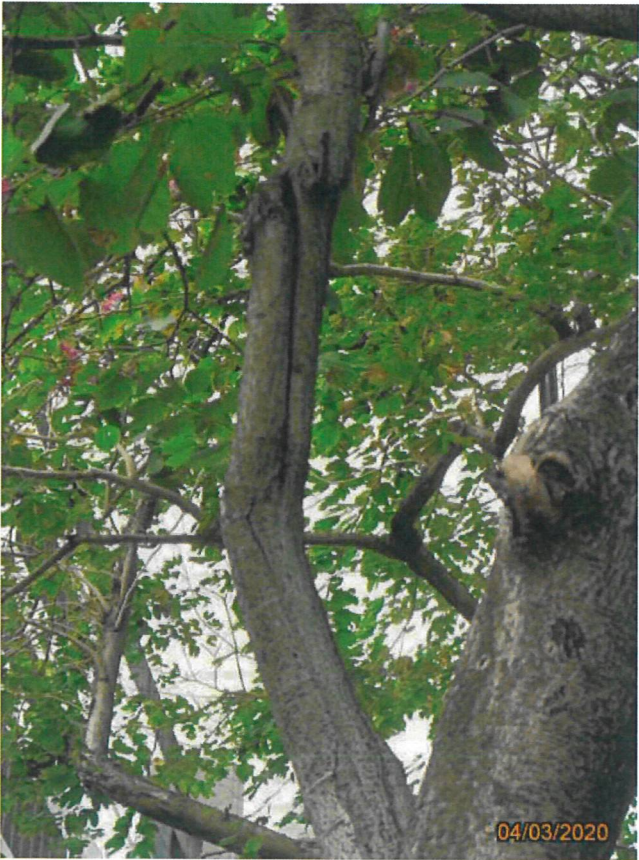
S039 - Wound on branch

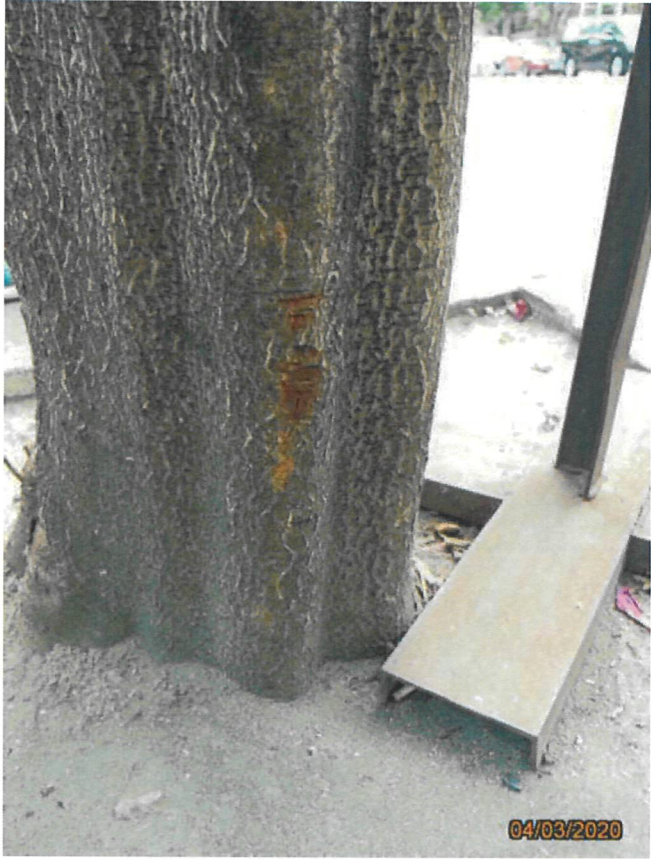
S039 - Wound on root collar (2)

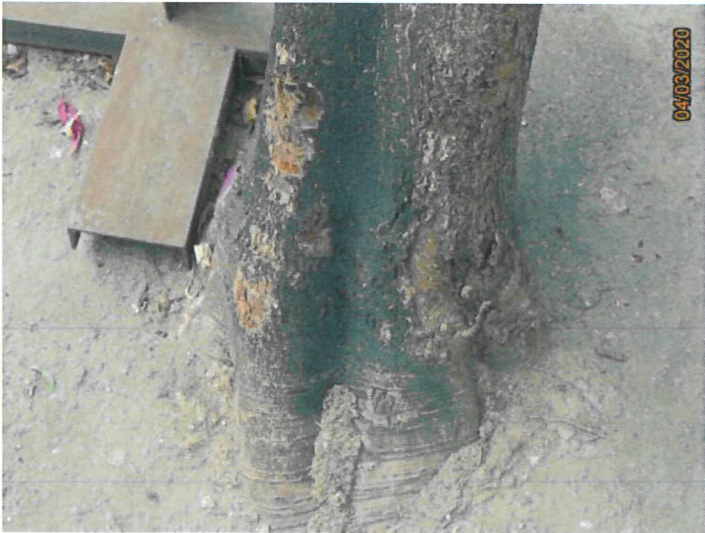
S039 - Wound on root collar

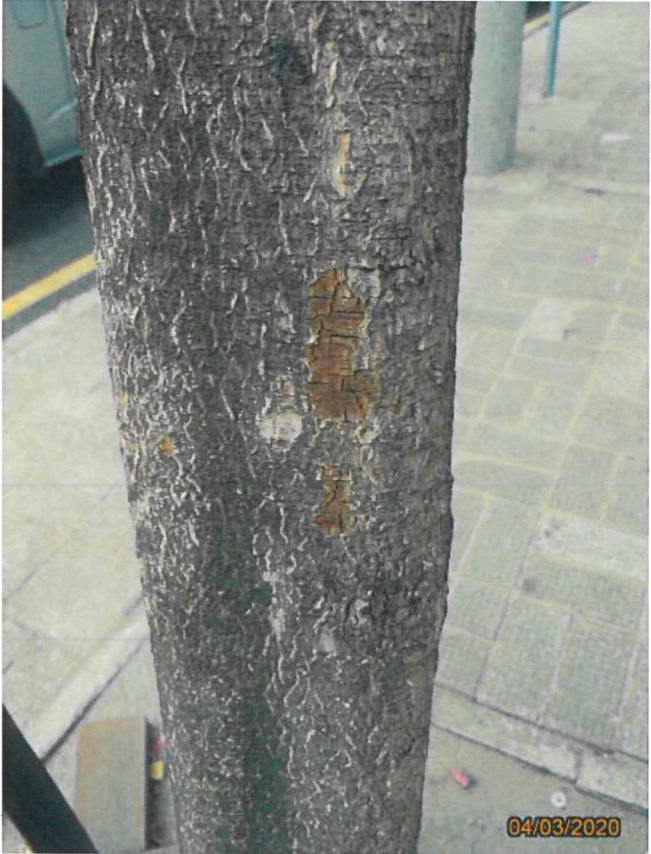
S039 - Wound on trunk

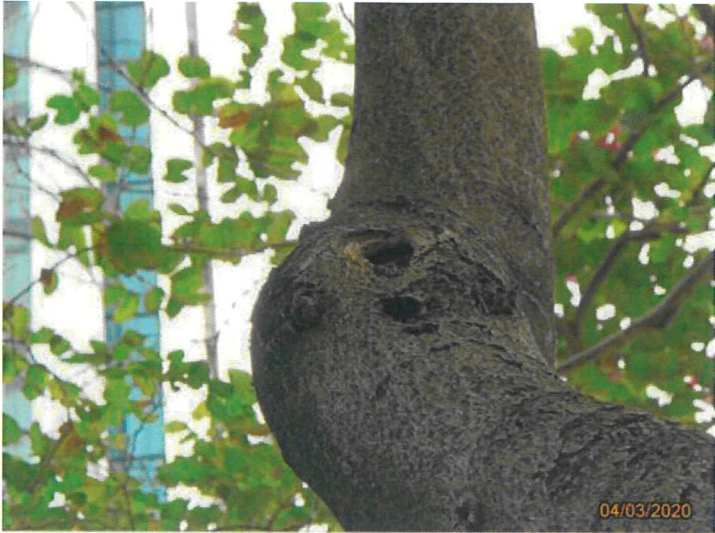
S040 - Cavity (2)

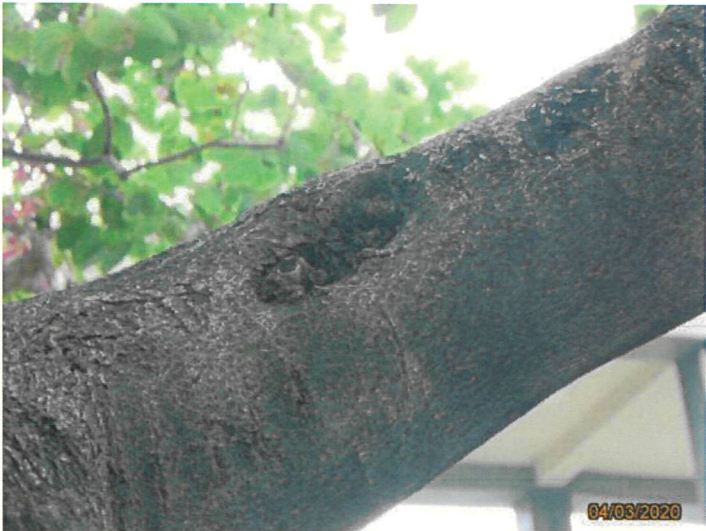
S040 - Cavity (3)

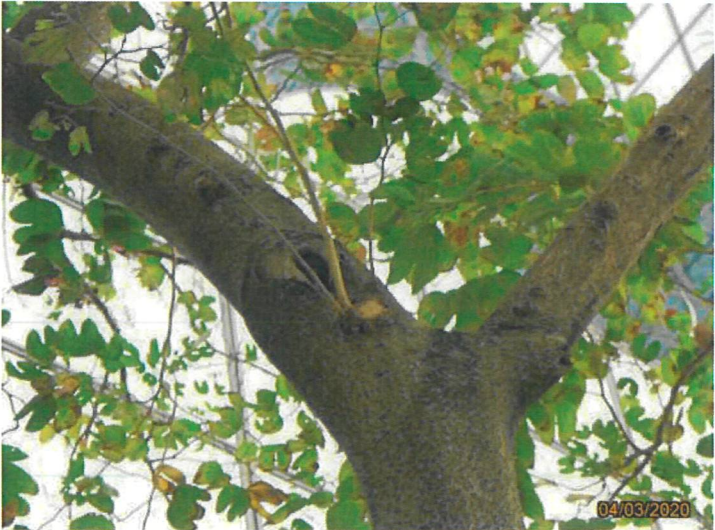
S040 - Cavity (4)

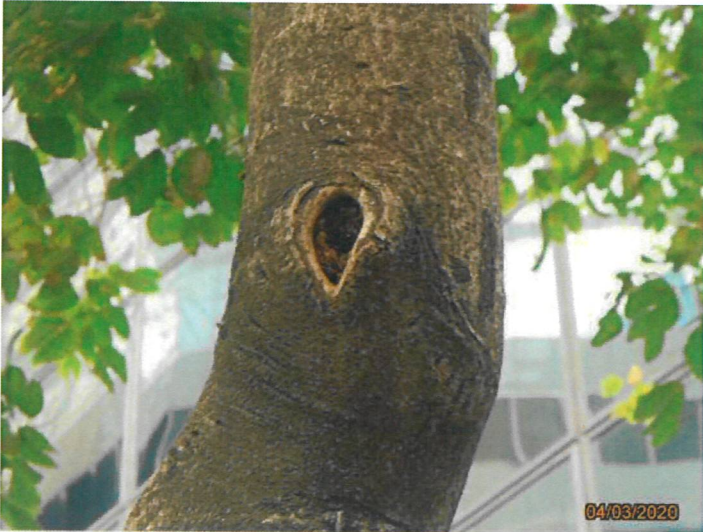
S040 - Cavity

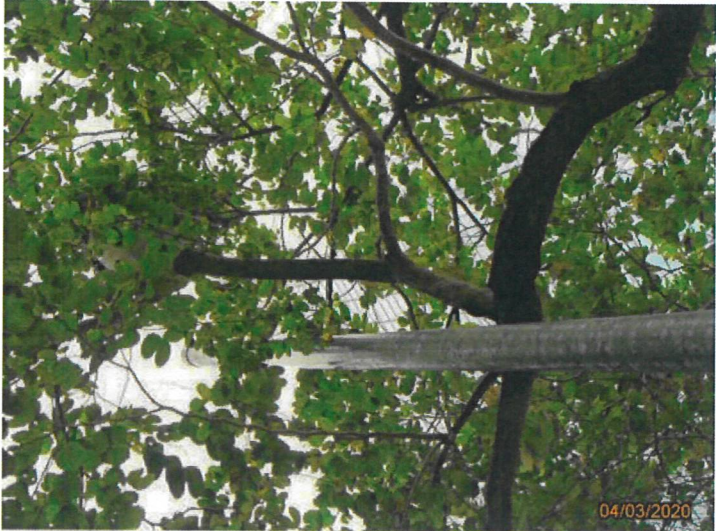
S040 - Conflict with lightpole

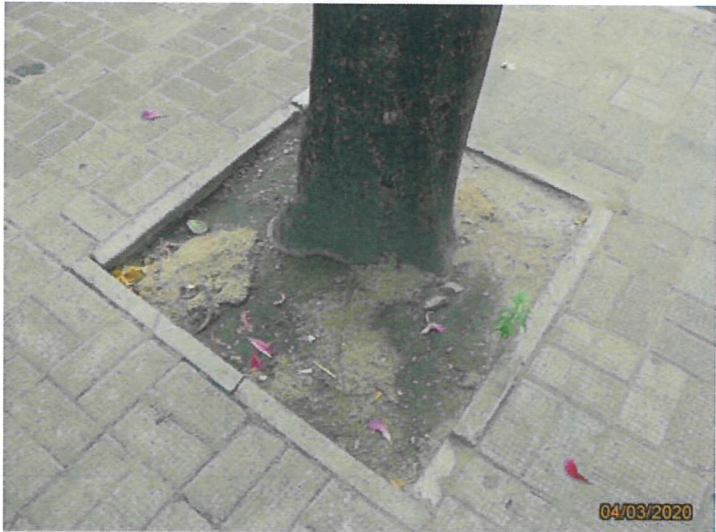
S040 - Restricted rooting area

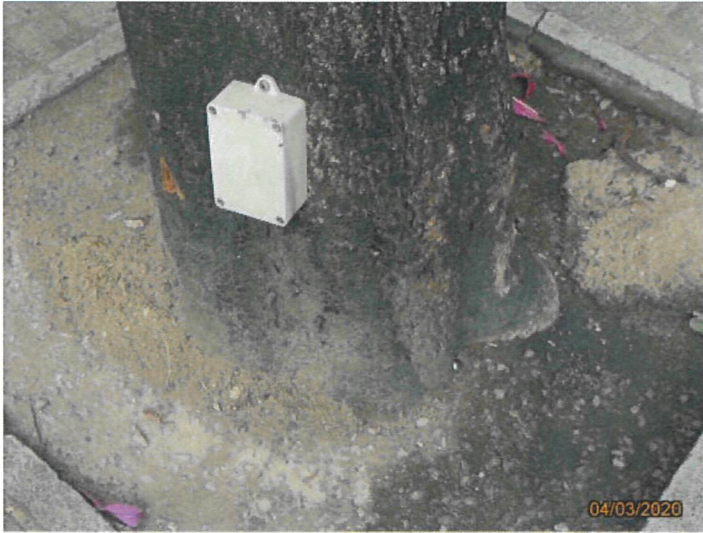
S040 - Tilt sensor attached on root collar

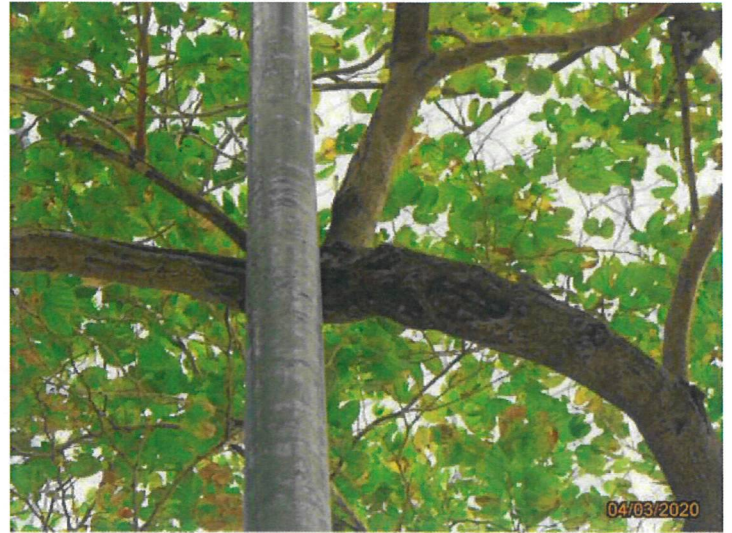
S040 - Wound on branch (2)

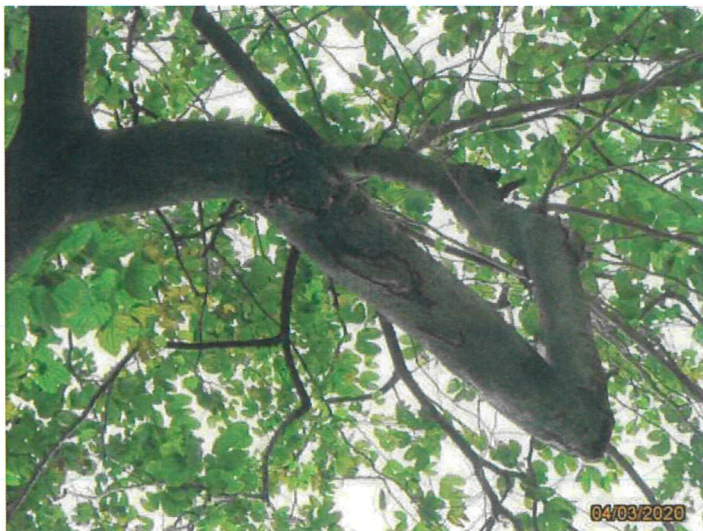
S040 - Wound on branch

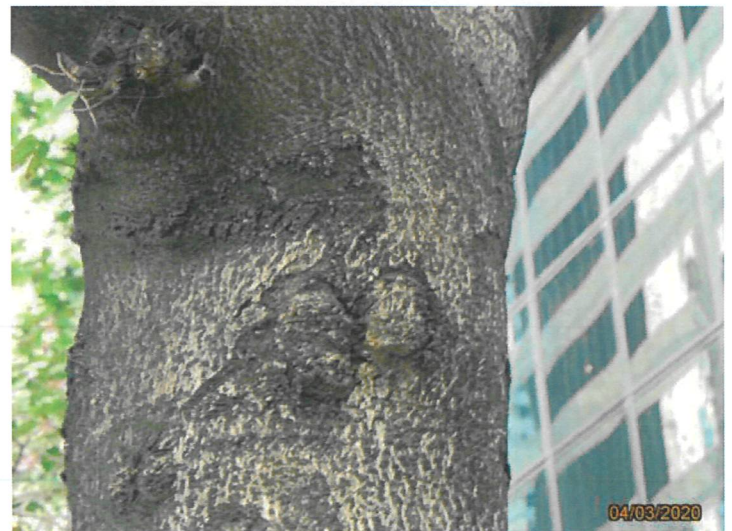
S040 - Wound on trunk

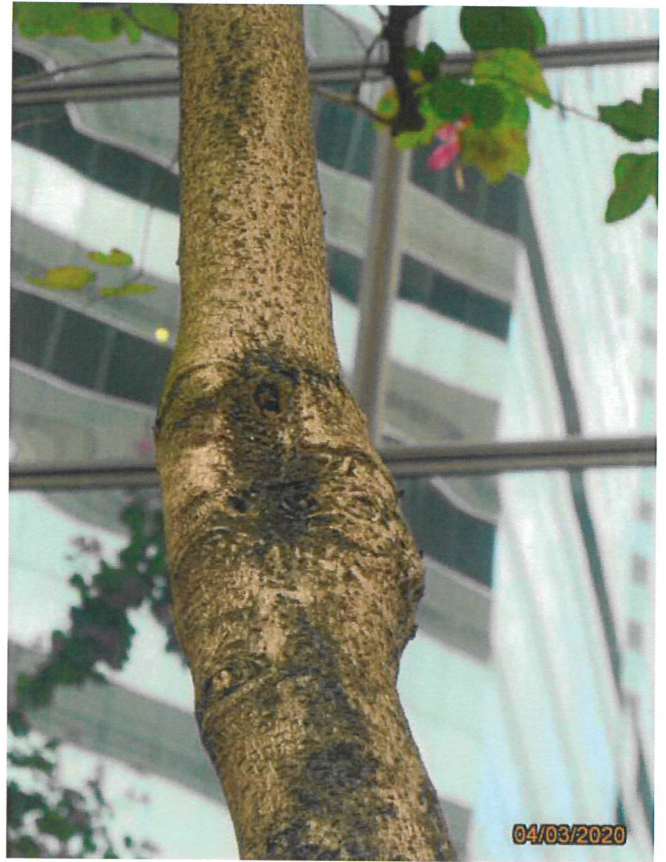
S041 - Cavity

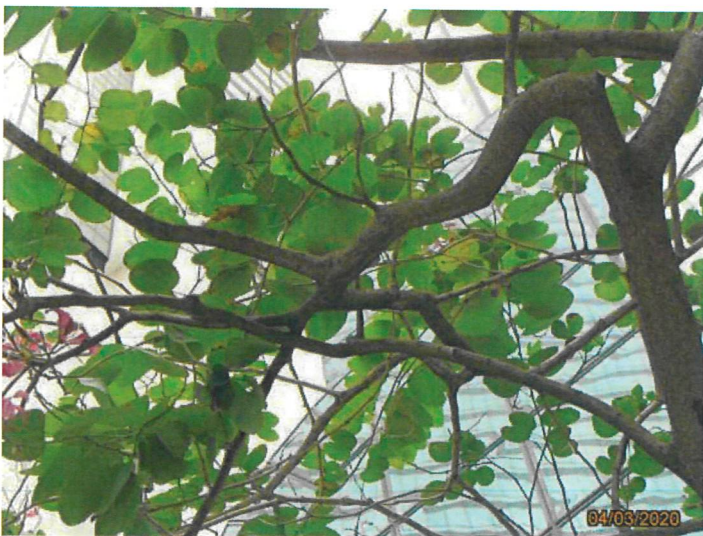
S041 - Crossed branches

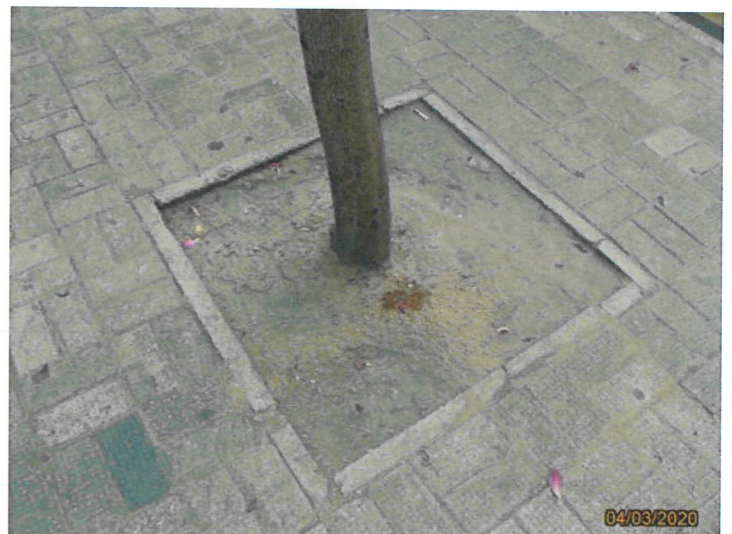
S041 - Invisible root collar and restricted rooting area
