**Shatin to Central Link
Contract 1123 – Exhibition Station and Western Approach Tunnel
Submission of Landscape Plan for Further Environmental Permit No. FEP-13/364/2009/H
and FEP-03/376/2009**

**Shatin to Central Link –
Exhibition Station & Western Approach
Tunnel**

Landscape Plan
for
FEP-13/364/2009/H & FEP-03/376/2009

LS/20426 Contract 1123_H2624 - Exhibition Station and Western Approach Runnel
Initial Tree Survey Report

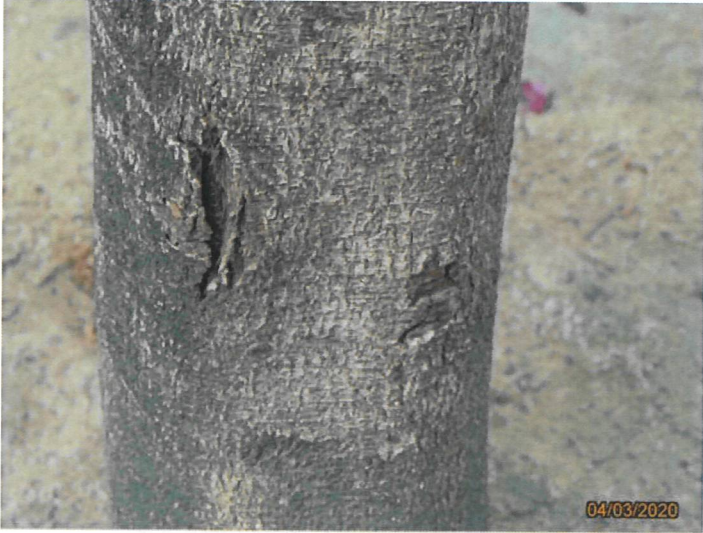
S041 - Wound on trunk (2)

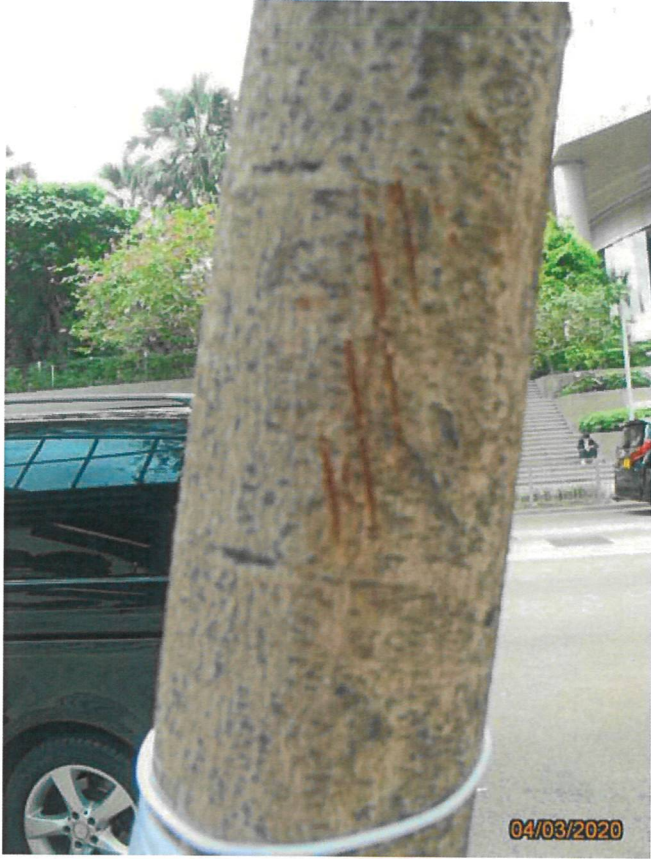
S041 - Wound on trunk (3)

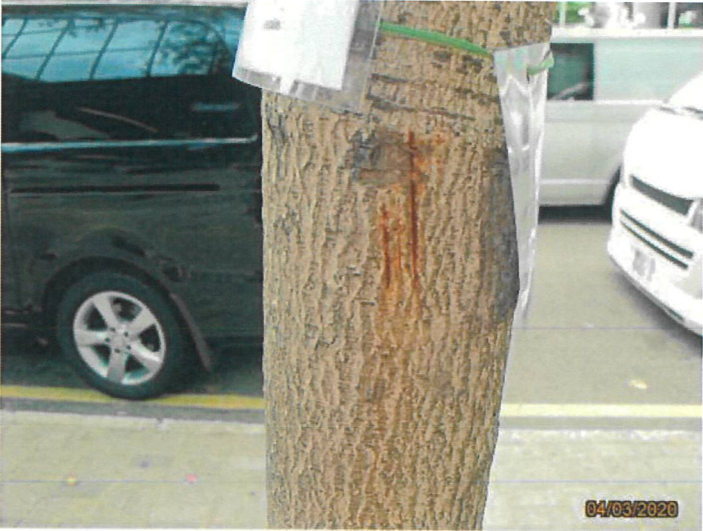
S041 - Wound on trunk (4)

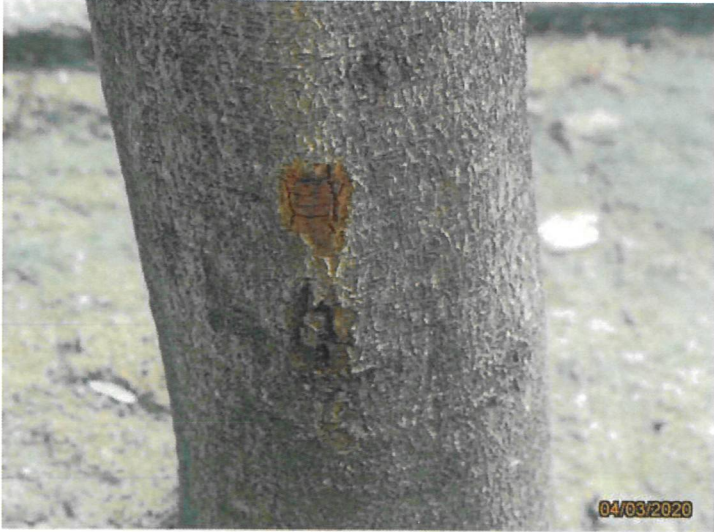
S041 - Wound on trunk

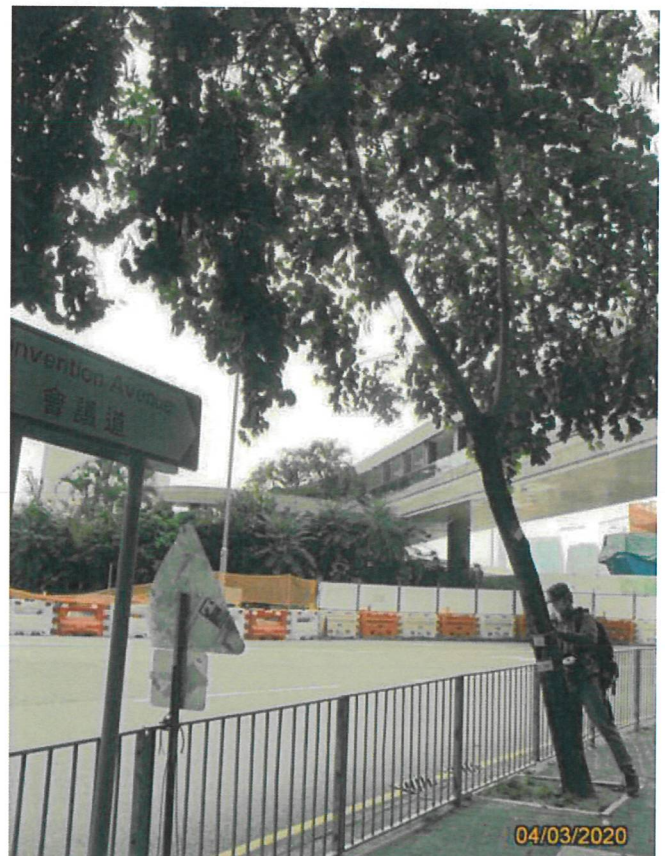
S043 - Leaning

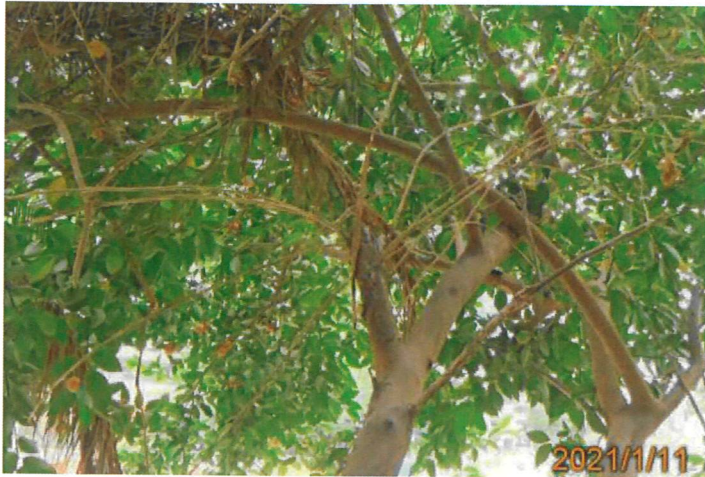
T225 - Dead branches

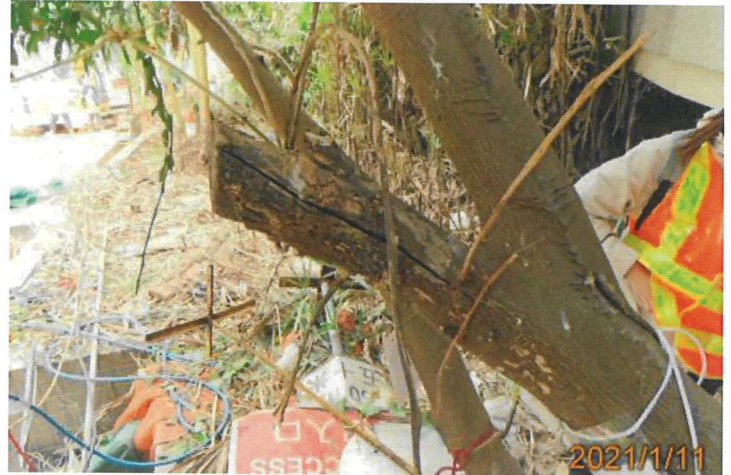
T225 - Dead stub

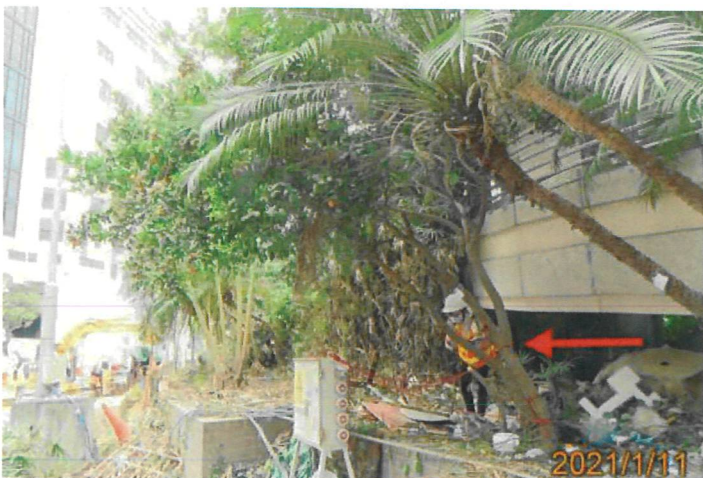
T225 - Guying with electric box

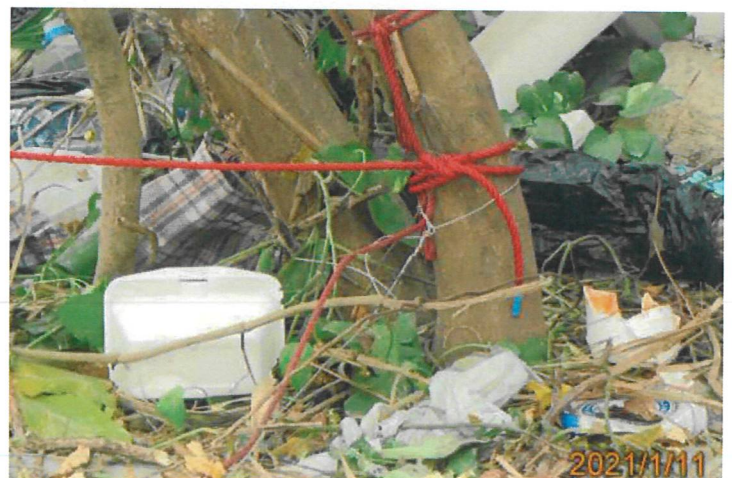
T225 - Multi-trunk

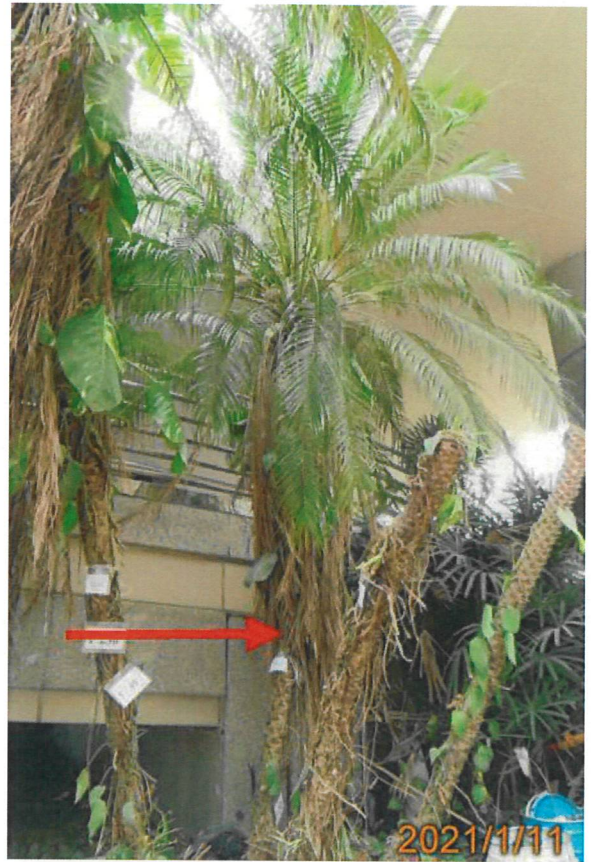
T226 - Overview and climbers on trunk

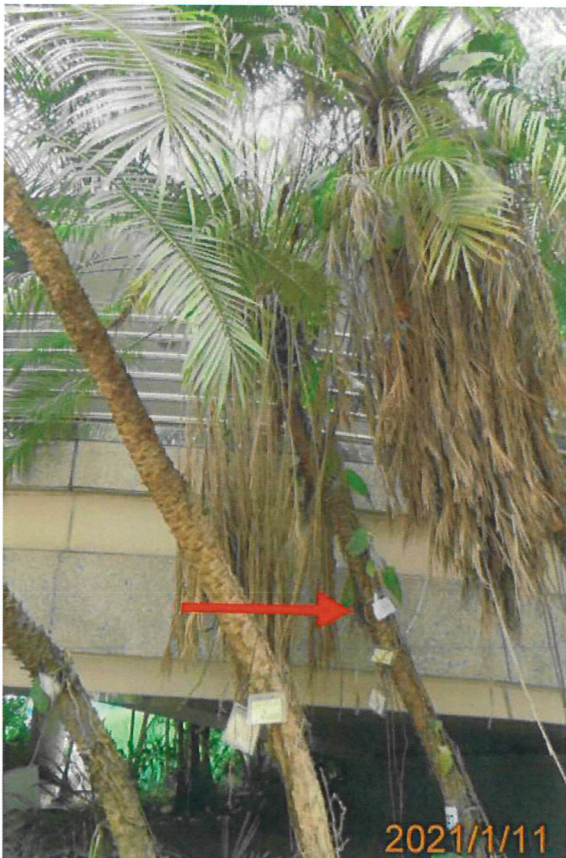
T227 - Climbers on trunk, leaning and shaded by T228

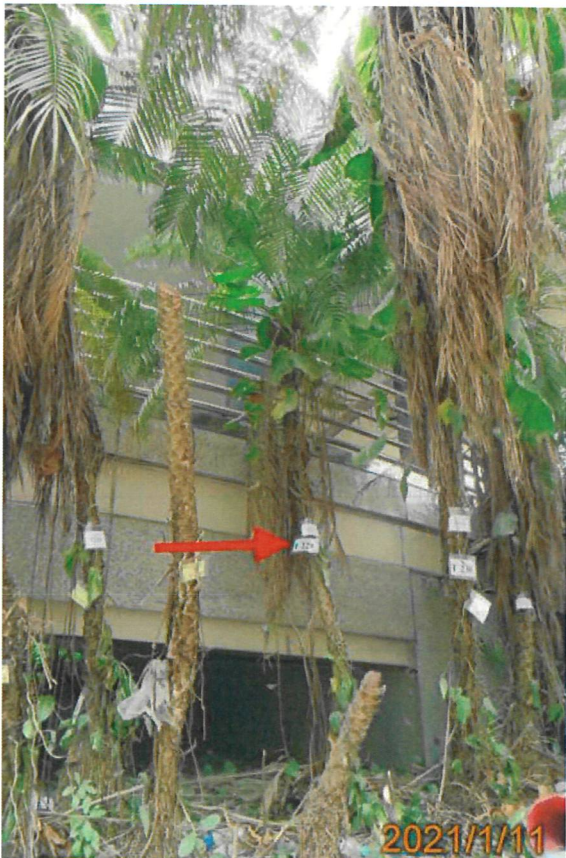
T229 - Climbers on trunk and crook trunk

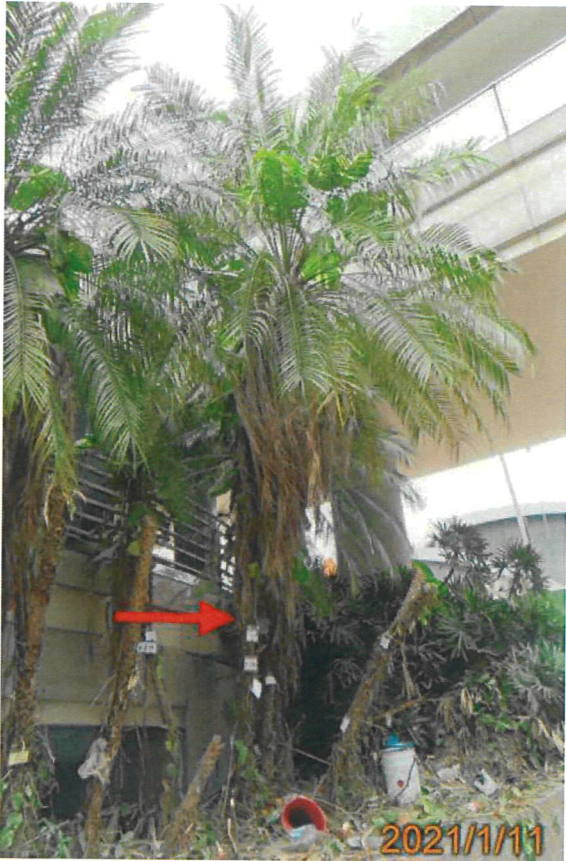
T230 - Leaning and climbers on trunk

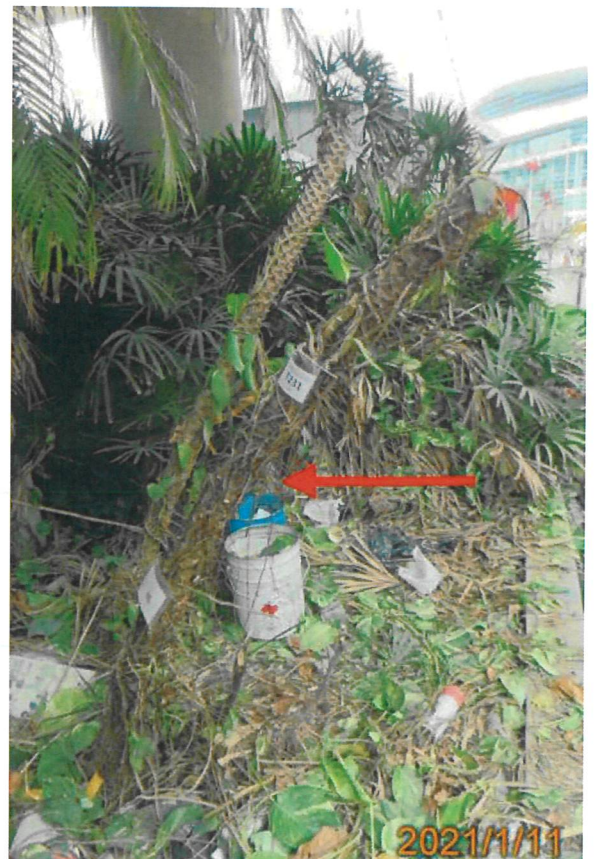
T231 - Climbers on trunk and leaning

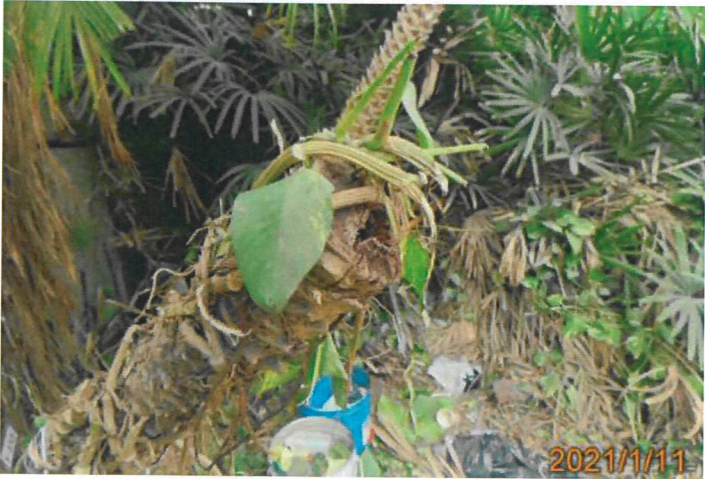
T231 - Topped and dead
